Accident Report
Entrapment Resulting in 1 Fatality
Kayak
19 August 2007
Class A

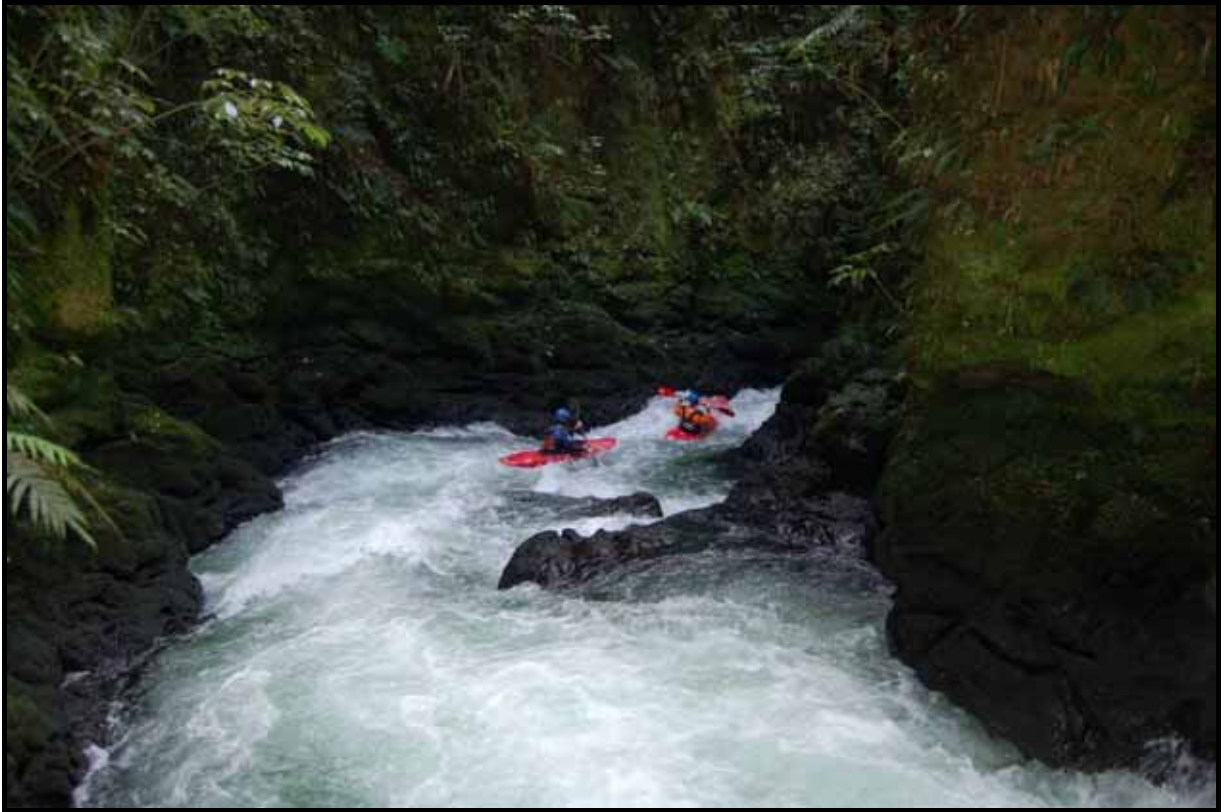
- 2.4.3 Due to the difficult terrain and winding nature of the river it is not practicable to scout all sections of the gorge. The group were aware that it was a hazardous stretch and of the danger of trees creating obstacles in the river. Before reaching the accident scene the group had passed under a tree that was suspended over the river (*Photograph 5 – Showing a section of the gorge above where the accident occurred*).

Photograph 5 (*courtesy of Andy Uhl, New Zealand Recreational Canoeing Association*)
Showing a section of the gorge above where the accident occurred
