Accident Report

Fatality

Unnamed Kayak

11 October 2006

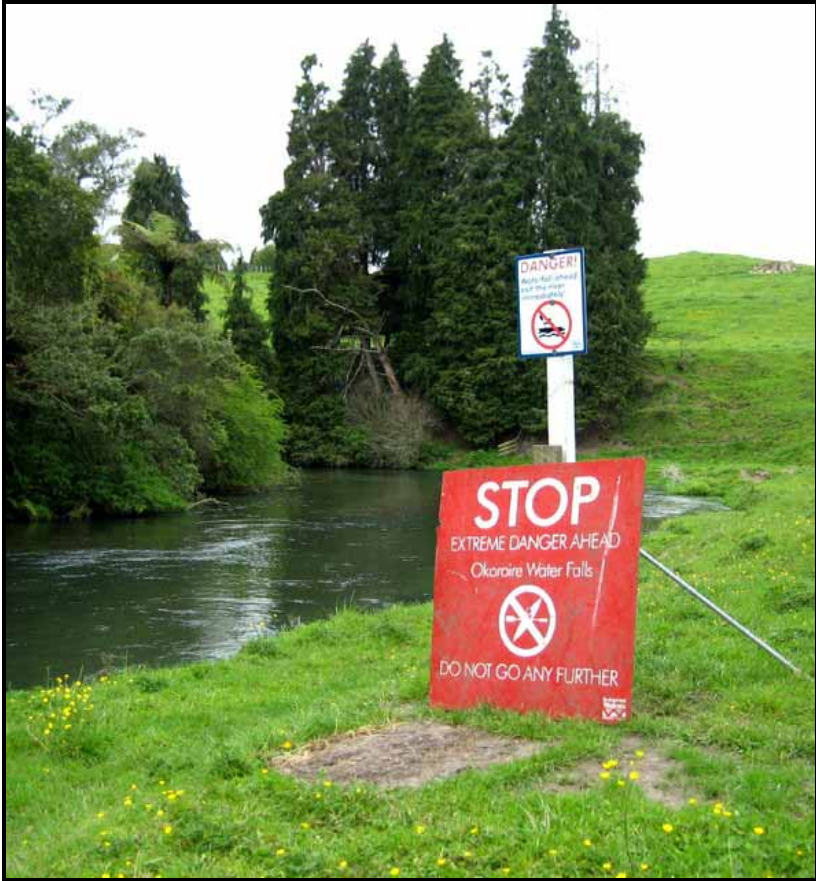
1. Warning signs:
The red sign was face down at the time of the accident.
The white sign was installed after 11 October.
The left hand bend is shown.

Warning signs are checked by EW staff annually and the sign on the right hand bank was in place when it was checked early in 2006. By 11 October it had fallen face down when it became detached from the post. The most likely explanation is cattle, which graze the area, rubbing against the sign. Following the accident on 11 October, a local kayaker informed EW that the fallen sign had been noted by kayakers in the previous weeks, but the information was not passed on.

3. The signs erected by EW in about 2002 were intended to prevent such an accident occurring. The information on the signs was clear and the erection of a large sign each side of the river indicated the importance of the issue. However, the construction of the signs was insufficiently robust to withstand either the river in flood or damage from cattle. When the first sign disappeared, no decision was made to replace it, nor was any attempt made to provide greater support for the sign on the right bank. Through this lack of action, an opportunity to prevent this accident was lost.

1. Environment Waikato replace the signs on the left and right banks and ensure the signs are substantially mounted to withstand any foreseeable flooding or other damage.
2. Those authorities with responsibility for navigation safety (regional councils, district councils and Maritime NZ) establish a section on their websites that provides safety advice to small craft operators. Information about known uncharted or unmapped hazards should be easy to find.
3. Information on the Waihou River and the danger presented at the “Okoroire Falls” should be included in the *NZ Whitewater* guide (the most commonly used guide for kayaking) when it is next revised and reprinted.

1. Immediately following the accident, as a temporary measure, Environment Waikato replaced the fallen sign on the right bank. Since that time, robust signs on substantial mountings have been erected on either river bank as well as an overhead sign. These signs, along with all others that warn of a similar level of danger in the region, are inspected monthly and records kept. A database of all signs has been established.

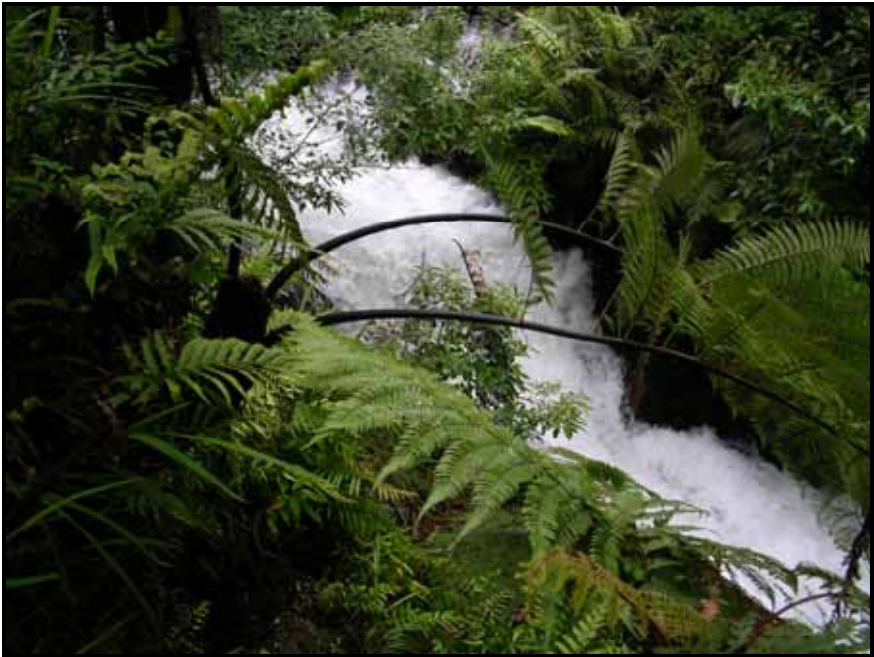
2. Rapids seen from the bush track.

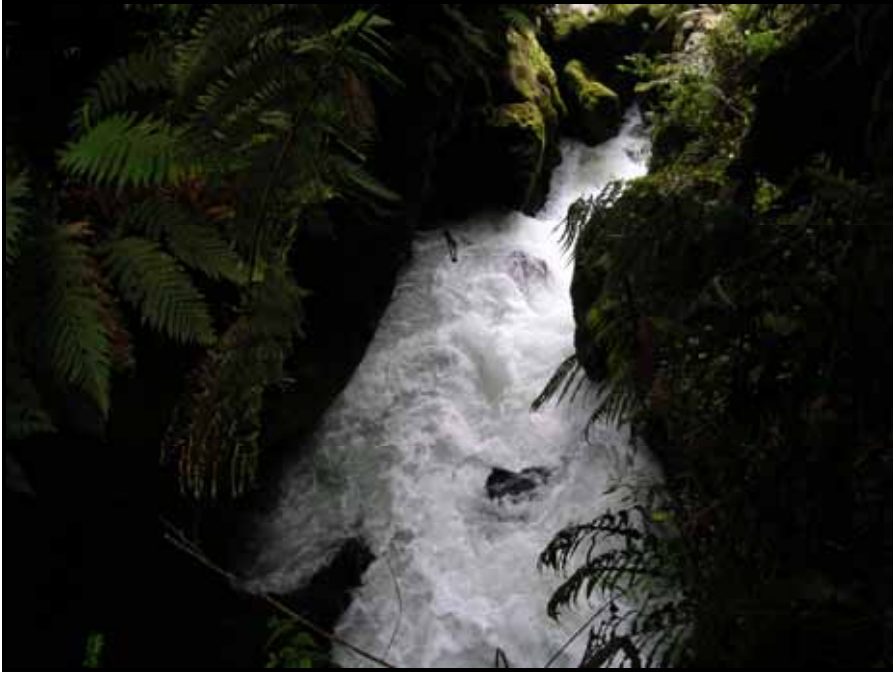
3. Rapids seen from the bush track.

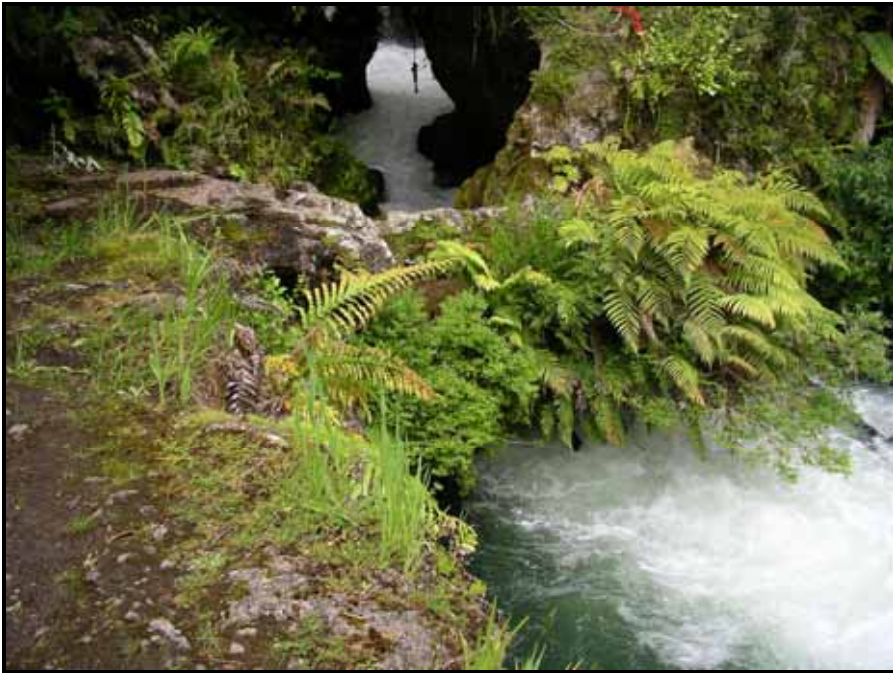
4. The natural rock bridge.

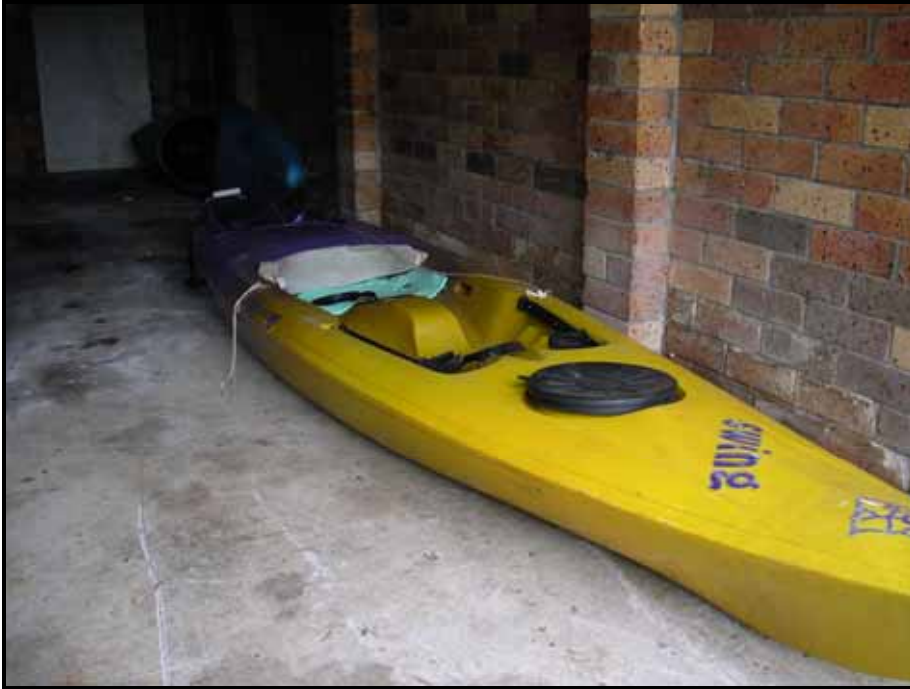
5. Skipper one's kayak. (Deceased)

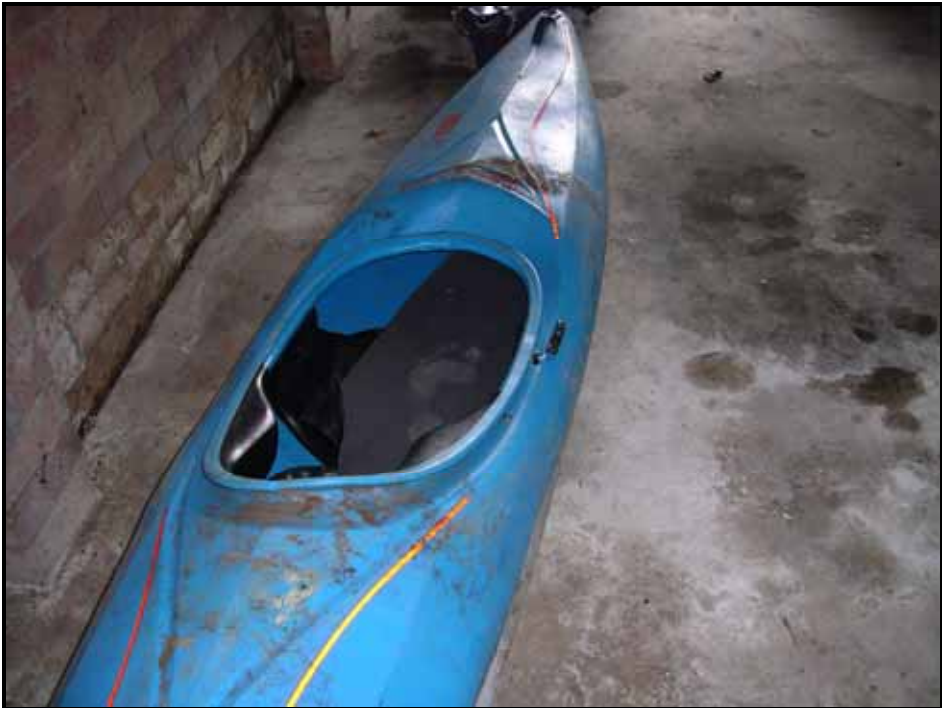
6. Skipper Two's kayak. (Survivor)
