Accident Report

Fatality

Kayak

13 January 2007

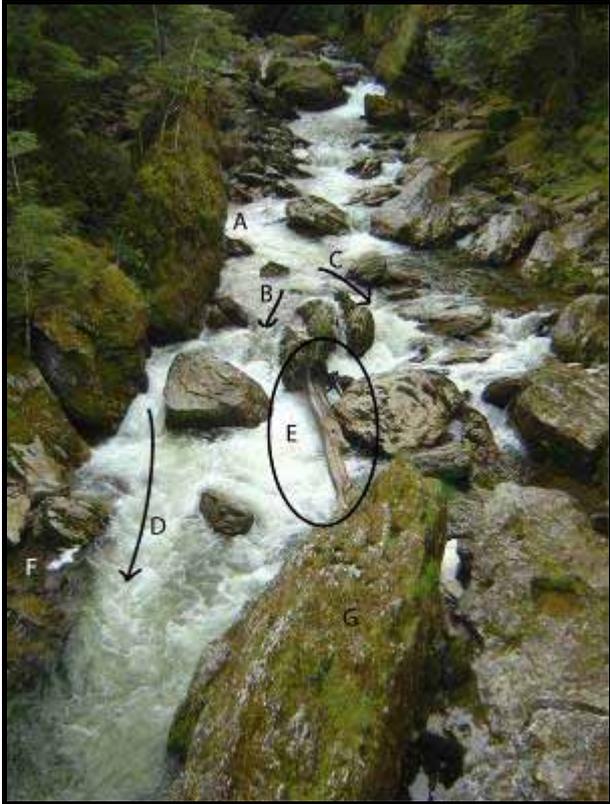
Plate 1
Accident Site Rapid

7. Dennis and his companion continued paddling down the river until they came to the rapid where the accident occurred at approximately 1500 hours. They both stopped in a small eddy on the true river right (*Plate 1, Accident site - point A*) from where they could boat scout and see the top of the rapid. The rapid was a Grade 4 rapid (*See Appendix 2*) characterised by numerous rocks with water flowing over and around them down a moderate gradient, and two obvious lines to either side of a pair of rocks (*Plate 1, Accident site - points B & C*).

8. Dennis's companion could see a clear line down the hard right of the rapid (*Plate 1, accident site - point B*). While he couldn't see all the detail of the rapid, he could see that the line he was looking at exited safely into a pool below the rapid (*Plate 1, Accident site - point D*). Based on the character of the river so far he felt confident that he could successfully negotiate any obstacles that came into view as he paddled the rapid.

The water level at the time of the accident was approximately 300mm higher.

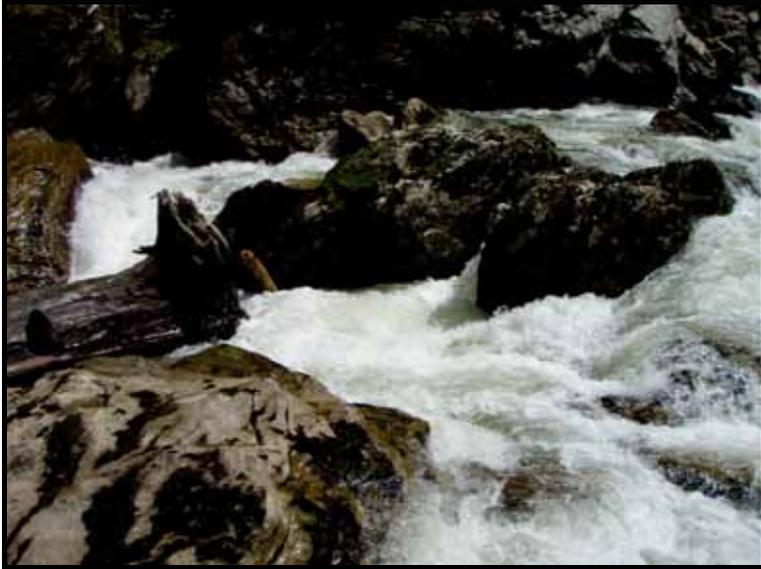
Plate 2
Accident Site (Point E)

9. Dennis's companion paddled out of the eddy and down the right hand side of the rapid. As he paddled down the rapid he became aware of a tree creating a significant strainer hazard (*Plate 1, accident site - point E*) in the line on the left of the river. He was unsure at exactly what point he became aware of the tree.
10. At the bottom of the rapid he stopped in an eddy on the right (*Plate 1, Accident site - point F*). He indicated to Dennis that he could proceed, but not that there was a strainer hazard in the rapid. Dennis's companion could see the tree strainer from where he was sitting in the eddy.

The water level at the time of the accident was approximately 300mm higher.

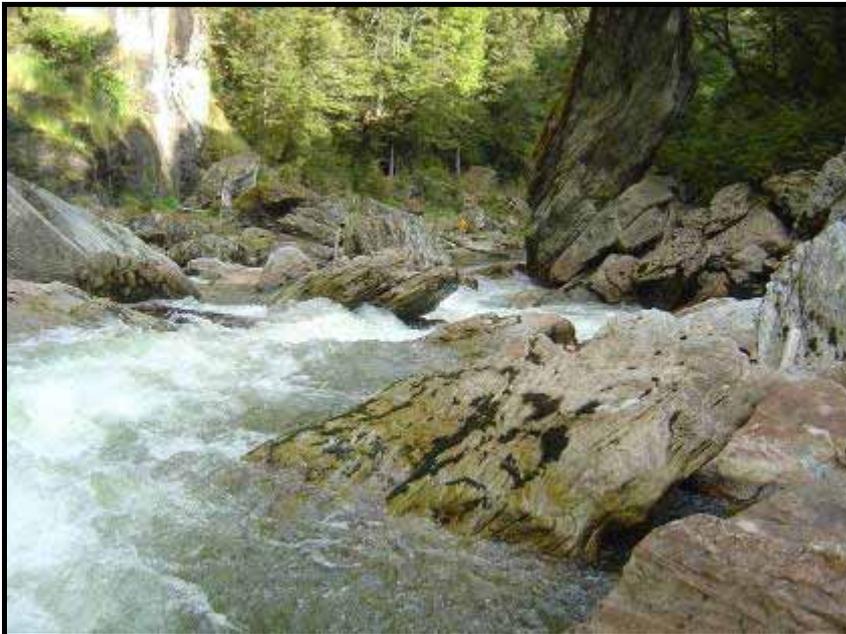
Plate 3
View of the rapid looking downstream from the eddy where Dennis and his companion began.

11. Dennis paddled out of the eddy and into the beginning of the rapid. As Dennis's companion watched, Dennis's kayak appeared to bounce off a rock (*Plate 3, point B: Point A the line Dennis's companion paddled*) and move quickly to the true left of the river, towards the line with the tree. At this point Dennis disappeared from his companions view behind rocks. His companion did not see Dennis again.

The water level at the time of the accident was approximately 300mm higher.

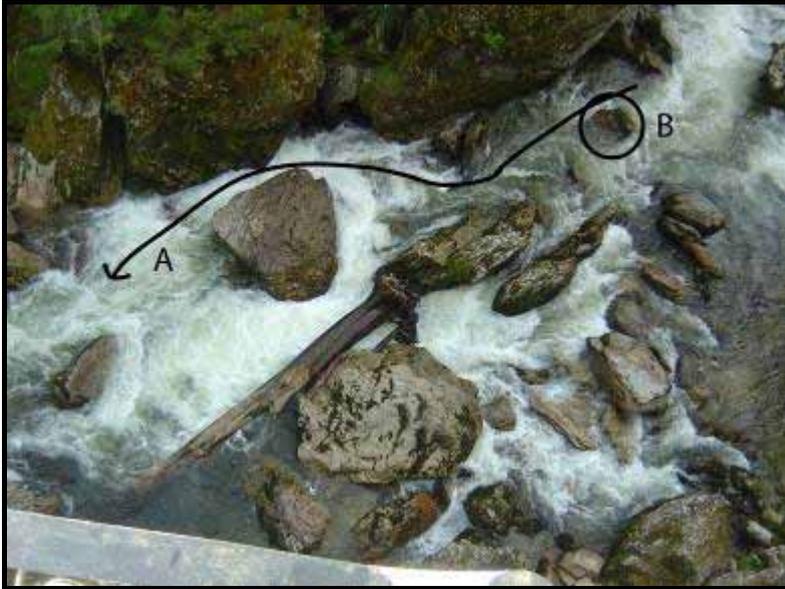
Plate 4

Accident Site showing rock (Point B) which Dennis bounced off and headed to centre left channel

The water level at the time of the accident was approximately 300mm higher.

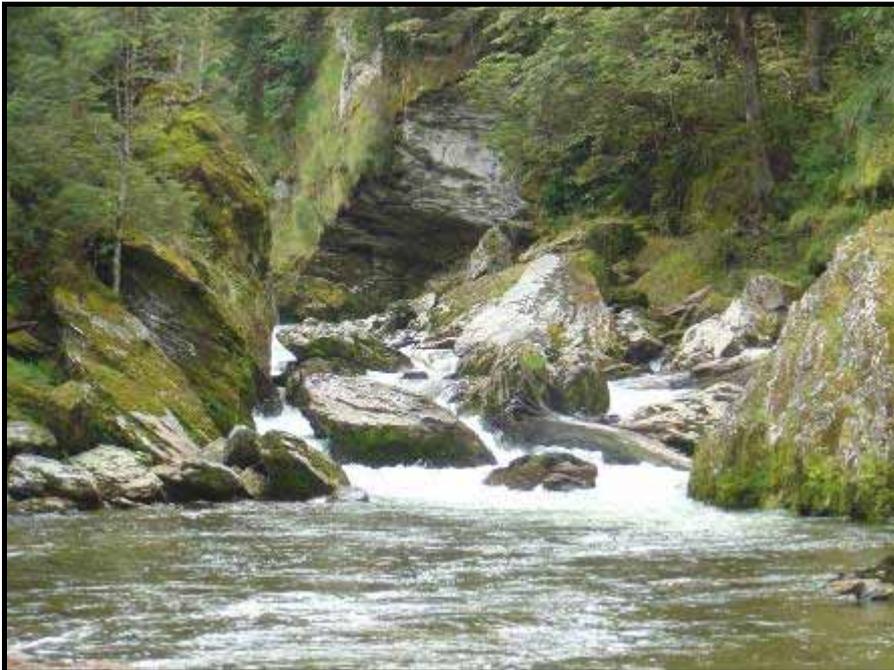
Plate 5

12. When Dennis did not appear out the bottom of the rapid his companion ferry glided to the true left of the river to look for Dennis. As he paddled across, Dennis's paddle floated out from under the log. His companion grabbed the paddle and continued to the true left side of the river. He scrambled onto a large rock on the true left (*Plate 1, Accident site - point G*) so he could look down onto the rapid. His companion continued running over the boulders searching for Dennis and blowing his whistle. He clambered down until he could look directly into the water adjacent to the tree, but could see no sign of Dennis. His companion searched for 30 minutes, then decided to go for help and began paddling downstream.

View of the rapid looking upstream from the true left.

The water level at the time of the accident was approximately 300mm higher.

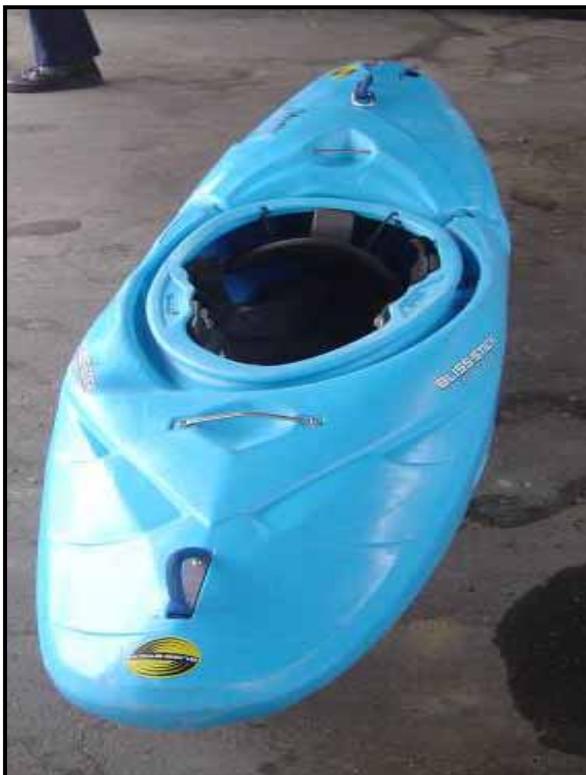
Plate 6

16. The kayak had sustained severe damage. There was a dent in the front of the kayak (*Plate 5*), a large dent in the rear underside of the kayak (*Plate 6*) and the kayak had folded and split behind the cockpit (*Plate 7*). Both of the foam structural pillars were displaced, particularly the rear one. The bottom of the rear pillar had slid out sideways and the top had popped free of its plastic bracket allowing the kayak to bend longitudinally. The seat had twisted and was out of place

Dent on right side in front of cockpit

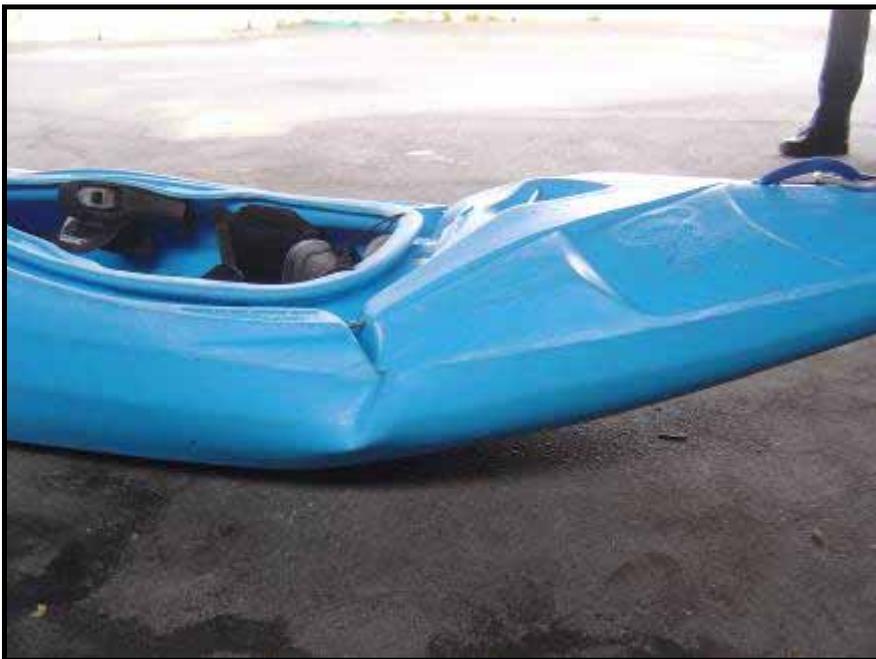
Plate 8
The fold behind the cockpit

10. It is probable that the prolonged exposure to the constant force of water against Dennis's body created a gradual lateral torque being transferred through to the kayak seat resulting in seat and pillar displacement. The displaced foam pillars and the constant pressure on the back deck of the kayak gradually resulted in the structural integrity of the kayak being compromised and the kayak being folded behind the cockpit. The manufacturer indicated that directly behind the cockpit is the weakest part of the top deck of the kayak. In the event of a severe pin the kayak is less likely to fold through the cockpit, or front deck therefore reducing the potential for entrapment in the kayak.

5. Dennis's body was entrapped underwater in his kayak from the afternoon of the 13 January through to 17 of January, approximately 3.5 days. The volume of the river fluctuated up to 20 cumecs during this time. The constant force of water on an entrapped person and pinned kayak results in substantial pressure. The prolonged exposure to the force of the water resulted in the kayak being folded.

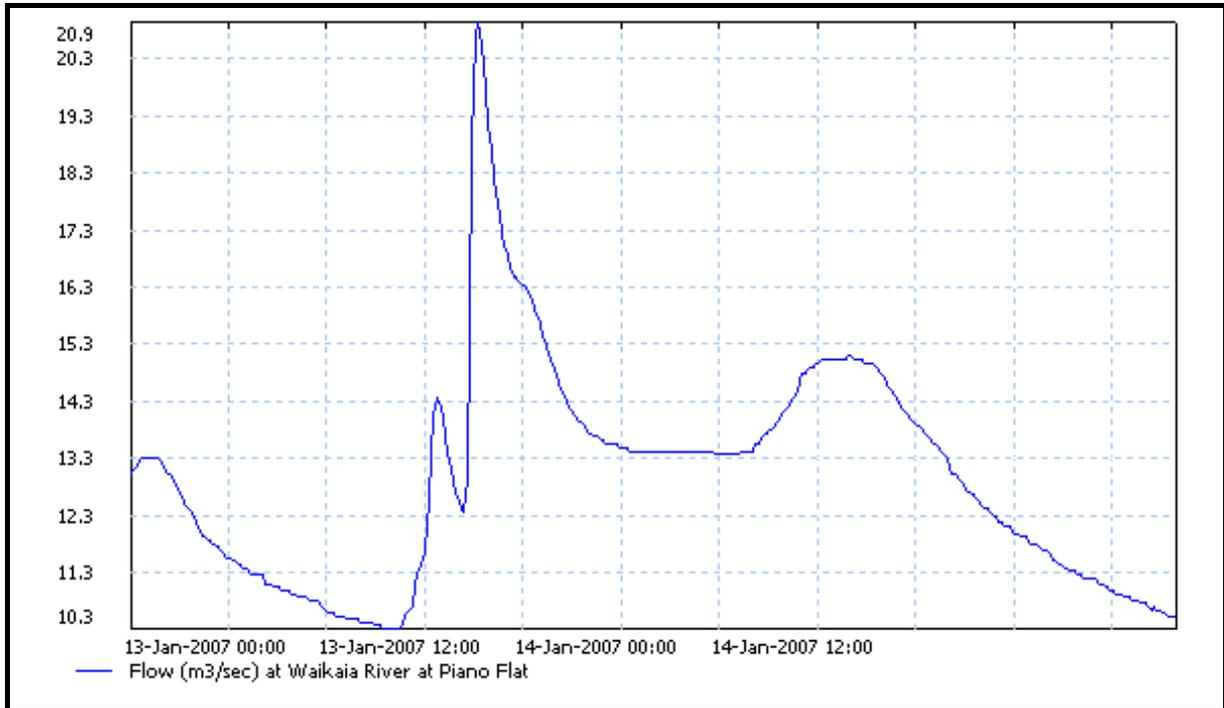
9. The Waikaia River was flowing at approximately 10.5 cumecs at the time of the accident (*see Appendix 4*). When Dennis and his companion put on, the river was at approximately 11 cumecs. It had been dropping steadily during the morning, but began to rise quickly later in the afternoon. Dennis and his companion had checked the river flow gauge the evening before the trip. It was 14 cumecs; towards the low end of the paddleable range of 10 – 50 cumecs according to the guide book they carried - *New Zealand Whitewater – 120 Great Kayaking Runs*, Graham Charles, 1999 (see Appendix 5). They were also aware that fine weather was expected for the next few days and they expected the river would continue to drop below a paddleable level. From the time of the accident until Dennis's body was recovered the river rose to approximately 20 cumecs and then dropped back down to below 10 cumecs.

River Flows recorded at Piano Flat on the Waikaia River on 13 and 14 January 2007.
