# Accident Report

Grounding

*Venture*

18 April 2006

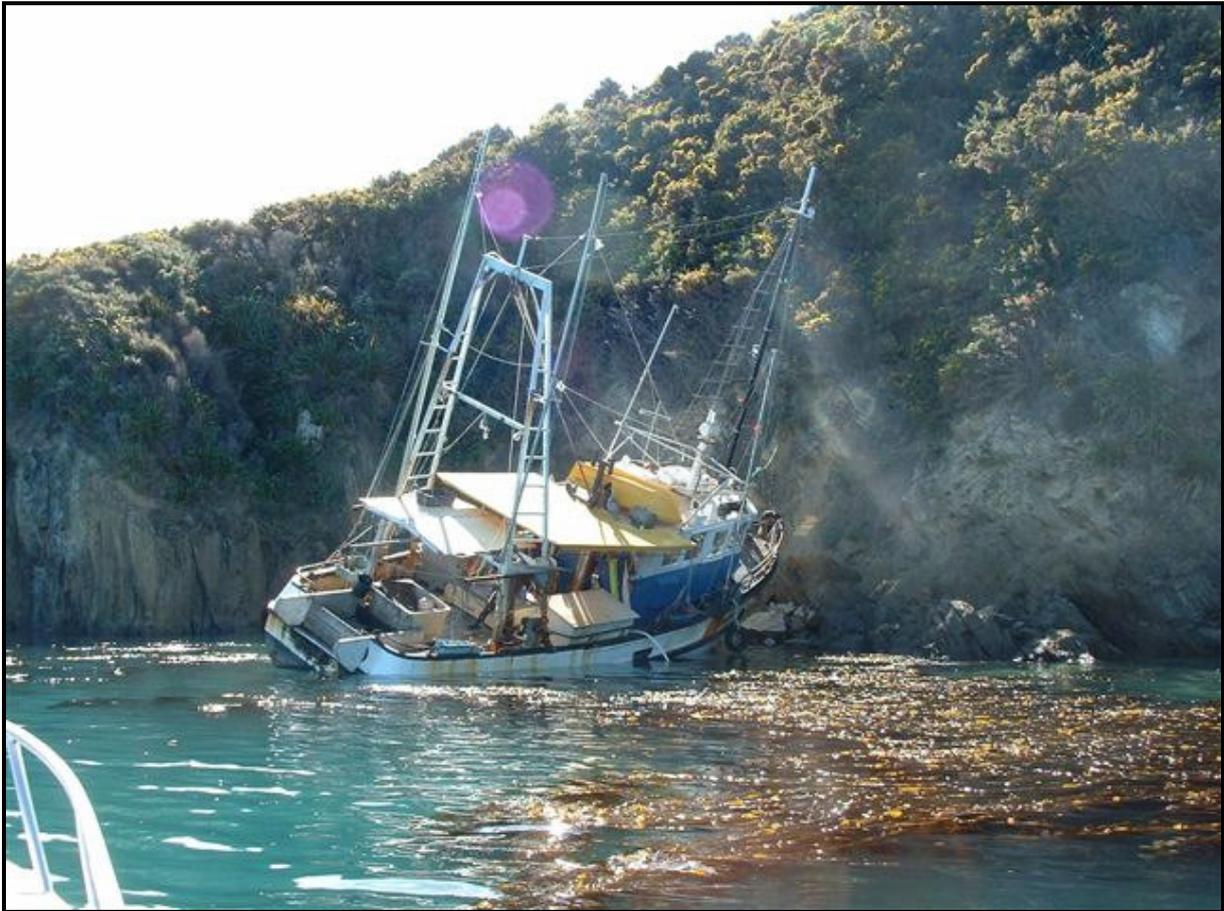
**Photograph 1**  
**Venture** aground

**Venture** sailed at approximately 2130 hours, shortly after the Skipper's nephew arrived on board, and proceeded outwards through Tory Channel at her cruising speed of 5 knots. The Skipper had the con and his nephew was also in the wheelhouse. The Deckhand was turned in and was going to take over the watch when the vessel cleared Tory Channel. The Skipper was steering by auto pilot and was sitting in a comfortable chair. At about midnight the Skipper's nephew turned in on the wheelhouse settee. Shortly afterwards the Skipper fell asleep in his chair, which resulted in **Venture** running aground on the north eastern side of Te Rua Bay, immediately to the east of Clay (Te Uira-Karapa) Point, Tory Channel.

The vessel grounded on sand and the force of the grounding was such that neither the Deckhand nor the Skipper's nephew woke up.

As the vessel lay over on the falling tide some water entered the after hatch. The space was pumped out several times to keep it dry. The hull remained watertight. The bow was caught on a sandbank but the stern was in deep water.

**Venture** had been at sea for eight days fishing with a two-man crew. In such circumstances a degree of fatigue is inevitable. The Skipper stated that, with the benefit of hindsight, it would have been better to be standing and hand steering the vessel on the outward-bound passage, and that in future he would not use the seat in pilotage waters.

1. The Skipper of **Venture** be censured for failing to observe **Marlborough District Council Navigation Bylaws 2002 3.3 (iii)**.
2. The Skipper of **Venture** establish procedures for managing fatigue on board his vessel as required by **Maritime Rules Part 31C.15**. These procedures should be presented to the Safe Ship Management Company for approval within 2 months of the release of this report.
