Accident Report
Foundering resulting in 2 fatalities
Viper 1
16 March 2009

Maritime New Zealand

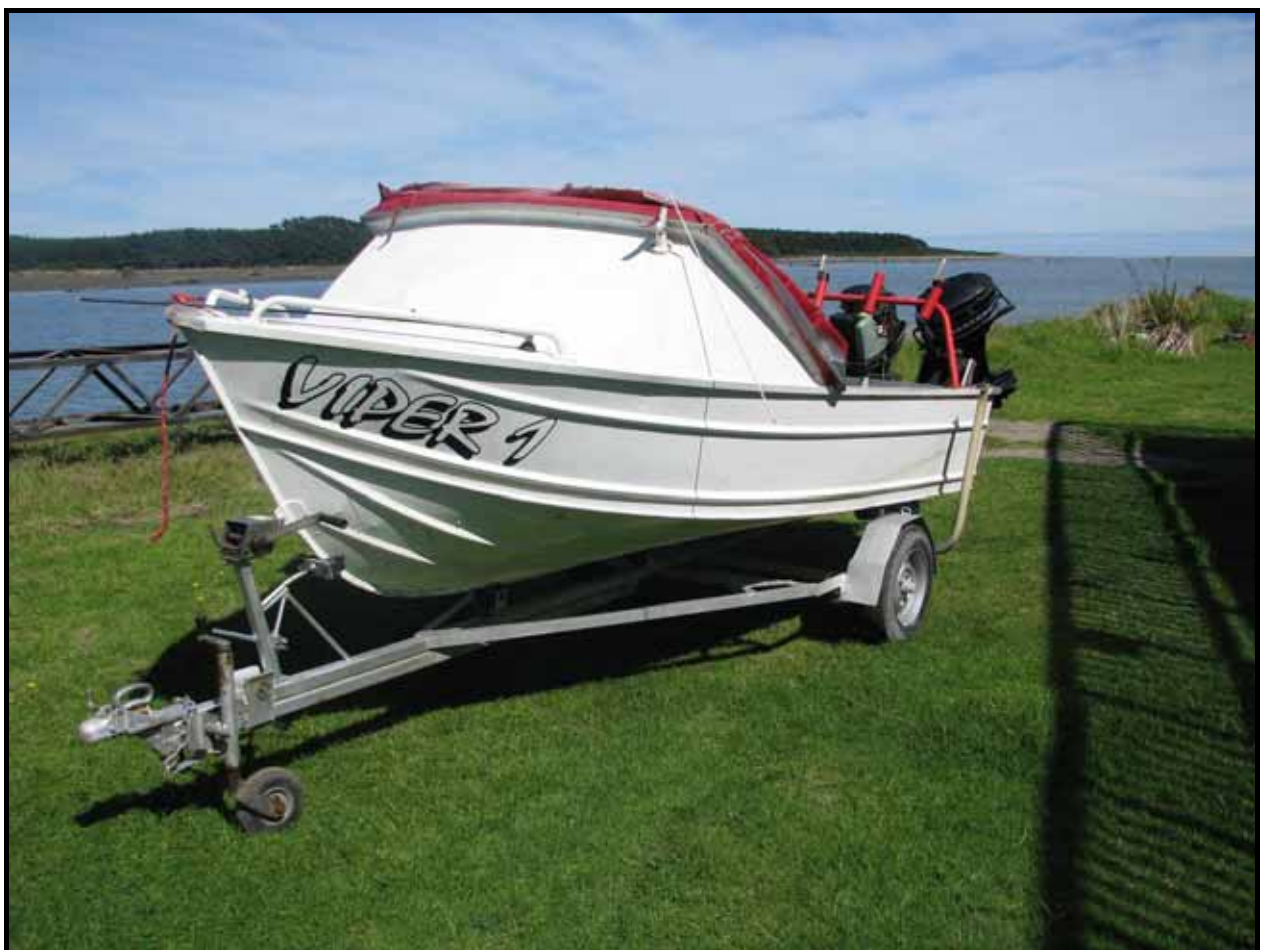
Photograph 1
Viper 1 post recovery.

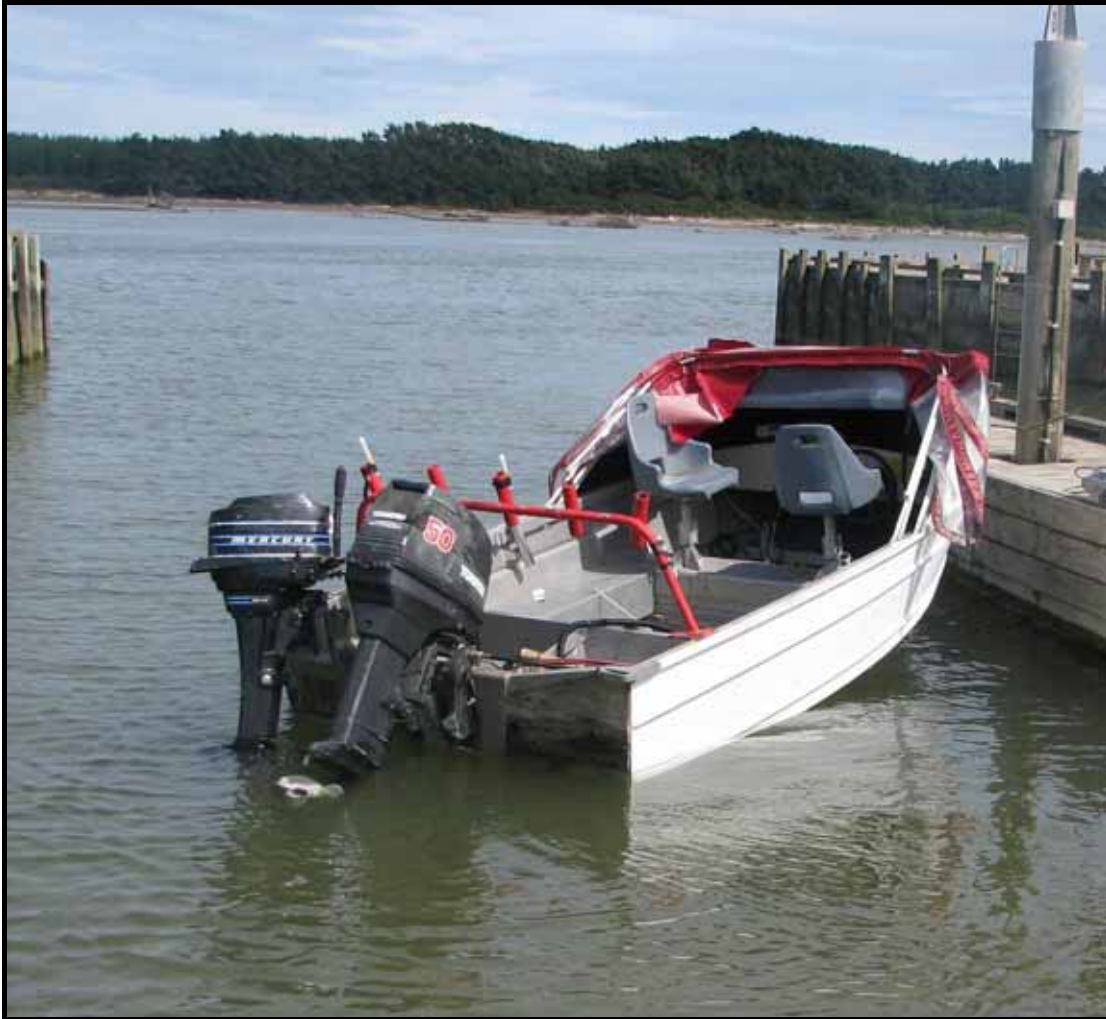
Photograph 2

The rod holder, pedestal seats, canopy, and plywood stern strengthening added to the vessel.

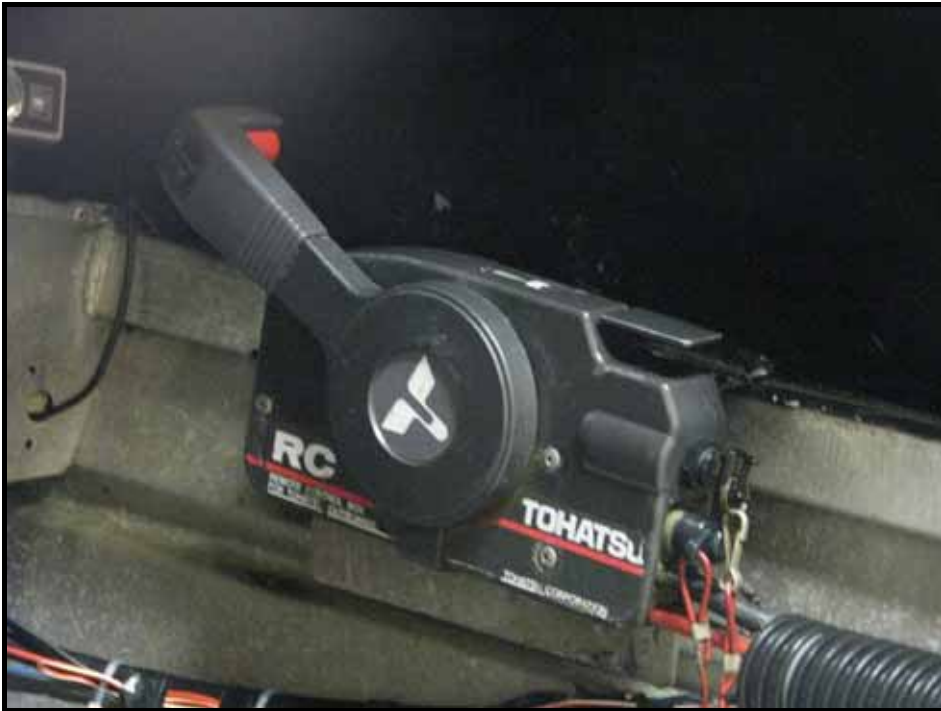
Photograph 3

- 3.8 The remote functions of the Tohatsu operated correctly. The key was found turned on, the engine was in the forward gear and the throttle was set at three-quarters. The Tohatsu manual describes that set in this position the engine would produce 3,750–4,275 rpm, indicating the vessel was well underway, or attempting to get underway, at the time it foundered.

The throttle at the three-quarter position.

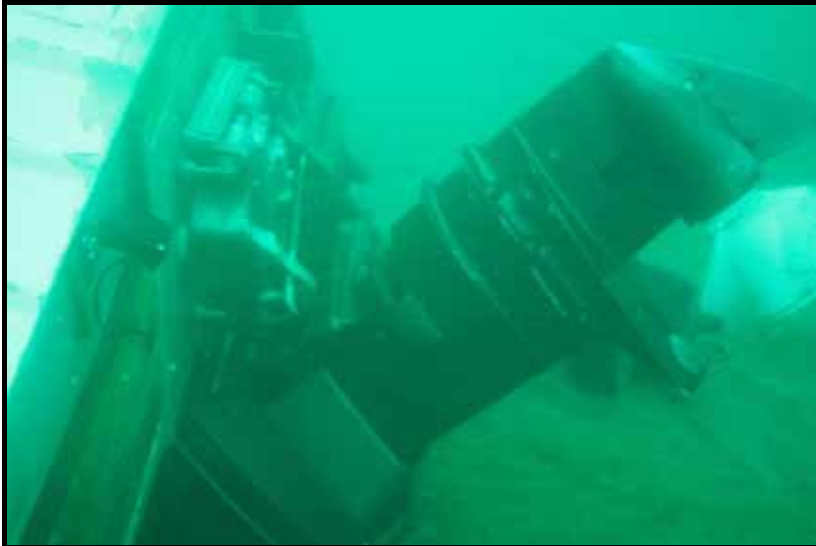
Photograph 4

- 3.12 When recovered, the engine was found to be in the full trim position. It is common for recreational boaters to trim an engine in this manner when negotiating an area where the propeller may touch the bottom, such as launching from the beach. When doing this it would be highly unusual for the vessel to be driven quickly with the throttle at three-quarters as was the case with *Viper 1*.

- 3.13 The high trim position of *Viper 1’s* engine could have resulted from two scenarios. One – the skipper may have intentionally raised the engine to this position. However, the only logical explanation for the skipper doing this is that the vessel was sinking at the stern and he was attempting to keep the engine’s air intake above the water. The second scenario is that the skipper may have been trying to trim the engine a little but the trim button stuck, causing him to temporarily lose control of the trim function, and the engine lifted completely.

Taken on the seabed, showing the trim of the engine.

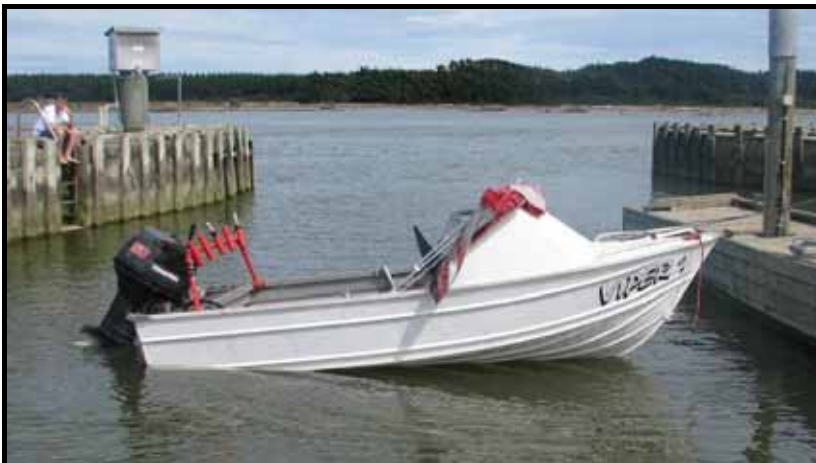
Photograph 5

- 3.14 A 9.8 horsepower Mercury, model 110, auxiliary outboard engine was also fitted to the vessel. This model was produced in the late 1970s, and when removed from *Viper 1* weighed 34 kg. The auxiliary engine was mounted on a standard auxiliary bracket, which hung slightly off the port quarter, exaggerating its weight.
- 3.15 At a conservative estimate, the total weight on the stern, which includes the engines, fuel and battery, was somewhere between 147–154 kg. This does not include the galvanised rod holder or any additional fishing equipment or weights that may have been in the vessel at the time it foundered.
- 3.16 This added weight had an overall affect of significantly reducing the stern freeboard of *Viper 1*.

Viper 1 sitting low in the stern.

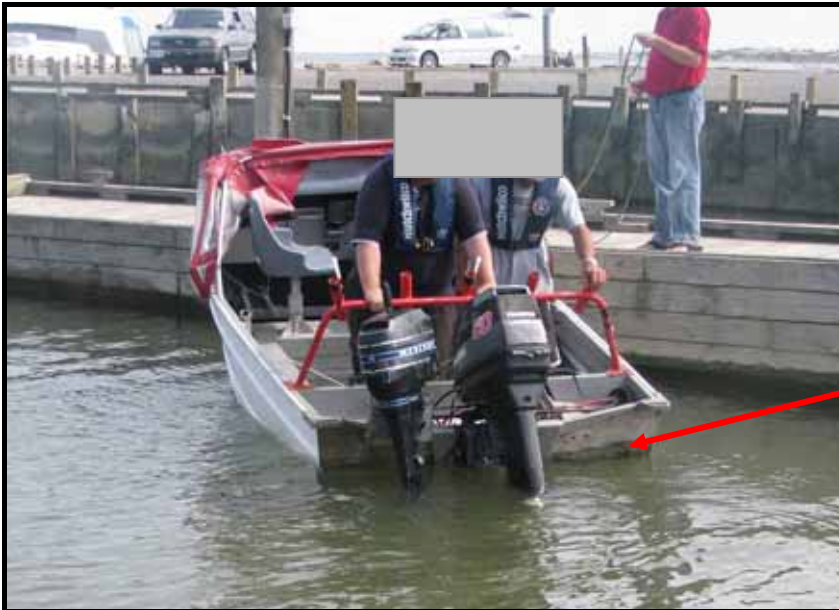
3.17 Photograph 6 shows the extent that the freeboard of *Viper 1* could be reduced with two people near the stern. Note how the extra weight of the auxiliary causes the vessel to list port side. The port transom-well drainage hole is submerged as a result, while the starboard transom-well drainage hole is sitting on the water-line. The general purpose of these drainage holes is to allow any water that may slop into the transom to drain out. They are not intended to allow water ingress into the transom-well.

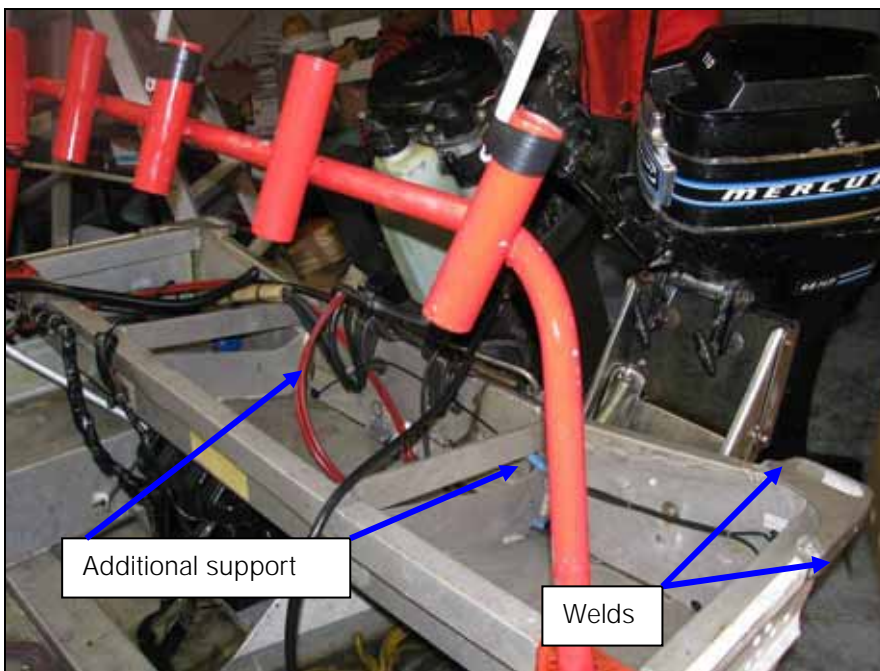
Photograph 7

3.18 Extra structural support had been added, and several repairs made, to the transom of *Viper 1*. The repairs included welds in the corners of the transom. The welds were free from defect and appeared to be in good order, however, they indicate that at some stage the transom had come away or been damaged and needed repair.

The welded repairs and additional transom support.

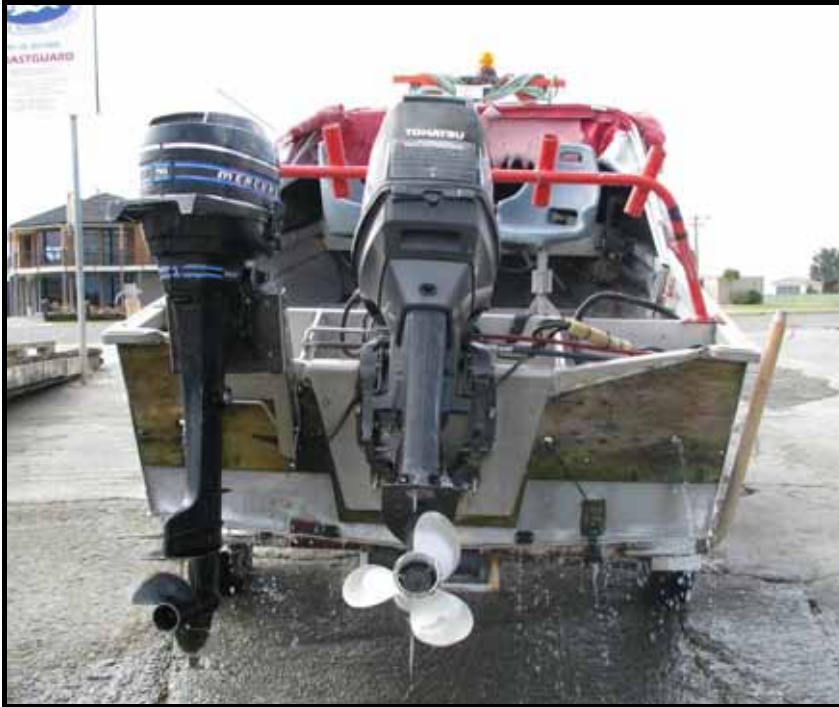
Photograph 8

- 3.19 A piece of marine plywood had been attached to the transom to offer further support. The investigation could not determine when this was attached or by whom. The plywood showed signs of weathering and had begun to deteriorate, with rot showing in some areas giving the appearance of having been on the vessel for several years. The plywood had also come away from the stern by as much as 15 mm around the transom-well drainage holes. This allowed water to freely ingress behind the plywood, placing additional weight and pressure on the stern.

The marine plywood attached to the stern.

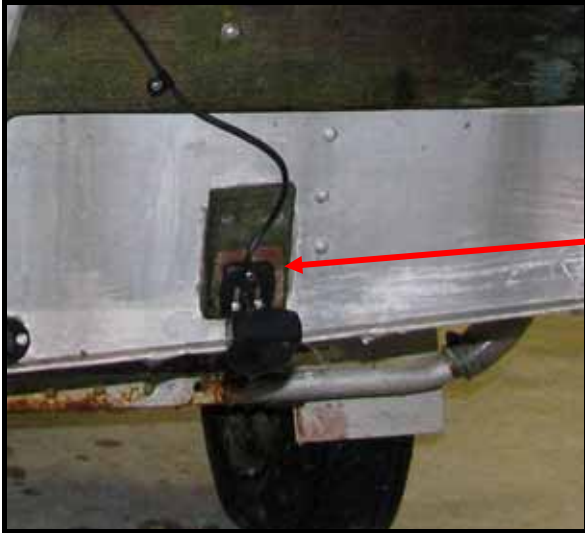
- 3.20 A Humminbird Matrix 12 depth sounder had been added to the vessel. The transducer for this was attached to a block of marine plywood on the transom and appeared to have replaced an older transducer. Two screw holes from the old transducers were not filled, allowing the ingress of water into the hull. The investigation was unable to determine exactly when this was replaced, however, the skipper's family believed the skipper had fitted the depth sounder sometime within the last 2 years.

New transducer mounted on top off old fitting

Photograph 9
New transducer.

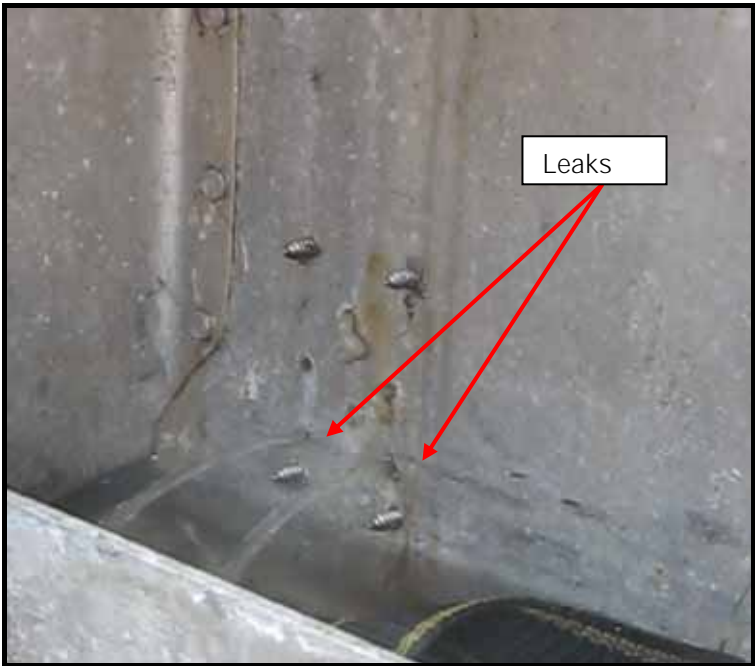
Leaks

- 3.21 Photograph 10 shows water flowing freely through the two old transducer screw holes. These holes are situated behind the battery box on the starboard side of the vessel. Two other old holes had been repaired with silicone sealant, and it is unknown if all of the holes were repaired in this way and the silicone failed, or if these holes were never filled.
- 3.22 At some stage silicone sealant had been added to the transom-well. This was most likely done to fill gaps that caused water to run from the transom-well into the floor space. The sealant had deteriorated with age and come away from the gaps it was intended to fill. With the freeboard reduced, water that drained into the transom-well soon found its way through these gaps and into the floor space.

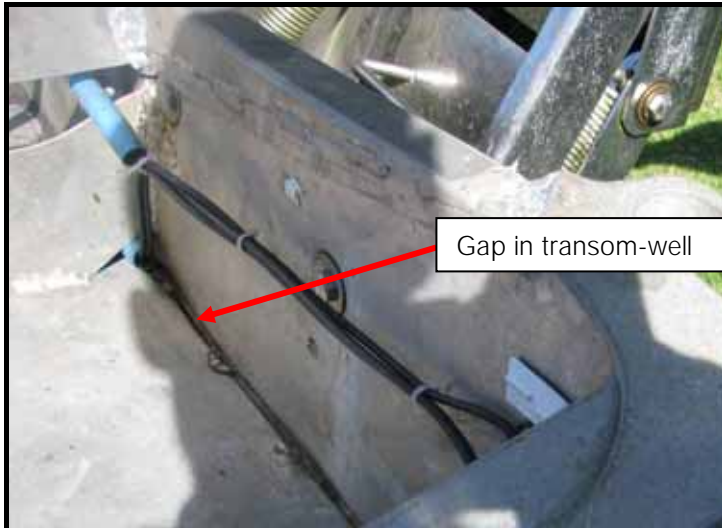
Photograph 11

3.23 The transom-well support bracket was found to be cracked and missing rivets. This damage did not appear to be new, and allowed for water in the transom-well to drain down into the floor space beneath the floorboards that were usually fitted. This type of damage suggests that at some stage the transom had been placed under significant stress. This could result from such things as the skeg touching the bottom, or operating an engine that exceeds the manufacturer's recommendations.

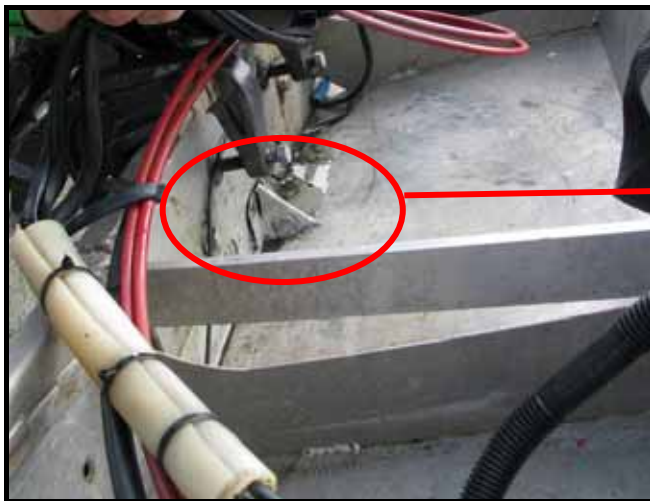
Photograph 12
Transom-well.

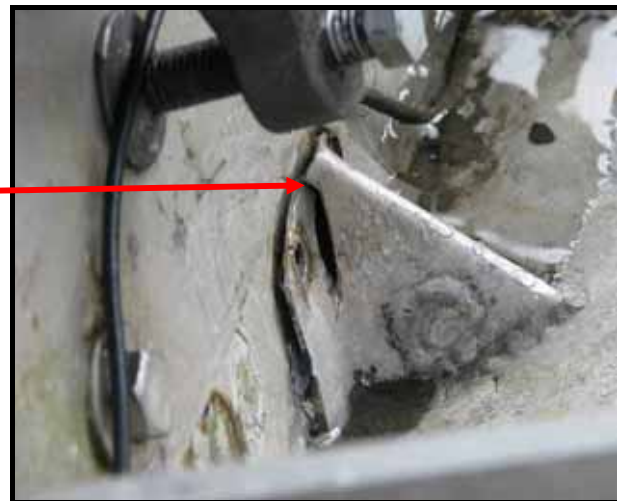
Photograph 13
A closer view of the transom-well support bracket.

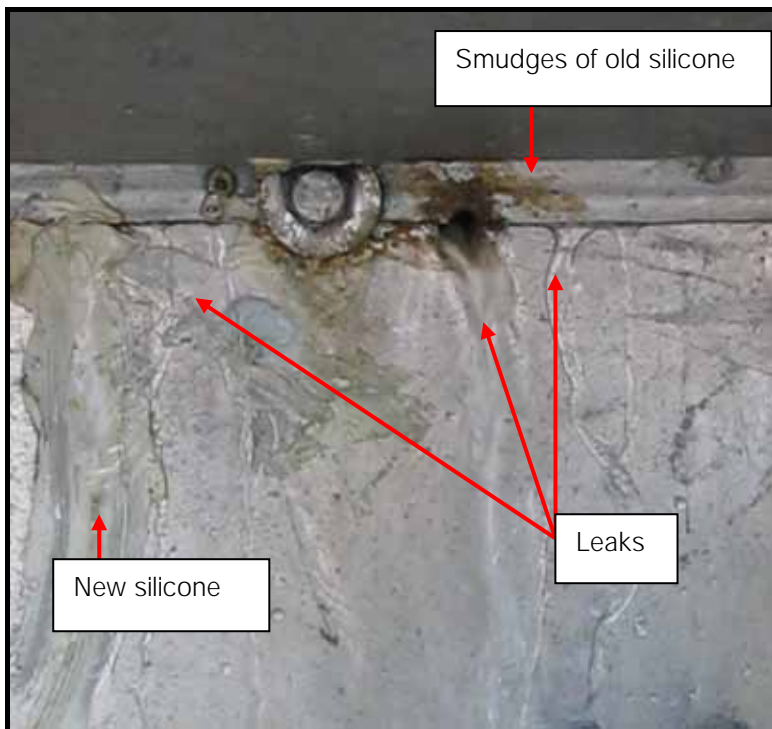
3.24 Water flowed freely through a missing rivet hole beneath the transom-well. Again, this water ran into the floor space. The hole was surrounded by smudges of old silicone, indicating that it had been repaired at some stage, but the silicone had since come away.

- 3.25 Photograph 14 shows water flowing freely through the missing rivet hole beneath the transom-well. Water can also be seen leaking through either side of the old rivet hole, in the seam between the transom and the transom-well.
- 3.26 Good practice would have seen the holes and cracks in the transom welded, not sealed with silicone.
- 3.27 Both of the bungs were secure when recovered from the seabed. The bungs were well fitted and did not leak.

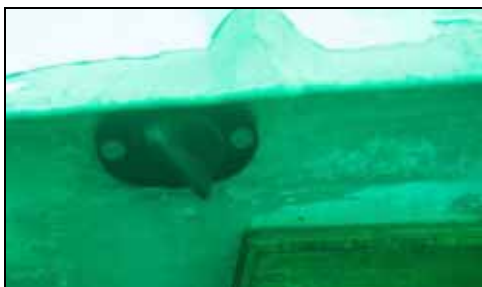
Photograph 15
The bungs were secure.

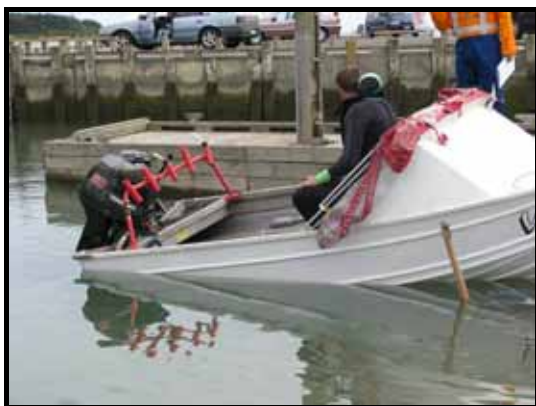
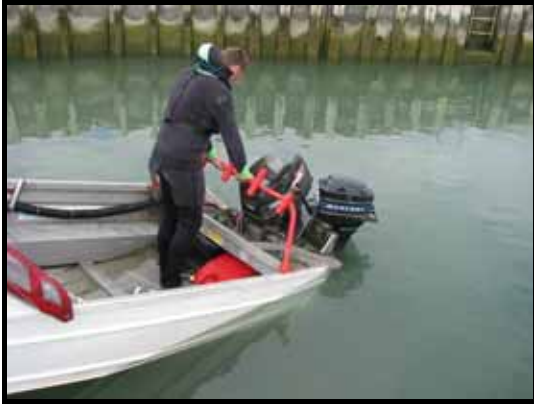
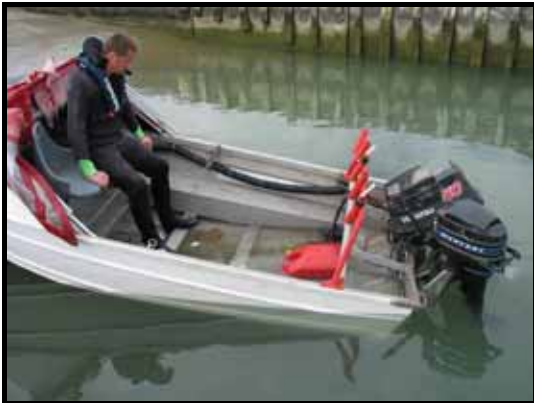
- 3.34 After 20 minutes of being in the water, the vessel had taken on approximately 95 L of sea water, with the resulting free surface effect significantly reducing the stability.¹ At this point, the vessel was so unstable that any movement was grossly exaggerated by the free surface effect, and *Viper 1* could have easily rolled. As such, it was considered unsafe for the two test subjects to remain in the vessel and the lighter of the two was removed.

Photograph 17
Viper 1 in the stability test at 26 minutes.

Photograph 18
Viper 1 in the stability test at 26 minutes, 30 seconds.

Photograph 19
Viper 1 in the stability test at 29 minutes.

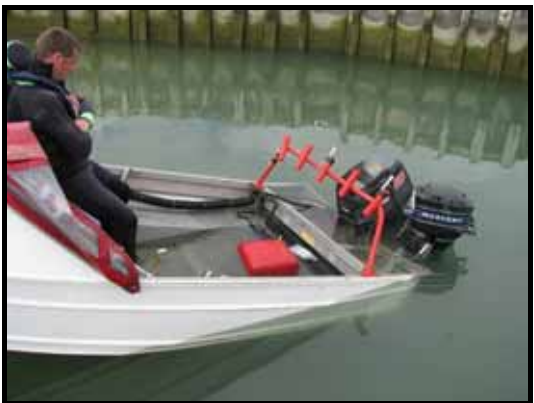
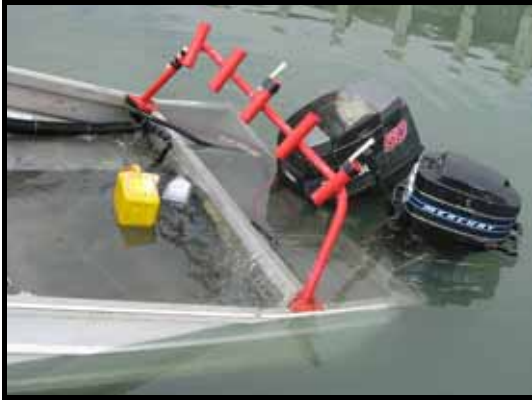
Photograph 20
Viper 1 in the stability test at 32 minutes.

Photograph 21
Viper 1 in the stability test at 33 minutes.

- 3.43 Any small waves or chop would cause the bow to lift even higher, and subsequently drive the stern lower into the water. As shown in the photographs taken at 32 and 33 minutes in the test, once the corner of the vessel is submerged water pours in rapidly and *Viper 1* sinks.

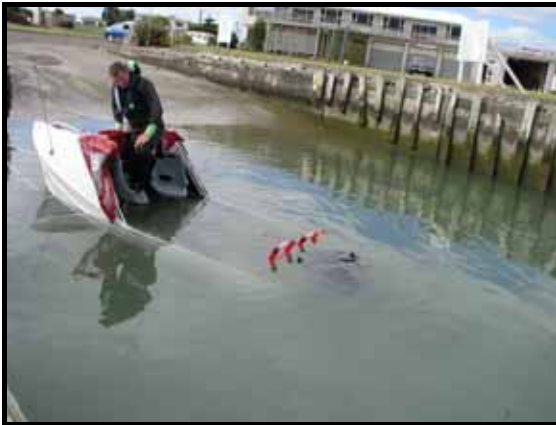
Photograph 22
Viper 1 in the stability test at 34 minutes.

- 3.39 After 34 minutes in the test environment *Viper 1* had completely sunk. Note that in Photograph 22 the bow has come to rest on the trailer.
- 3.40 With the leaks situated in the transom area it is considered unlikely that the vessel would take on water while underway.

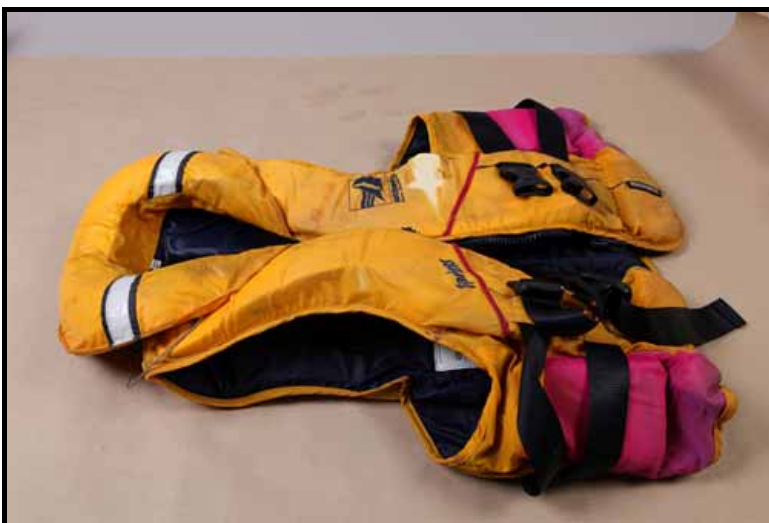
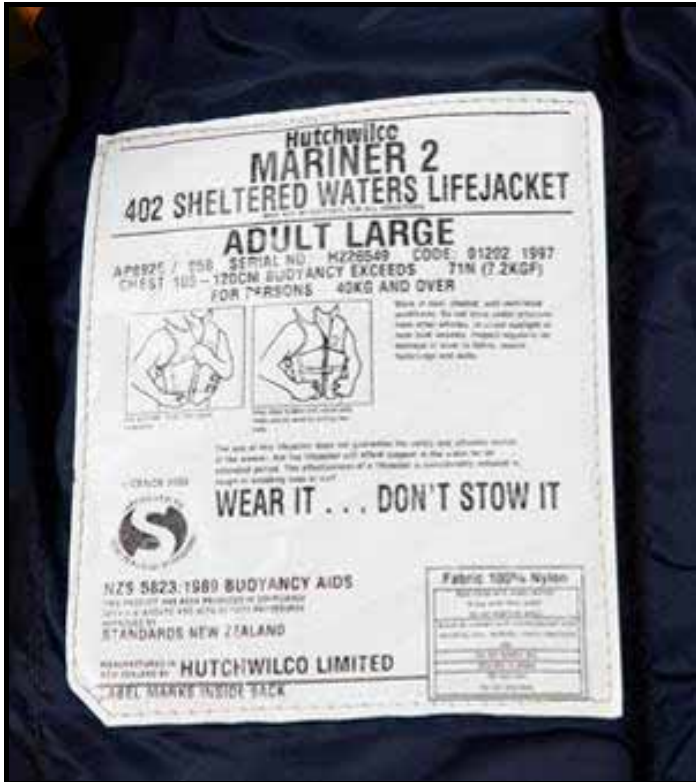
Photograph 23

- 3.74 The lifejackets worn by the skipper and the passenger were rated as 402 sheltered waters lifejackets. These were manufactured in accordance with New Zealand Standard 5823:1989.

3.81 The lifejackets worn by the skipper and passenger were both designed for people over 40 kg and had a minimum buoyancy of 71 n.

The lifejacket worn by the skipper.

Photograph 24
The label on the skipper's lifejacket.

- 4.11 Although wearing a lifejacket at all times is good safe practice, a 401 open waters lifejacket, such as an inflatable, would have been more appropriate in this case and would have increased the chances of survival.

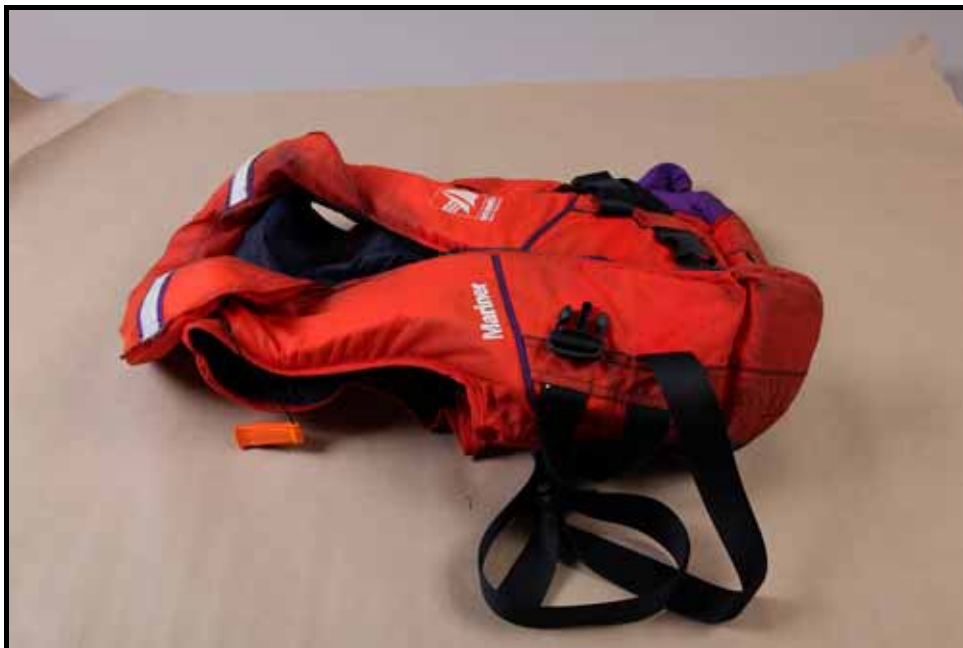
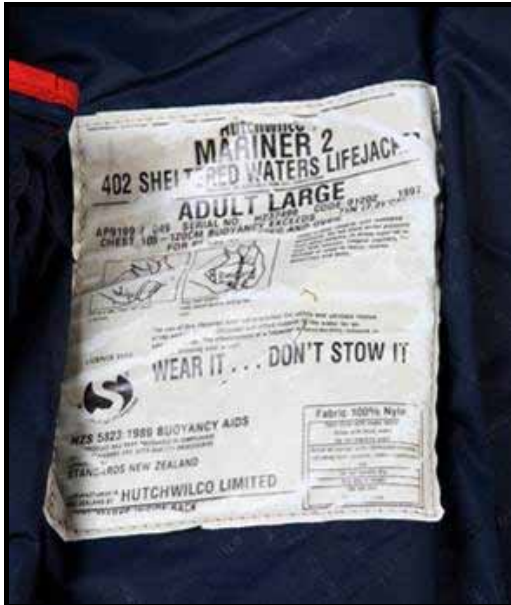
Photograph 26

Photograph 25
The lifejacket worn by the passenger.

The label on the passenger's lifejacket.
