Accident Report

Passenger Injury

Wainui

9 June 2007

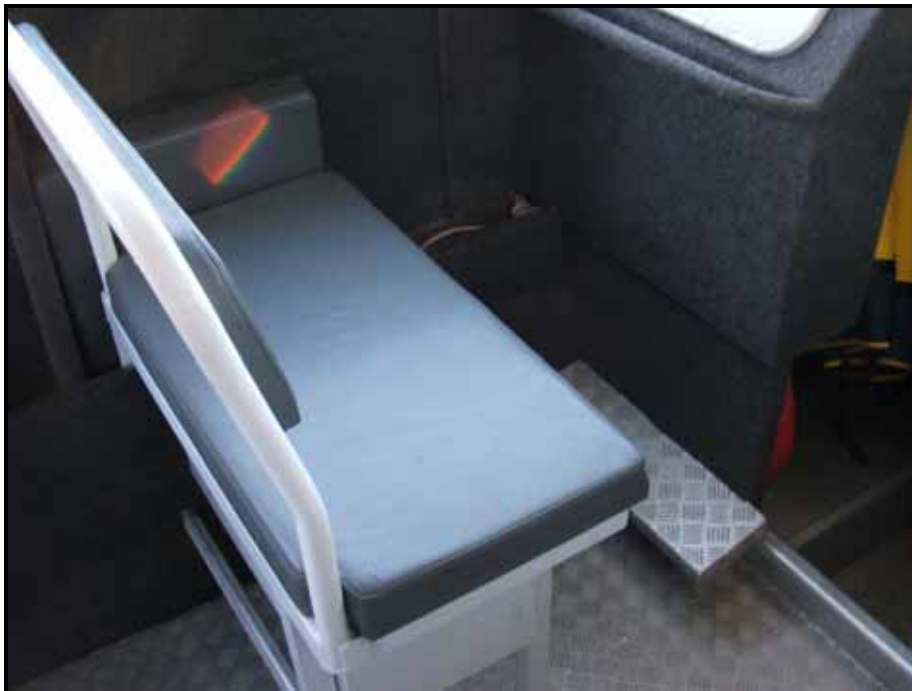
The Skipper was conning from a forward starboard position, with one passenger sitting beside him to port and the other immediately behind the Skipper in the second row of seats.

Both passengers were riding the waves by standing up whilst holding onto a hand rail in front of each seating position.

Photograph 1
Forward Seat Configuration

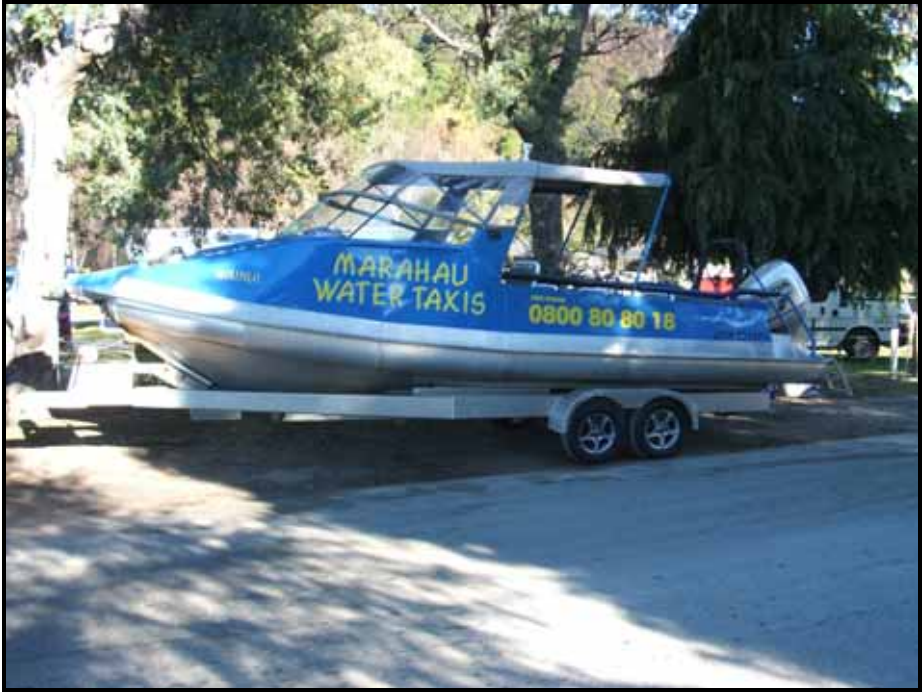
Wainui is a 7.5 metre aluminium pontoon style vessel, powered by a 225 Hp outboard motor, built in 2005.

Photograph 2
Wainui
