Investigation Report  
Collision between  
*Waitohi* and *Atua*  
26 October 2011

## **Maritime New Zealand**

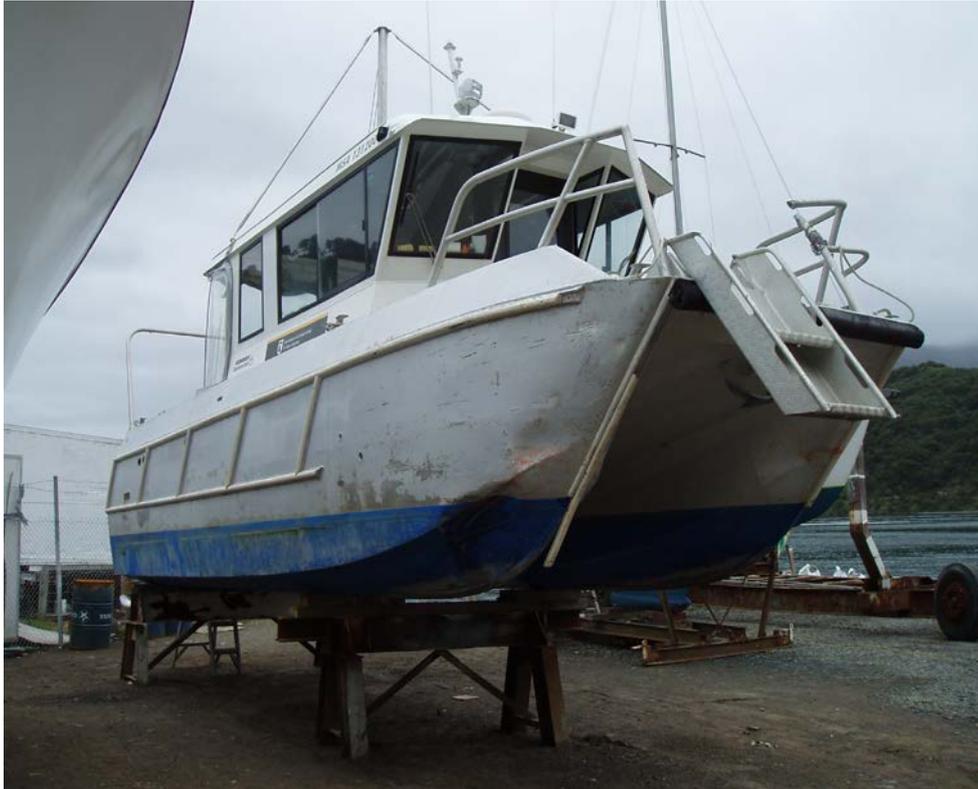
**Figure 1 Waitohi**

**Atua** was a total loss, but was salvaged because its rigging remained attached to **Waitohi** after the collision. **Waitohi** sustained cracking and dents to both bows and some warping to the transom.

3. **Waitohi** is an 8.5 metre catamaran powered by twin 175 hp Honda outboards. This vessel is based out of DOC's Picton office, while its sister ship **Waiata** is based out of the Havelock office.
4. The vessel is fitted with a Furuno Chart-plotter global positioning system (GPS), radar and echo sounder. Its normal operating speed is 20 knots. At the time of the collision, the vessel had a valid SSM certificate.

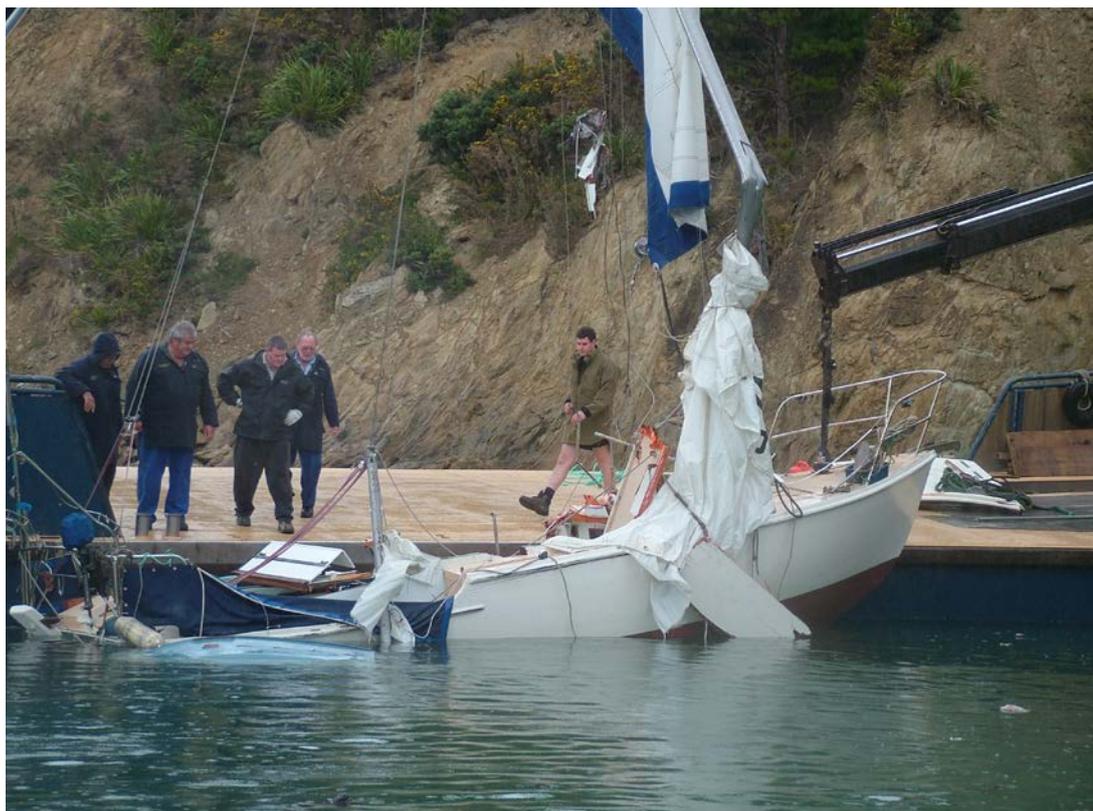
**Figure 2 Atua**

5. **Atua** is a 28 foot Herreshoff-designed rigged sloop and was built in 1963. The vessel was powered by a 15 hp Yamaha outboard with a top speed of about 5½ knots. The vessel was fitted with a hand-held GPS and VHF radio.

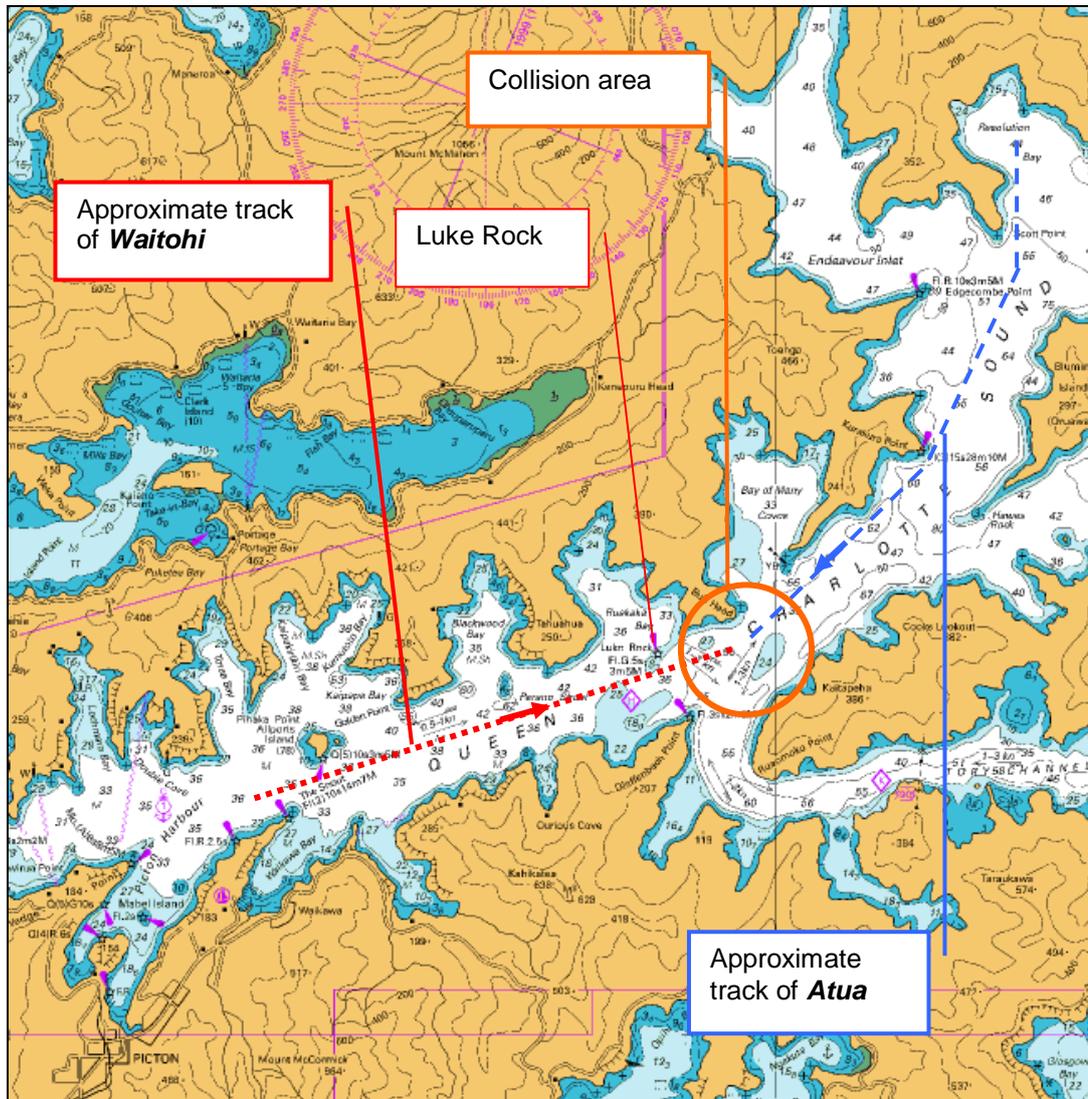
Figure 3 Chart of overall area

20. Both vessels were in sight of each other for some time prior to the collision. The skipper of *Atua* said he had seen *Waitohi* and was unconcerned about the vessels' respective courses.
