Accident Report
Wakanui
Head Injury - Buller River on
2 February 2005
Class B Non Serious Harm

REPORT NO.: 96 364
WAKANUI – HEAD INJURY

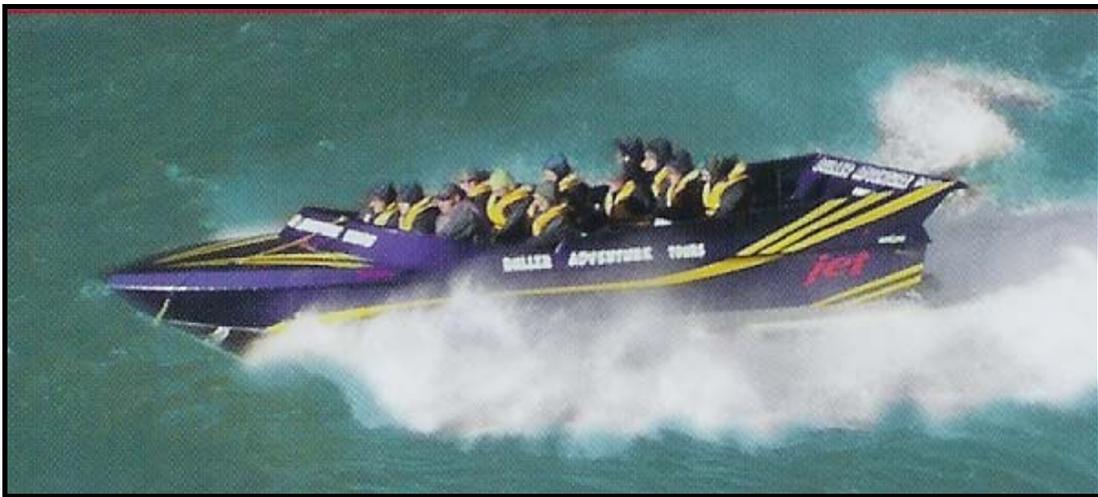
Wakanui

During a ‘Hamilton turn’ one of the passengers slid across the bench seating and hit his head on the handrail. He was given first aid and then taken to hospital where he received stitches for four cuts around his right eye. The spin was a routine event as part of the tour. There were no other injuries.

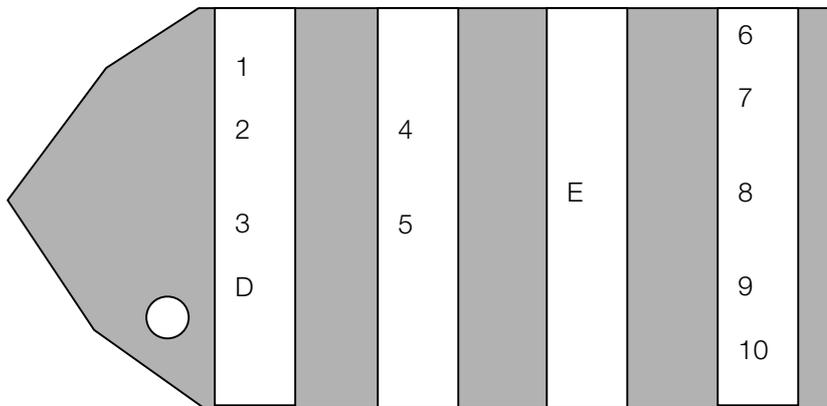
Seating Arrangement

4 – Injured passenger

- Three male passengers from a Kiwi Experience tour seating 1, 2 and 3. These passengers chose to sit at the front.
- The injured passenger and his partner were seated in 4 and 5. They also chose their seats.
- Seats 6-10. A family of five consisting of husband and wife with their two children and grandmother (age 78). The driver recommended they sit at the back, as it was the least turbulent part of the boat.
