LESSONS LEARNT
BY ACCIDENT

LOOKOUT!

JUNE 2008 ISSUE NINE

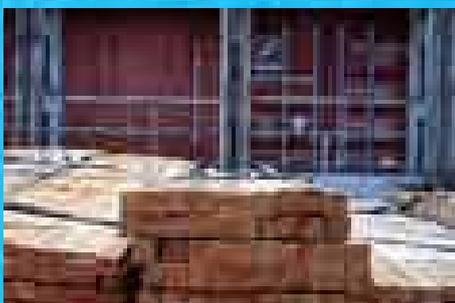
1

An experienced stevedore fell about 5 m into a void space within a ship's hold, fracturing his pelvis, an arm and a leg.

The stevedore was working at night in light drizzle on a multi-purpose container vessel. He was working with another colleague to stow timber in the hatch square of number three lower hold, on top of previously loaded timber¹.

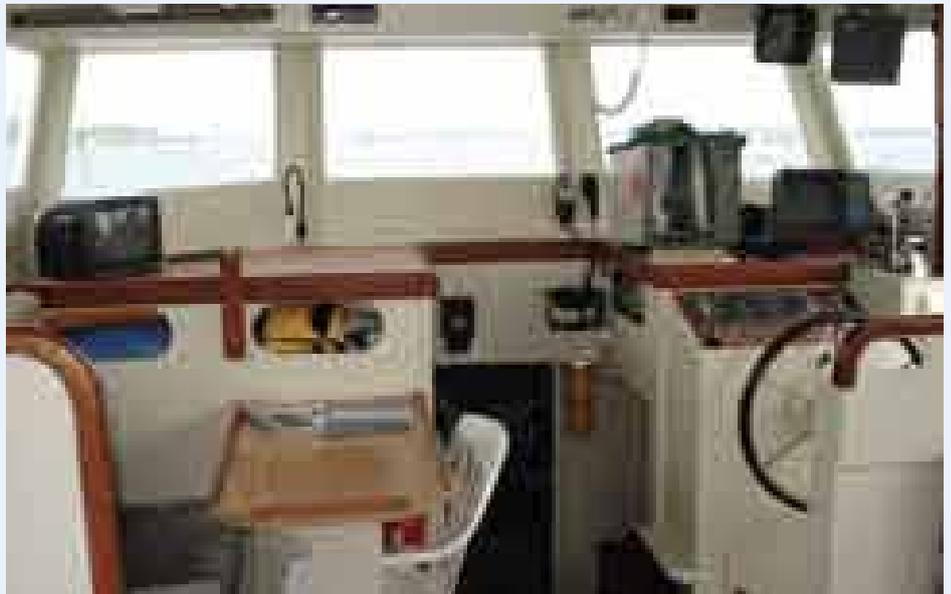
THE WHEELHOUSE SHOULD NOT BE LEFT UNATTENDED. PHOTO: PROFESSIONAL SKIPPER MAGAZINE

1. Poor watchkeeping standards has again caused a collision at sea. The deckhand on the first vessel had been away from the wheelhouse for about 20 minutes, while the second deckhand had been away for about 5 minutes. Both failed to observe the collision prevention rules, and the basic principles of a navigational watch set out in the Advisory Circulars to Maritime Rules Part 31. In particular, the wheelhouse should not be left unattended, and a watchkeeper should not accept other tasks that might conflict with the responsibility of keeping a lookout.

4. Watchkeeping alarms are fitted to help prevent accidents such as this, and should never be switched off.

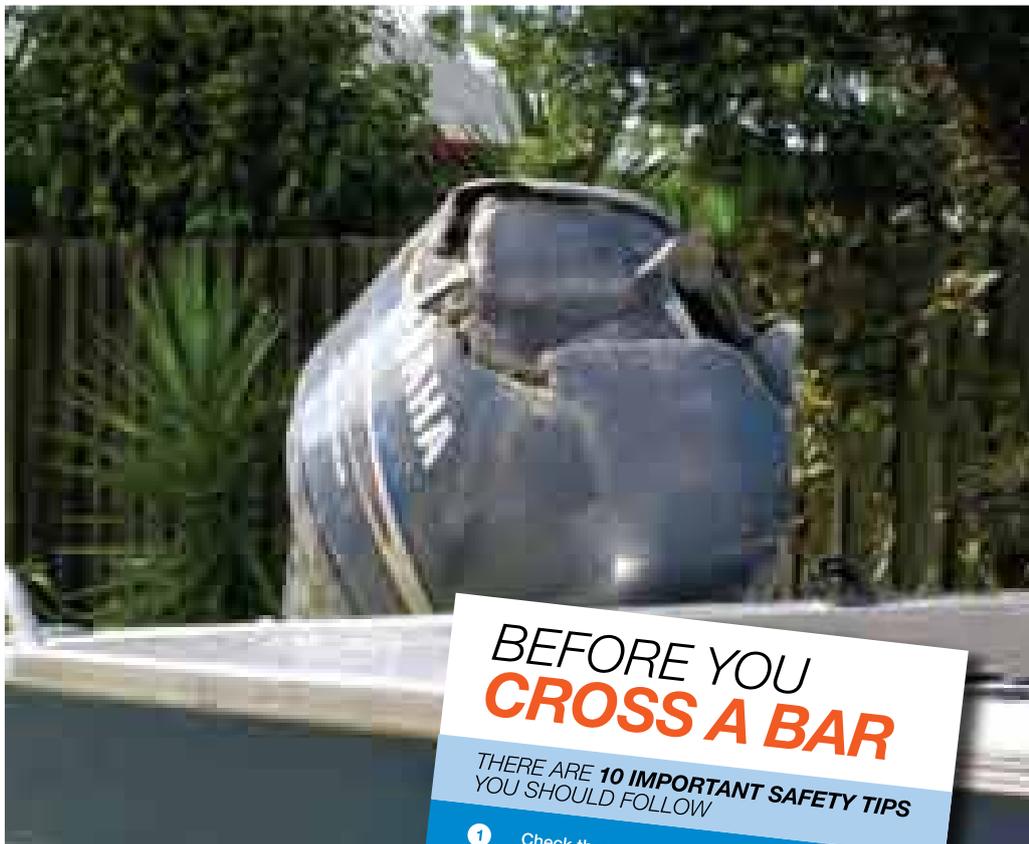
The three men were returning to port after retrieving craypots. It was low water, and conditions were rough with an onshore wind. As they started to cross the bar, the boat overturned, trapping the skipper and one of the crew underneath the hull. The third man managed to clamber on top.

As the two trapped men struggled clear of the upturned hull, the skipper became entangled in the anchor warp. It had broken free of its locker and had wrapped several turns around his torso and one leg before fully deploying. Because it was still tied off to the runabout, the skipper was being wrenched by the taught warp.

THE RUNABOUT CAPSIZED DURING THE BAR CROSSING.

1. Legal requirements in New Zealand for all persons on a boat crossing a bar are to wear a lifejacket, and at all other times of increased risk.

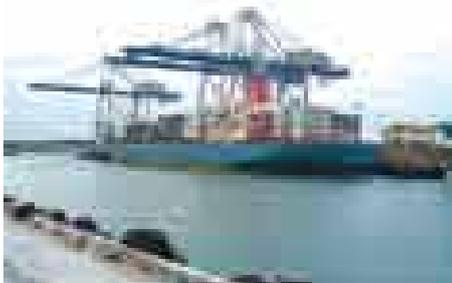
▲ THE CONTAINER VESSEL – NOT AWARE OF THE SMALLER VESSEL.
▲▲ THE FISHING VESSEL – TOOK LATE AVOIDING ACTION.

He said two ARPA radars were operating on the 6 and 12 mile ranges. The guard alarm had not been activated and targets were only acquired manually after they were observed. A quartermaster, who was keeping a visual lookout, also made no reports of the near approach of any vessel.

4. Fishermen should remember that although they can often see a larger vessel, they may not always be equally visible. Give way vessels cannot always be relied upon to take the appropriate avoidance action, and a stand on vessel must be ready to respond in sufficient time to keep well clear and not, as here, where the late avoiding action of the fishing vessel only narrowly avoided a serious collision.

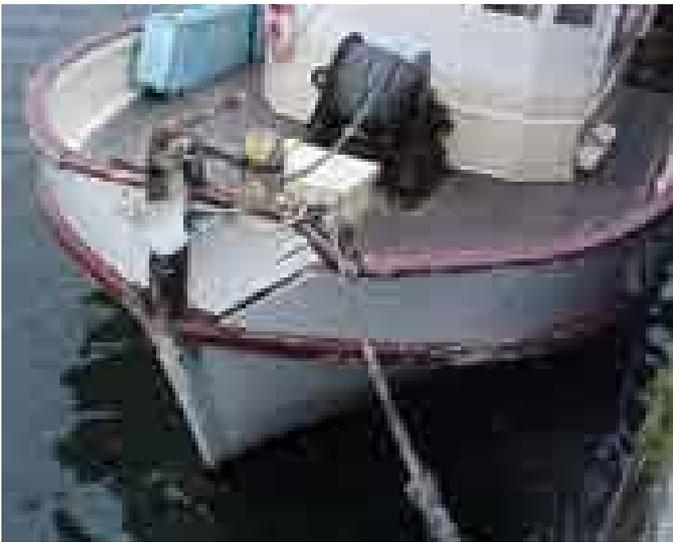
The skipper immediately put the main engine astern but was unable to stop the vessel colliding with the southern breakwater. The vessel sustained moderate damage to its bow.

THE FISHING VESSEL SUSTAINED DAMAGE TO THE BOW WHILE ENTERING THE HARBOUR.

2. The actual conditions at the bar were worse than either the skipper or his friends ashore had estimated. In marginal conditions, or when the quick flashing blue light is activated, the strength and direction of the set and sea conditions must be fully ascertained before entry, with the assistance of a responsible, qualified person ashore.

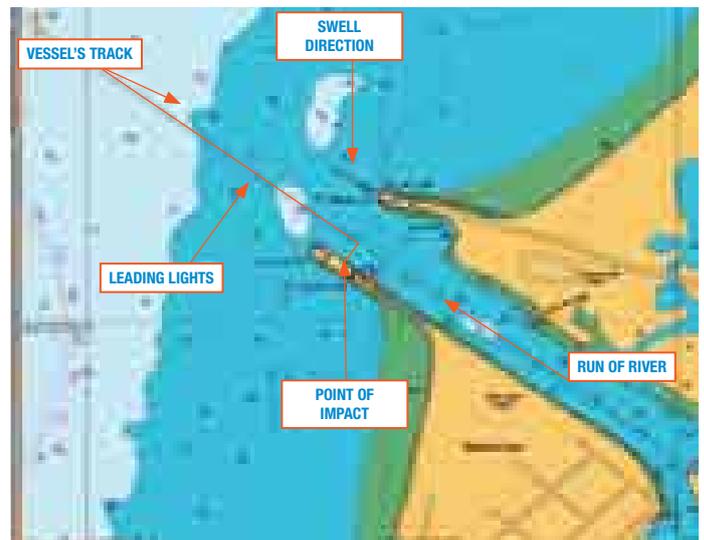
The skipper made two alterations to his heading to try and align the vessel with the leading lights line, but the combination of the run from the river and the following swell caused the bow to suddenly slew heavily to starboard and the vessel to broach.

THE CHART EXTRACT OF THE ENTRANCE TO GREYMOUTH INDICATES THE APPROXIMATE TRACK OF THE VESSEL.

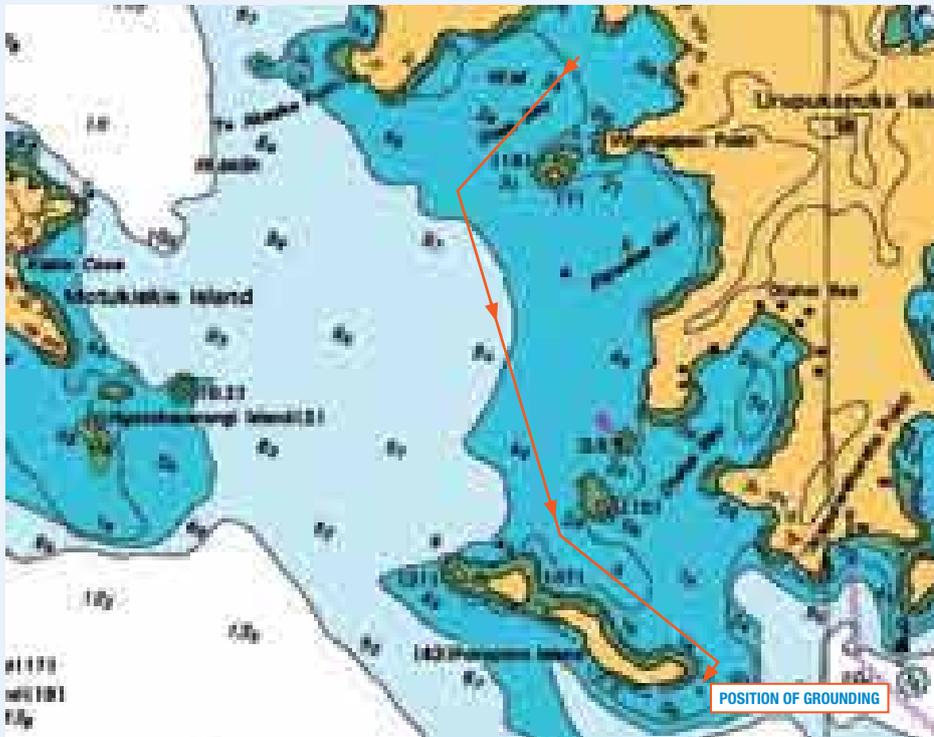
VESSEL TRACK AND POSITION OF GROUNDING

A 9 m yacht's lifting keel and hull was extensively damaged after it grounded on a charted rock in the Bay of Islands.

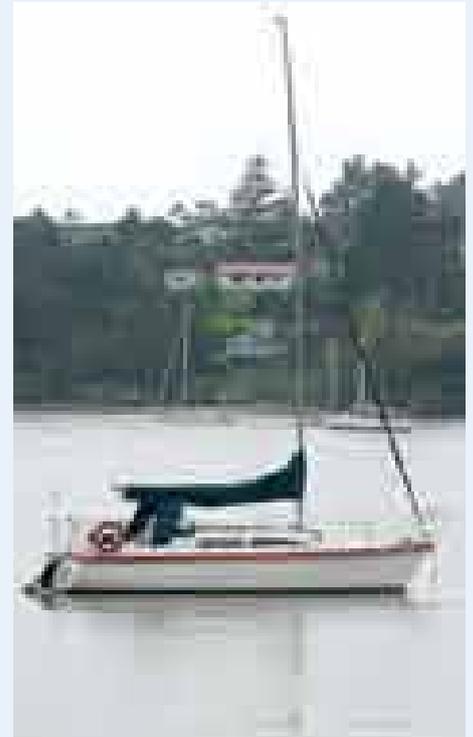
THE YACHT GROUND ON A CHARTED ROCK

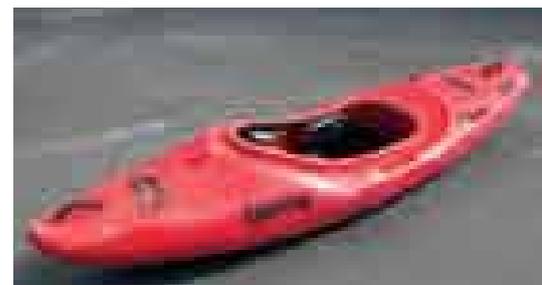
The team managed to raise the alarm and rescuers were able to reach the trapped kayak by raft. The kayaker's body was found pinned against the tree

▲ THE KAYAK WAS PINNED AGAINST A LOG.
▲▲ THE ACCIDENT SCENE.
