LESSONS LEARNT
BY ACCIDENT

LOOKOUT!

MARCH 2009 ISSUE TWELVE

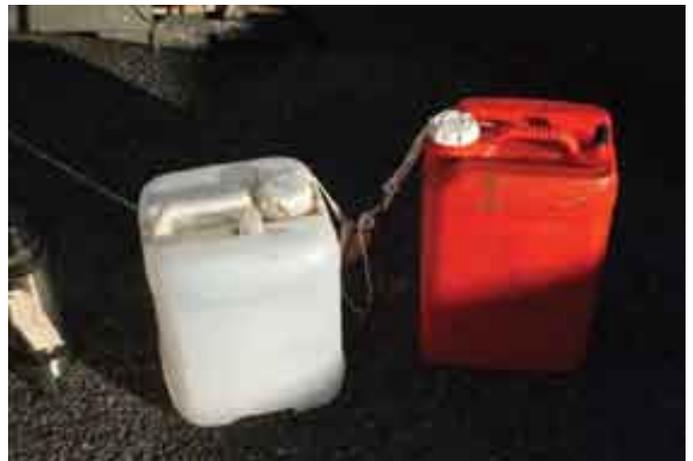
The first man managed to calm his companion, but by then the canoe was being blown toward the opposite shoreline, which was rugged and uninhabited. The pair decided to cut loose two 20 litre containers from under the canoe seats, which had been used as additional buoyancy, and abandon the canoe.

▲ THESE 20 LITRE CONTAINERS FROM UNDER THE CANOE SEATS, USED AS ADDITIONAL BUOYANCY FOR THE CANADIAN CANOE, WERE CUT LOOSE FOR FLOATATION WHEN THE CANOE ROLLED.

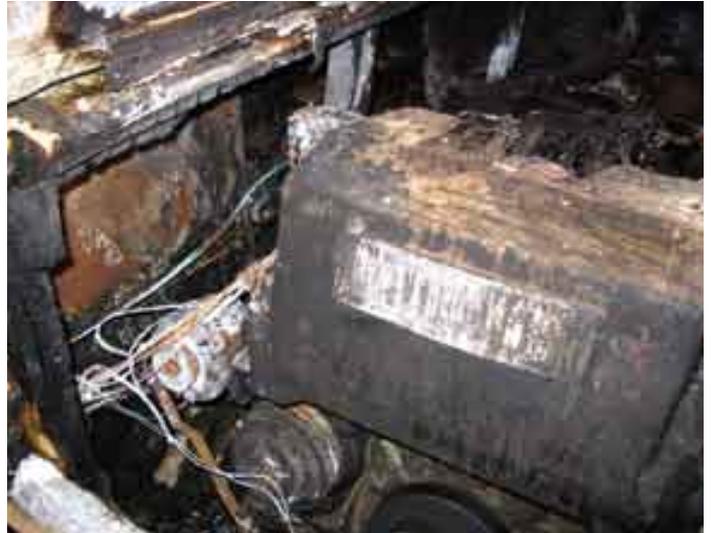
▲ THE STARBOARD ENGINE FIRE WAS "ELECTRICAL" WHEN IT BEGAN, BUT PROGRESSED INTO A GENERAL FIRE, WITH A VARIETY OF SUBSTANCES, INCLUDING FOAM RUBBER, PLASTIC, WIRE INSULATION, OIL, METAL, GREASE AND DEBRIS, WOOD AND PAINT.

1. The exact cause of the fire cannot be determined, although it is thought to have been an electrical fire originating near the alternator and a bundle of wires leading to a battery bank. The fire may have been fed by the scavenge fans, and by the sudden rush of oxygen when the skipper opened the engine bay cover.

3. The recommended complement of extinguishers for a boat of this size would be two 4.5 kg or 9 litre portable

extinguishers or two suitable dry powder equivalents, with one positioned near the engine bay, and the other in an easily accessible space away from the machinery.

4. In the absence of a fixed fire-fighting system, a covered hole or port can be cut to allow access to the engine bay. An extinguisher can then be dispersed into the enclosed area, without opening the cover, which avoids providing a fresh oxygen source to the flames.

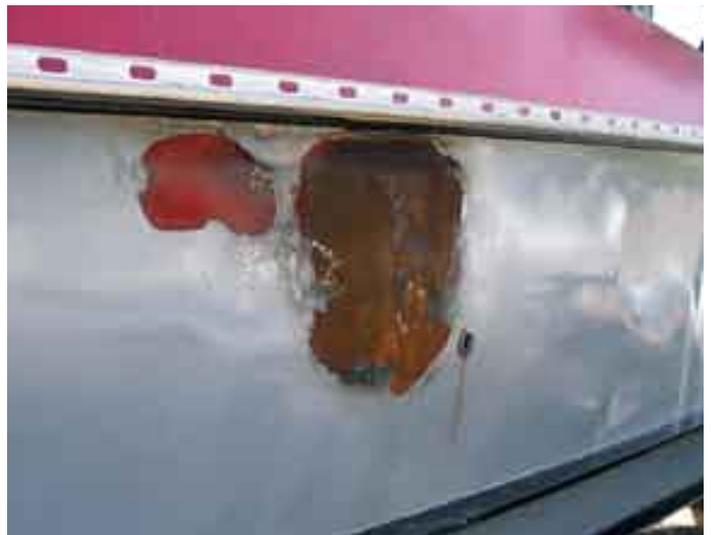
▲ A HEAVY OXIDATION PATTERN WAS VISIBLE ON THE OUTSIDE OF THE HULL AS A RESULT OF THE FIRE.

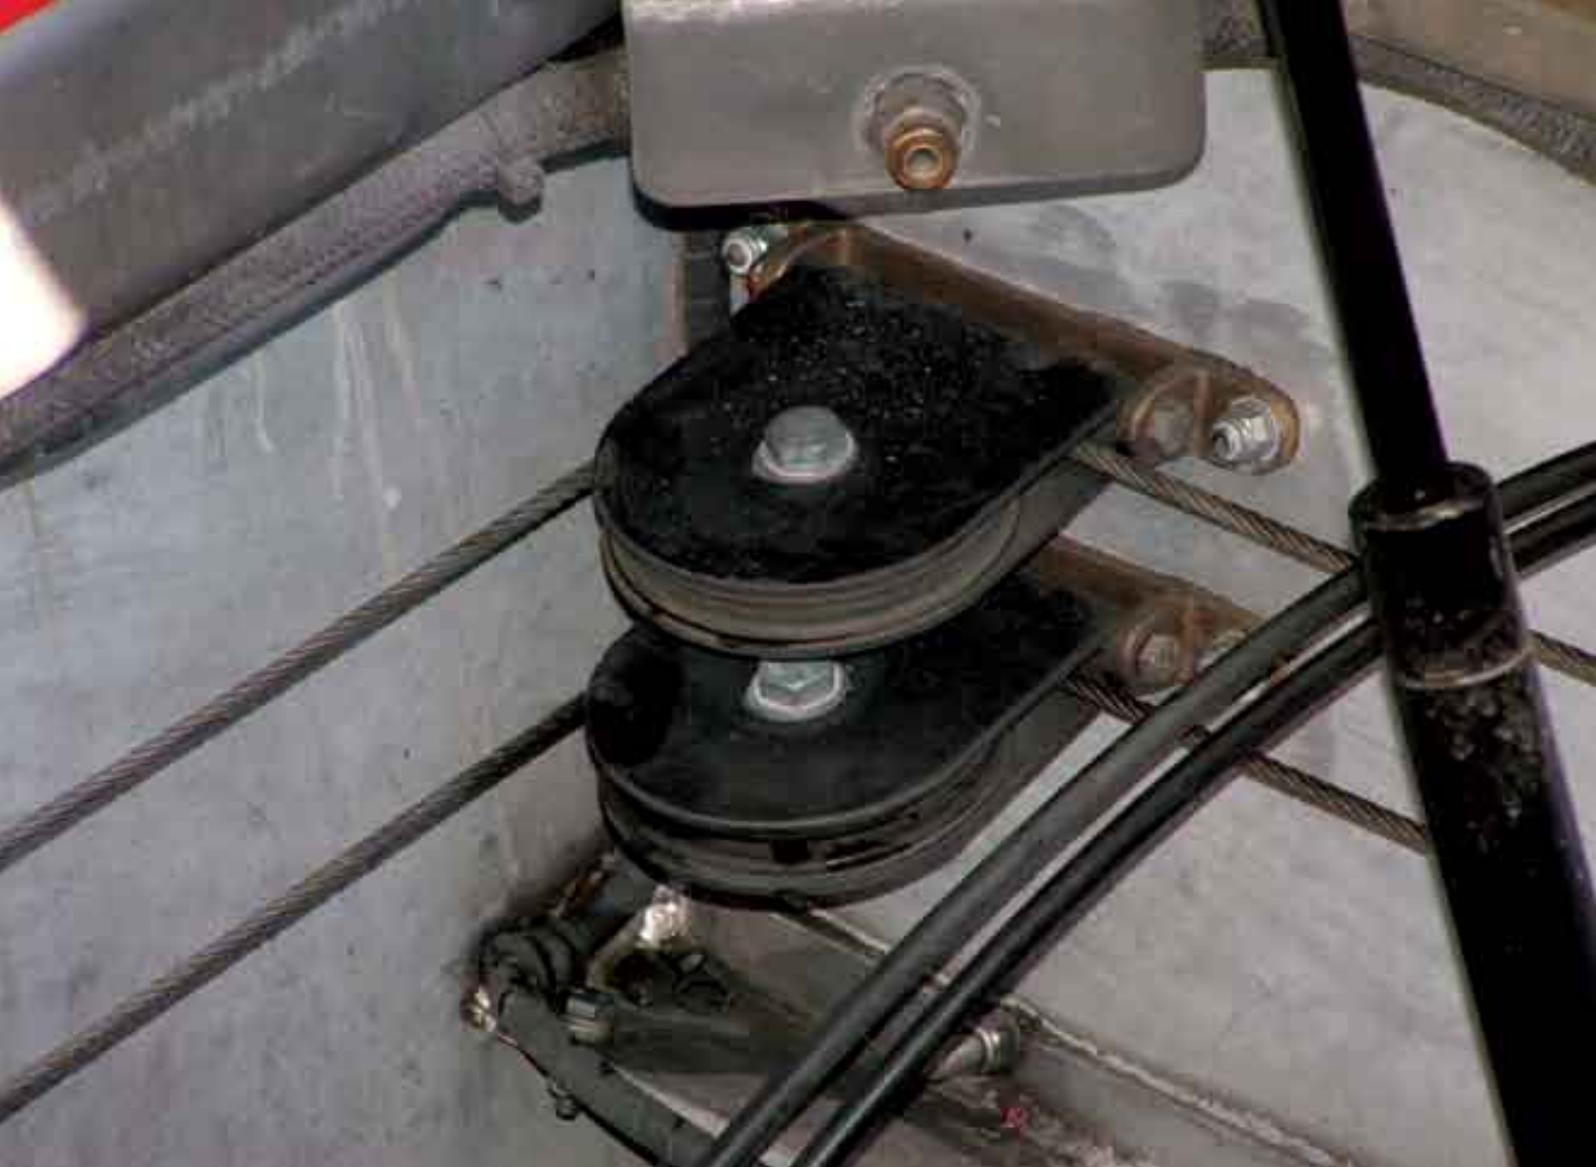
▲ THESE 75MM DIAMETER STEERING CABLES ARE COMMONLY USED IN JETBOATS. THEY ARE TOO SMALL AND FALL BELOW THE RECOMMENDED MINIMUM SIZES.

1. The operator's maintenance schedule required that the steering cable be replaced every 1,000 hours, whether it showed signs of wear or not. This cable had completed 941 hours and, a few days earlier, a junior mechanic had noticed a couple of broken strands on the cable. Checking with his superiors, he had been told that, as the cable was soon due for replacement, it would be fine for a few more days.

2. The pulleys the cable ran around were found to be smaller than recommended by the cable manufacturer, and this was later the subject of a Maritime New Zealand Safety Bulletin *Issue 17, Small Craft Wire Cable Steering Controls*. However, the relationship between cable wire and pulley diameter is a complex issue. New Zealand industry engineers are currently testing alternative systems that may allow smaller diameter pulleys to be safely used on jetboats.

In the interim, the jetboat operator has reduced the cable replacement time from 1,000 hours to 500 hours. They have improved the cable inspection requirements, including the need to pay close attention to the normally hidden section behind the pulley. This requires turning the steering lock fully both ways, and using a mirror on an extension pole with a torch, to carefully check for any broken strands. If any broken strand is detected, the boat is immediately removed from service and the steering cable replaced.

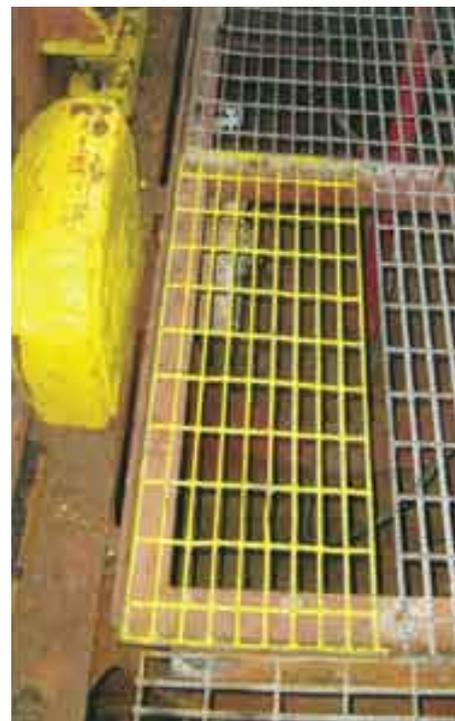
A design fault was identified with these grates that allowed them to be incorrectly placed once shifted, leaving them unstable and insecure.

▲ THE GRATES WERE ORIGINALLY DESIGNED SO THAT THEY WOULD ONLY BE SECURE IF THEY WERE PLACED CORRECTLY, HOWEVER, THE DESIGN MADE IT EASY FOR THE GRATE TO BE INADVERTENTLY REPLACED BACK-TO-FRONT.

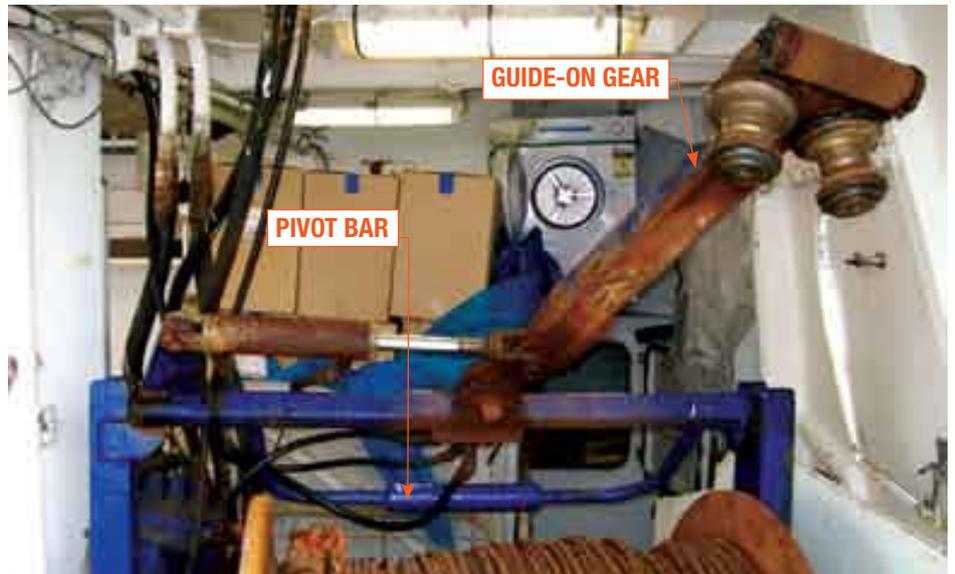
On this occasion the pivot bar may have failed, and struck the mate in the chest. He walked off the deck suffering extreme pain and was later transferred to hospital for x-rays.

▲ DOWNWARD MOVEMENT ON THE PIVOT BAR LIFTS THE GUIDE-ON GEAR ASSEMBLY.

1. The mate says he saw the swivels approaching, and slowed the winch and raised the guide-on gear to allow them to pass before increasing winch speed again. His view is that the pivot bar did not fail until the speed came on. The manual controls put the mate in a potentially hazardous situation.

- changing to a remote winch control similar to that found on several other vessels of a similar type and size operated by this company.
