# LOOKOUT!

DECEMBER 2008 *ISSUE ELEVEN*

***A yachtsman dies***  
***after falling overboard***

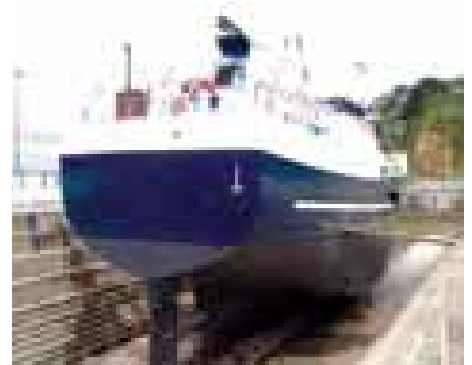
As the vessel continued with the haul, the position of the catch and the swell tended to cause it to roll to starboard. A significant amount of water started to enter through the open starboard hatch. The hook room

▲ THE VESSEL – THE WHITE ARROW SHOWS LOCATION OF HATCH.  
▲▲ THE HATCH.

**1.** A breather pipe that led to the steering flat was found to terminate near the open hatch, and water had shorted out the steering pump. This design flaw had not been noticed before and the company plans to make changes on this and all of its vessels of similar design.

**2.** The hatch was last checked 8 days prior. It was an internal inspection as the ship was at sea. There was no external inspection, but the ship had been surveyed and found to be in good order 5 months earlier. The ship's engineer has been advised to ensure a regular external inspection is done, perhaps before the vessel leaves port.

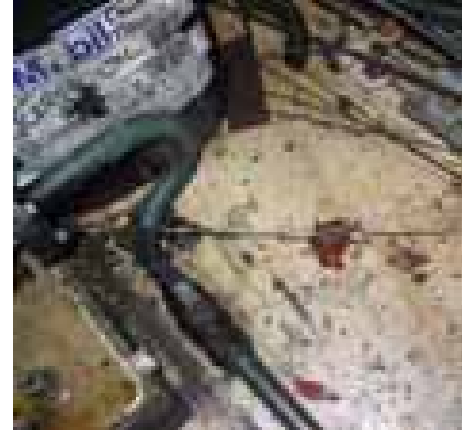
BROKEN FLEXIBLE PULL WIRE REPAIRED WITH A KNOT.

**1.** A fire safety officer reported that the most likely cause of the fire was plastic falling onto the engine's turbocharger casing and igniting. Inspection showed numerous plastic containers, aerosol cans and diesel-soaked rags scattered around the engine room. An open plastic container full of diesel sat by the main engine, and plastic trousers had been hung up to dry. There were several examples found of improper engineering practice. A flexible wire pull allowed the full flaps to be shut off remotely from the accommodation. This wire had broken at some time and had been repaired with a knot. The knot would not have

fitted through the small diameter tubing that led to the accommodation, and the valve could not have been fully shut remotely. In short, the standard of general housekeeping on board was poor.

**3.** The fixed fire-fighting system did not fully deploy. A cover had been fixed over the lever, which was triggered remotely by a flexible wire. Screw holes in the

wall showed the cover had been fixed at several different heights, but had finally been secured too low to allow the lever to complete its arc of travel. It had wedged against the cover when the system was deployed and not all of the gas had been discharged.

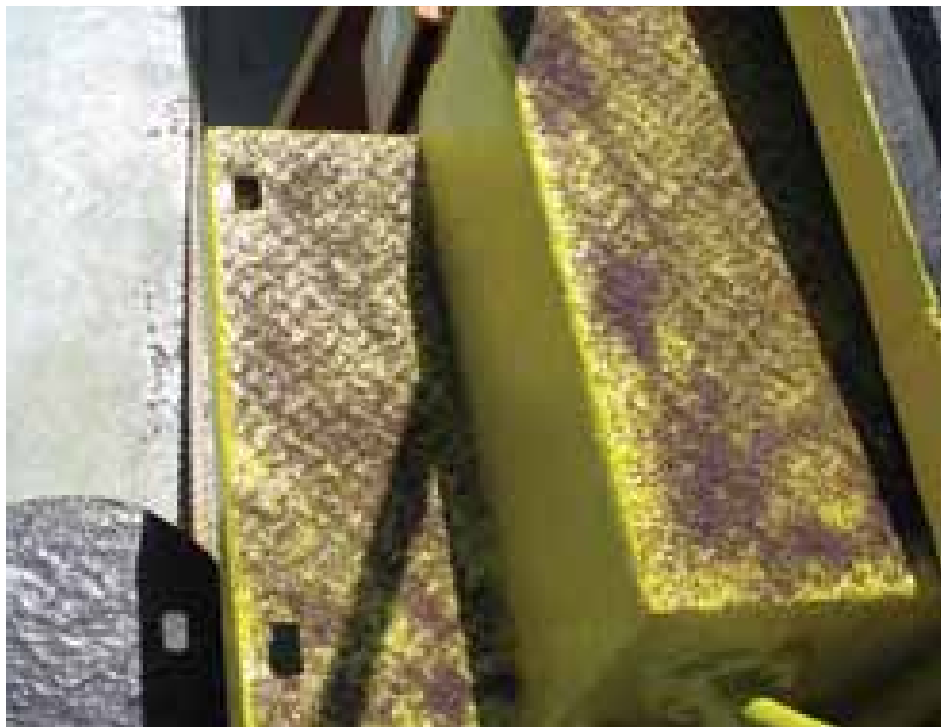
As they started to lower the suspended gangway, one side of it caught on the bracket used to attach it to the side of the ship. A third crewmember moved the end of the gangway that was on the wharf to try and dislodge the trapped side. The trapped side came away suddenly, catching the crewmember on that side by surprise. He dropped his rope and the full weight of the gangway shifted suddenly to the other crewmember who was knocked off the fixed stairs.

▲ DETAIL SHOWING NEW NON-SLIP SURFACE.  
▲ REPAINTED STEPS AND NEW GANGWAY BRACKET.

a new gangway bracket. It has also set in place a new policy that the removable stairs be left in place until the gangway has been removed. There is also a plan for a permanent crane to be built on the wharf for lifting gangways off vessels, and the company is considering a redesign of handrails in the area.

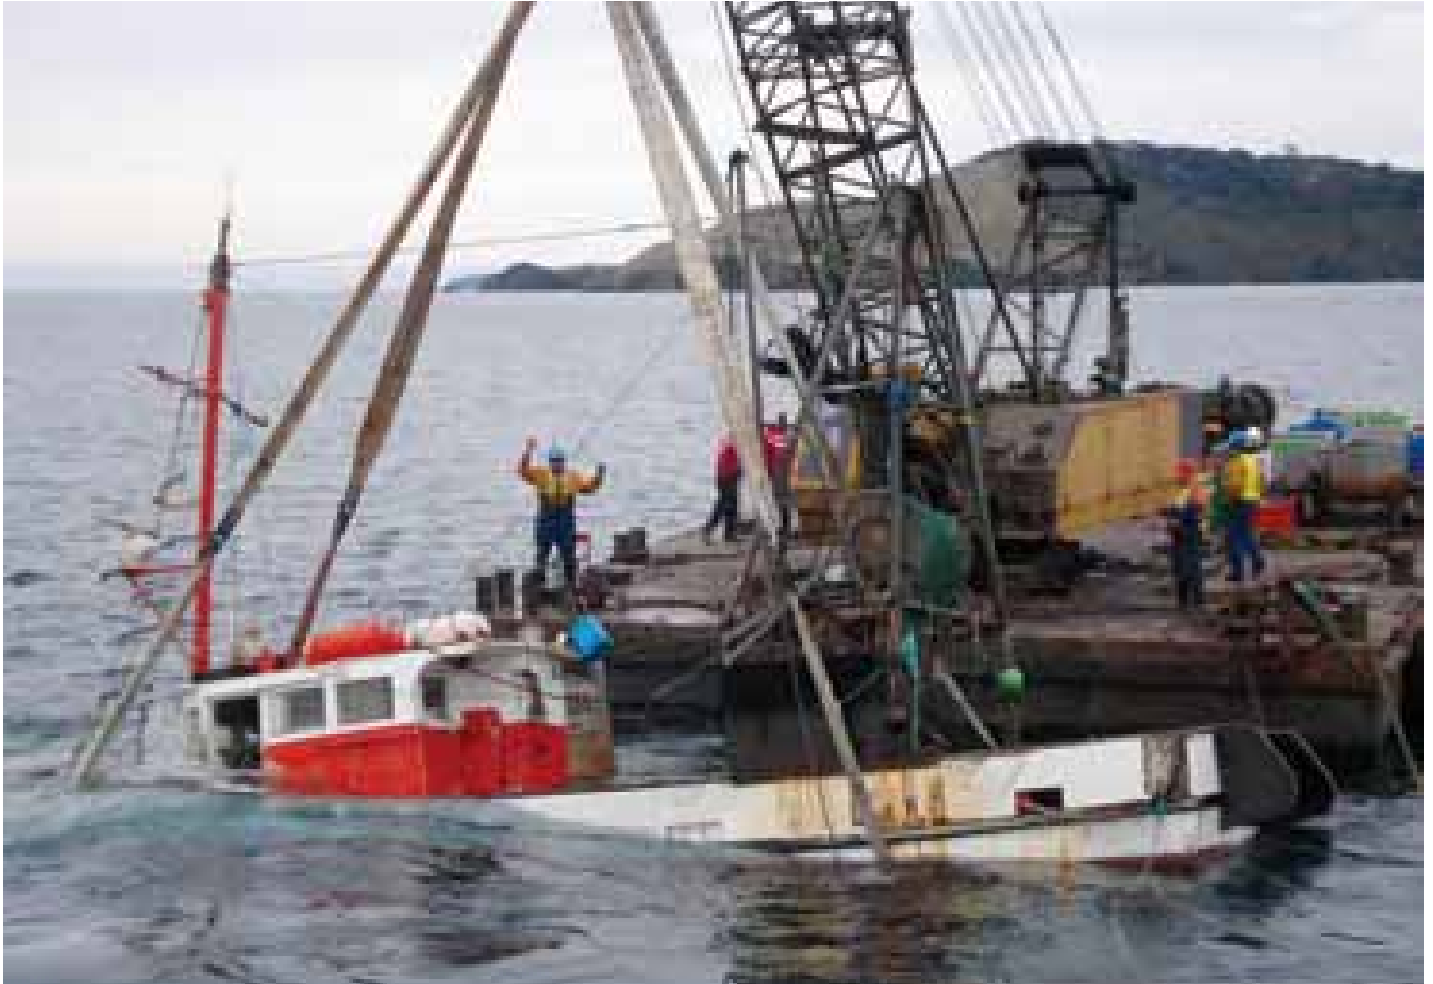
THE VESSEL MID-SALVAGE.

**2.** The vessel's only life raft did not deploy, however even if it had, it was rated to carry only four people. It is not known for certain why the life raft did not deploy automatically via its hydrostatic release unit. It was, however, fitted in a homemade cradle lined with carpet strips. The cradle was a tight fit with high arms, and this could have been a factor. The automatic deployment mechanism and the life raft painter had also been incorrectly assembled. As a coastal limit vessel this vessel was required to have a liferaft or liferafts with sufficient aggregate capacity for all on board.

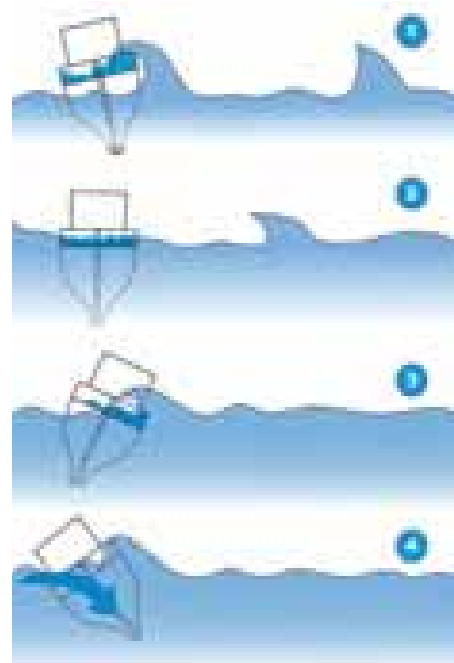
GRAPHIC SHOWING PROBABLE CAPSIZE SEQUENCE  
(WAVE HEIGHT REPRESENTATIVE OF THAT AT THE AFT DECK).

1. THE FIRST WAVE STRIKES. THE VESSEL SHIPS A LARGE QUANTITY OF WATER OVER THE PORT BULWARK RAIL ONTO THE AFT DECK. DUE TO THE WEIGHT OF WATER ON DECK THE VESSEL TRIMS HEAVILY BY THE STERN, POSSIBLY TO THE LEVEL OF THE AFT BULWARKS. THE DYNAMIC FORCE OF THE WAVE STRIKING THE VESSEL AND THE HEELING EFFECT OF THE WATER ON DECK CAUSES IT TO ROLL HEAVILY TO STARBOARD.

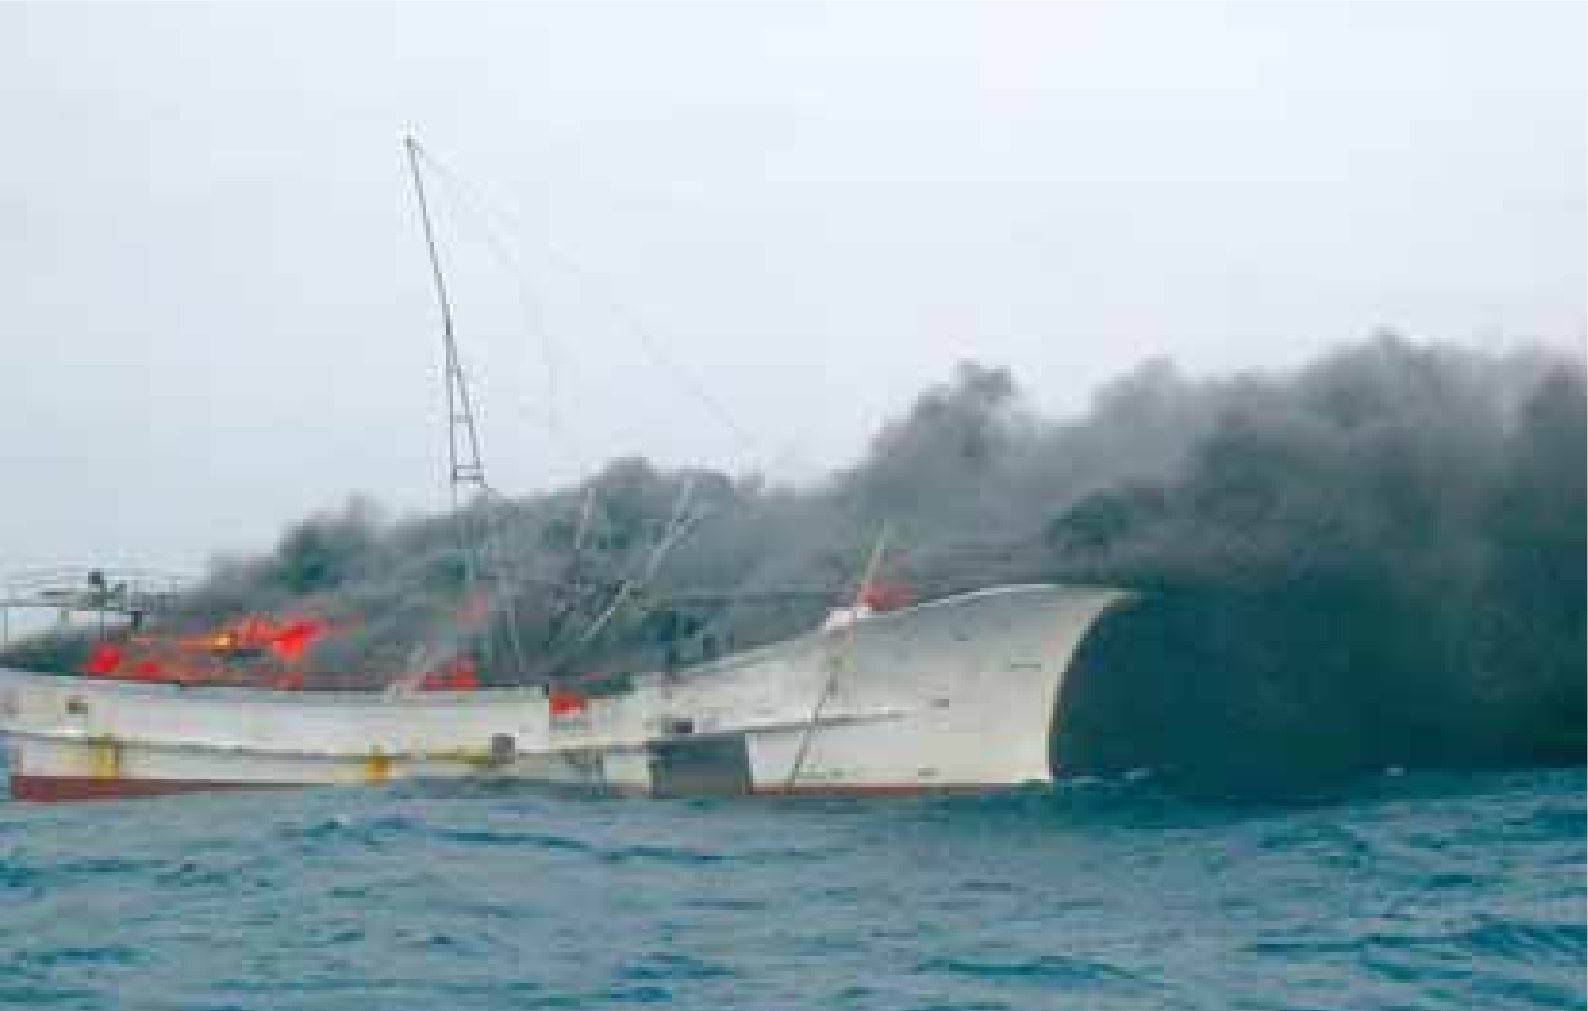
▲ THE VESSEL ABLAZE.

**1.** As the vessel was never recovered, the cause of the engine room fire cannot be confirmed. The vessel had been rewired following a fire 2 years earlier and all materials were to marine grade. It is possible that water from the wheelhouse dripped below to the engine room, causing a short circuit.

**2.** When the CO<sub>2</sub> fixed fire-fighting system failed to arrest the fire, the crew decided to enter the engine room wearing breathing apparatus to manually extinguish the fire. By opening the engine room door, the crew gave the fire an additional source of oxygen. Best practice when using a fixed fire-fighting

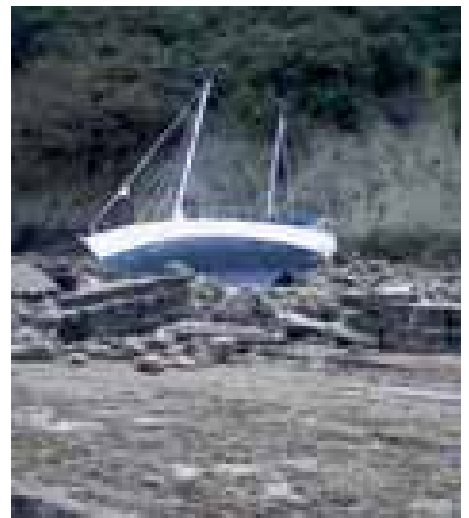
His body was recovered without a lifejacket, and when the yacht washed up onto rocks, the yachtsman's safety harness was found lying unused on the cockpit seat.

THE VESSEL WASHED ASHORE.

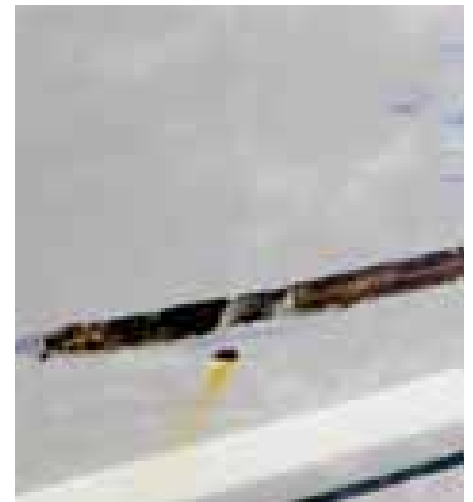
Both vessels sustained only minor damage. The skippers decided to continue fishing and returned the vessels to port for repairs a few days later.

DETAIL OF DAMAGE TO HULL SUSTAINED BY ONE VESSEL.

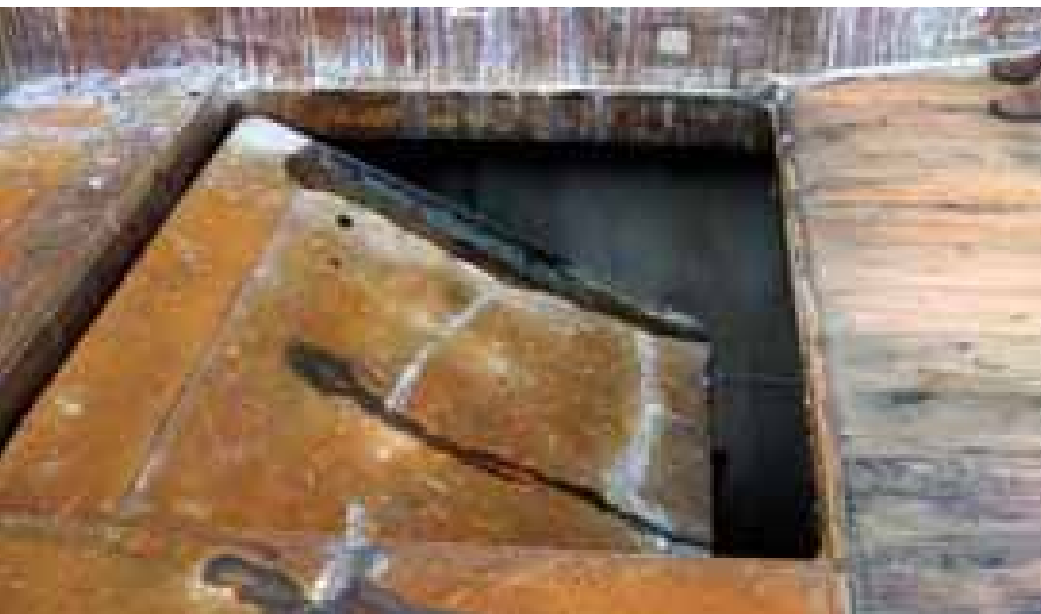
▲ OPEN HATCH VIEWED FROM INSIDE FISH POUND.  
▲ OPEN HATCH VIEWED FROM TRAWL DECK.

The deckhand at the hatch controls continued until the hatch cover was about 1.25 metres below the deck. Shortly after, he decided to close the hatch again as the safety line was not yet in place, and he felt the open hatch was a hazard.

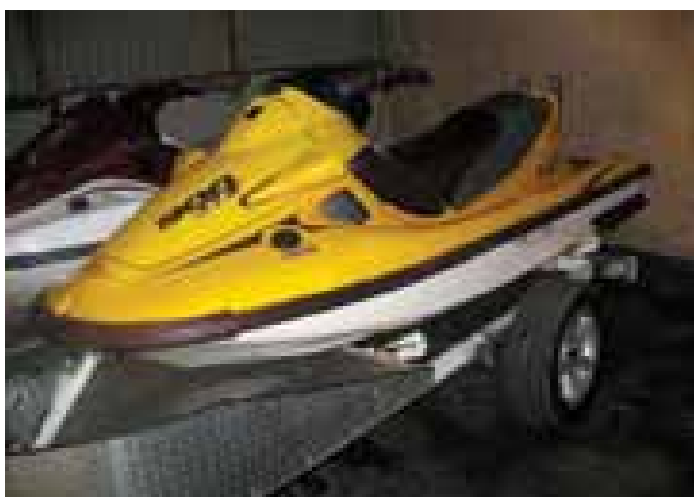
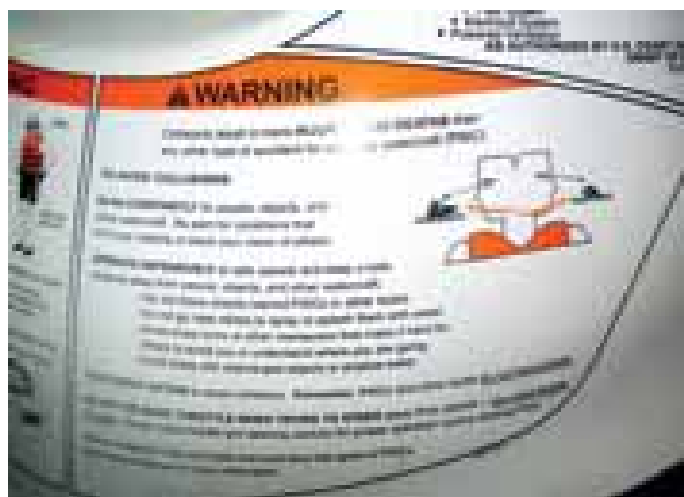
ONE OF THE JET SKIS.

DETAIL OF WARNING SIGN ON ONE OF THE JET SKIS.

**1.** The driver of the second jet ski was very inexperienced, having driven one only three times, several years ago. Despite this, he was travelling at speed with two children on board, and in close proximity to another craft that was also carrying a child. The driver's inexperience meant he did not fully realise that releasing the throttle would cause him to
