IHI SERVICE INFORMATION	QAS—0021A
DECK CRANE DAMAGE PREVENTION OF CARGO BLOCK	15th Nov. 2013

The cargo block of IHI deck crane was damaged by operator's mistake during operation. We have confirmed with the following 2 cases about the cause of damage from the result of investigations. Please note that do not operation which is not allowed in our instruction manual, it may directly cause an accident.

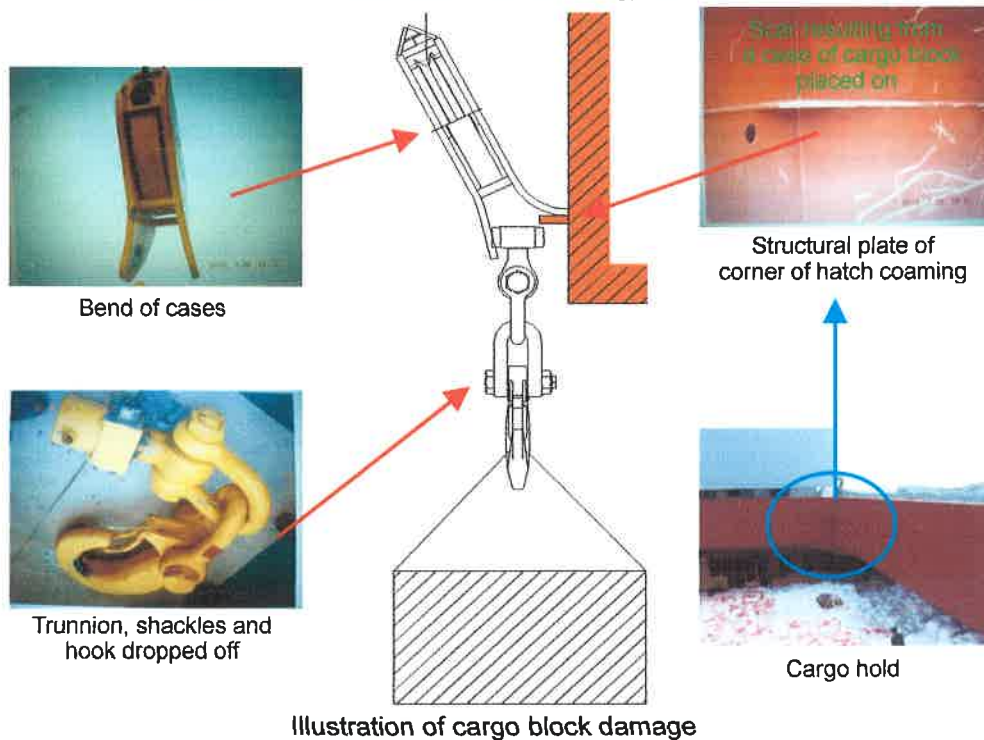
The cargo block body is comprised of two cases holding a sheave unit. In this case, two cases were bent outward and led to dropping trunnion, shackles, and hook held in lower part of two cases.

Case 1: The crane operator continued the lowering operation during a case of cargo block placed on a structural plate in the corner of hatch coaming. This condition was subjected two cases to have excessive force. In the result, it led to cause the damage to the cargo block and cases were bent.

This is the damage from carelessness (Not watching) during operation.

! **DANGER**.....1) Operator : Watch cargo and loose gears carefully and do not hit against hull and around objects during operation.

! **DANGER**.....2) Stevedore : Overwatch cargo and loose gears carefully during slinging work and crane operation. Instruct crane operator not to hit against hull and around objects.

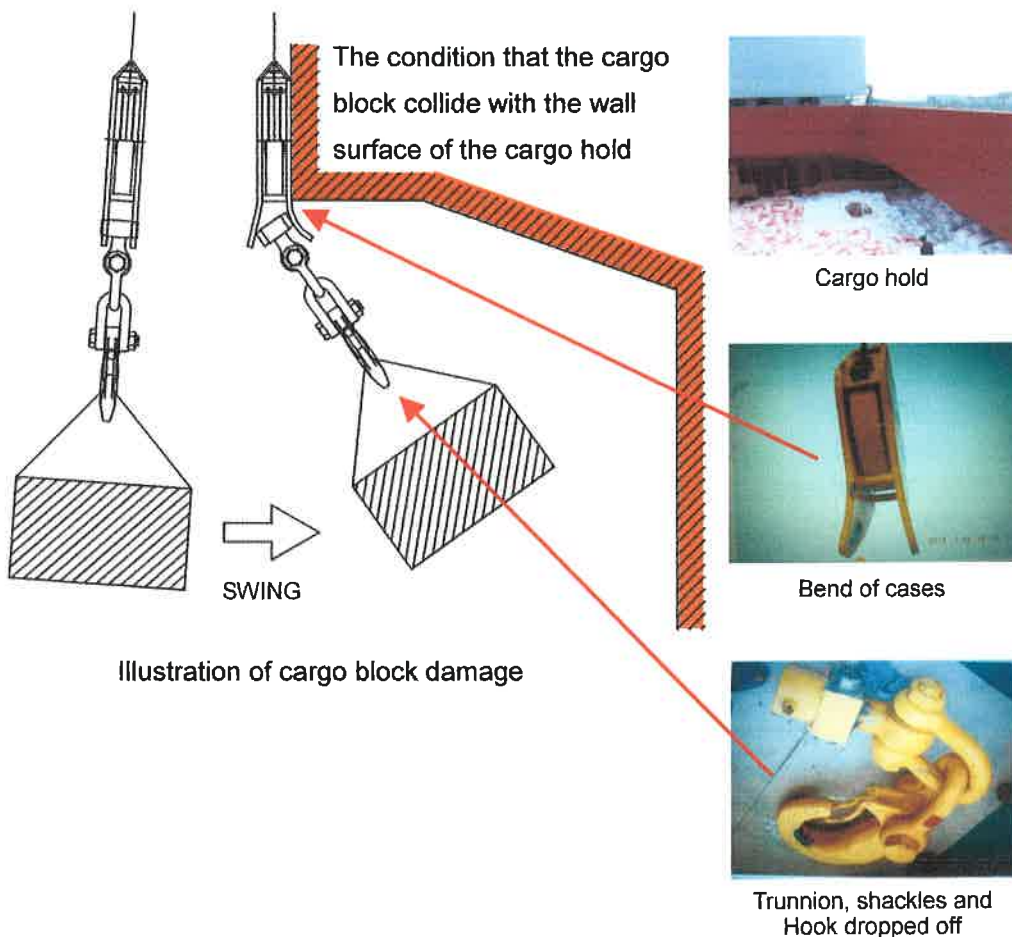
The crane operator operated the cargo by swinging motion, it caused the cargo block to collide with the wall surface of cargo hold. This condition is subjected the two cases to have excessive force. In the result, it will lead to cause the damage to the cargo block and the cases are bent.

This kind of operation is not allowed to prevent any damage to the cargo block.

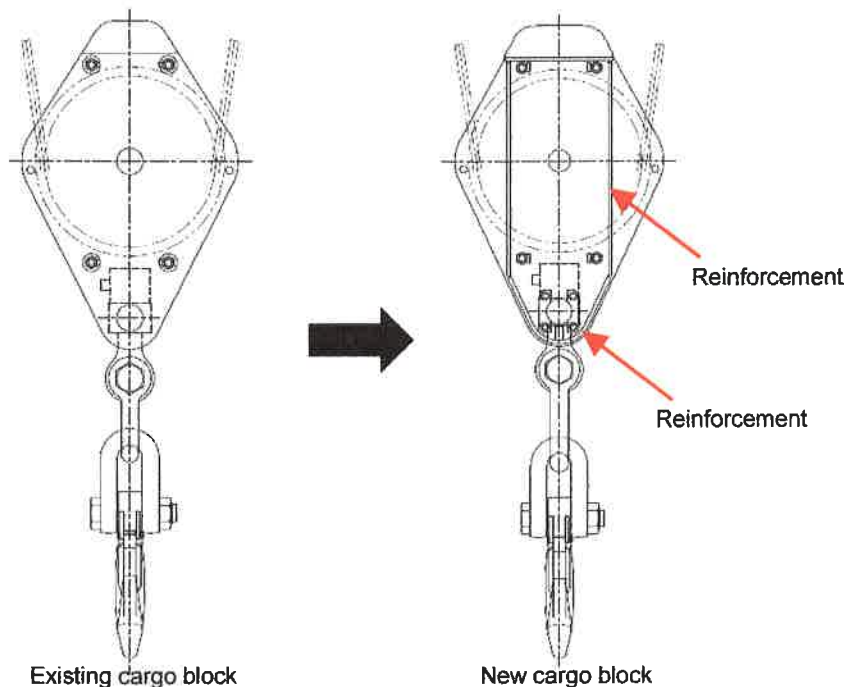
We confirmed that the damage to the cargo block was due to operator's mistake during operation as mentioned above. However, we will take measures to increase safety by changing cargo block into more strong structure.

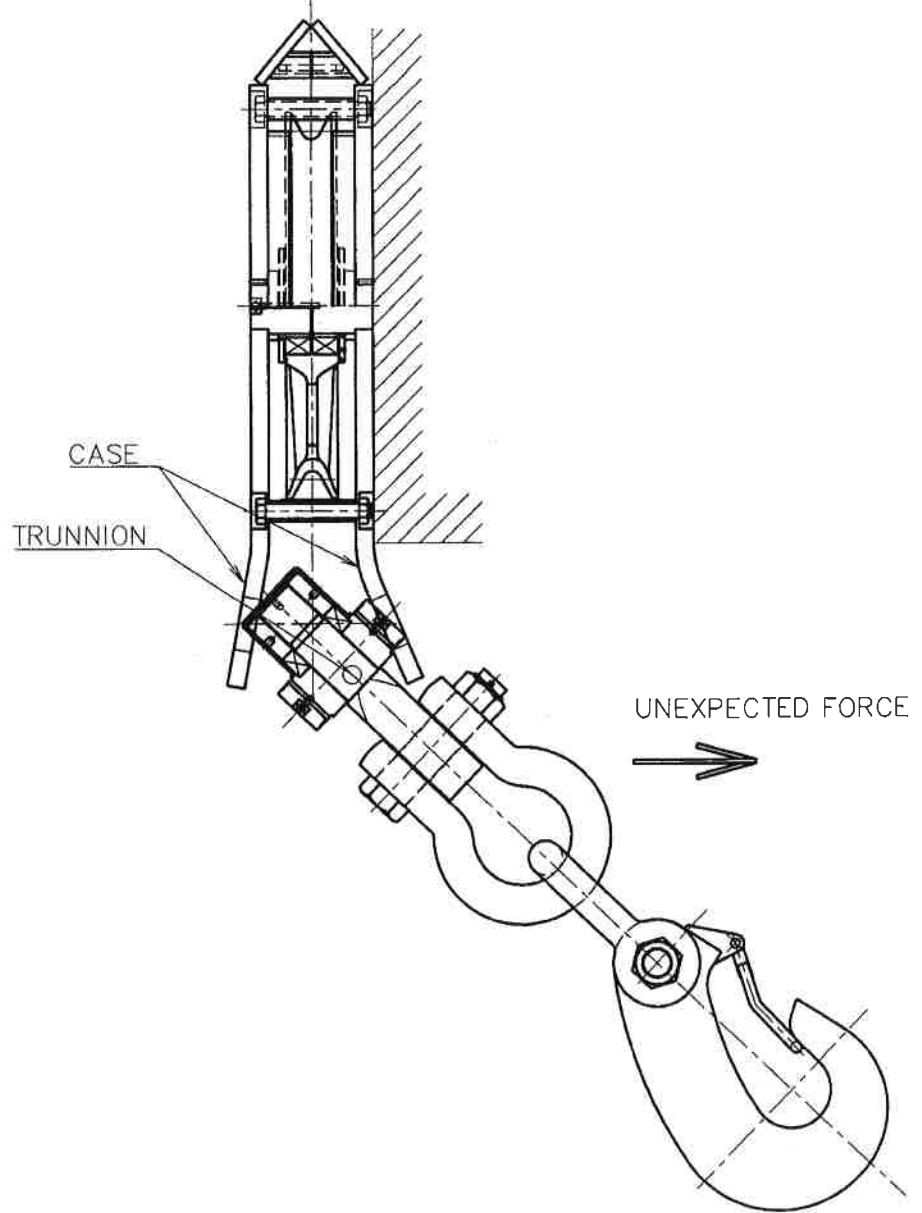
ABNORMAL CONDITION
(FOR EXAMPLE)

We had received the report of cargo block damage that the trunnion dropped out from cargo block's case in loading and unloading of log at New Zealand. (See attached P.3.)

We have been informed that the cause of damage is the out of essentially intended method for using (mishandling) by customer who is related to this matter. We think that this cargo block damage is not based on our quality and design.

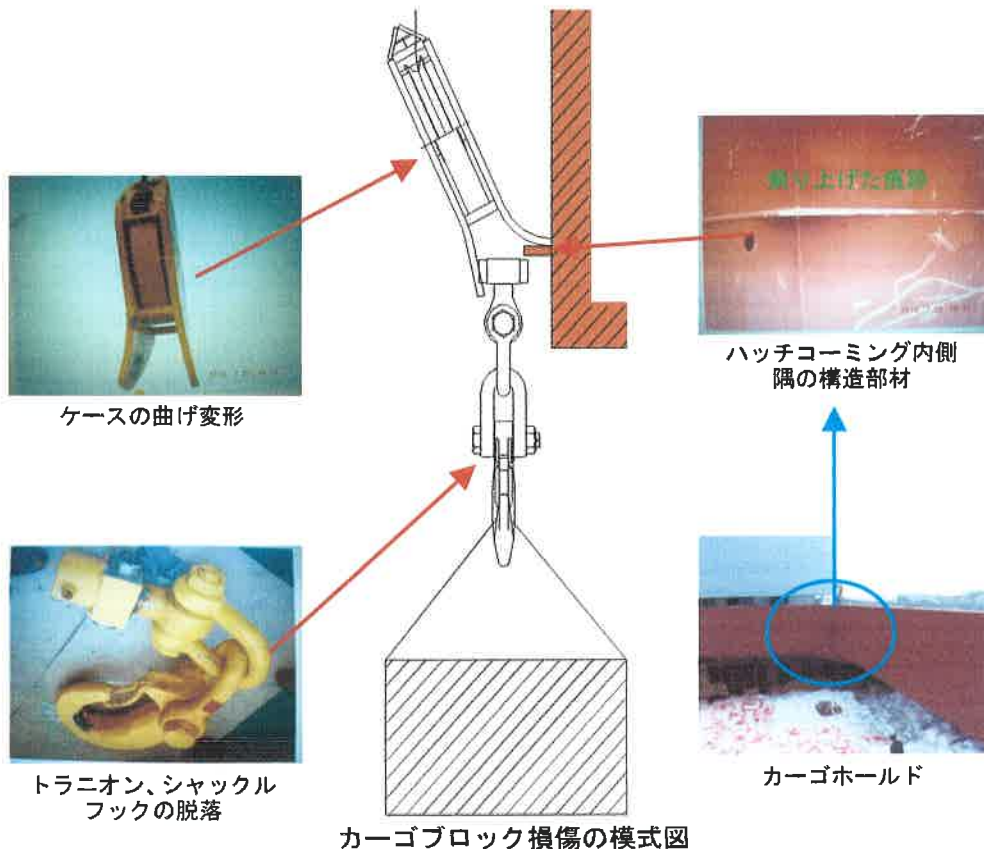
シーブユニットを挟み込みカargoブロック本体を構成する 2 枚のケースが、曲げ変形し、2 枚のケースの下部に保持されていたトラニオン、シャックル、フックが脱落しました。

事例 1： 船体のカargoホールドへ貨物を積み込む際、ハッチコーミング内側の隅にある構造部材の上にカargoブロックのケースが乗り上げた状態で、そのまま巻下げ動作を継続したため、ケースに無理な力が掛り、曲げ変形しました。

これは、荷役中の不注意（よそ見）で損傷した事例です。

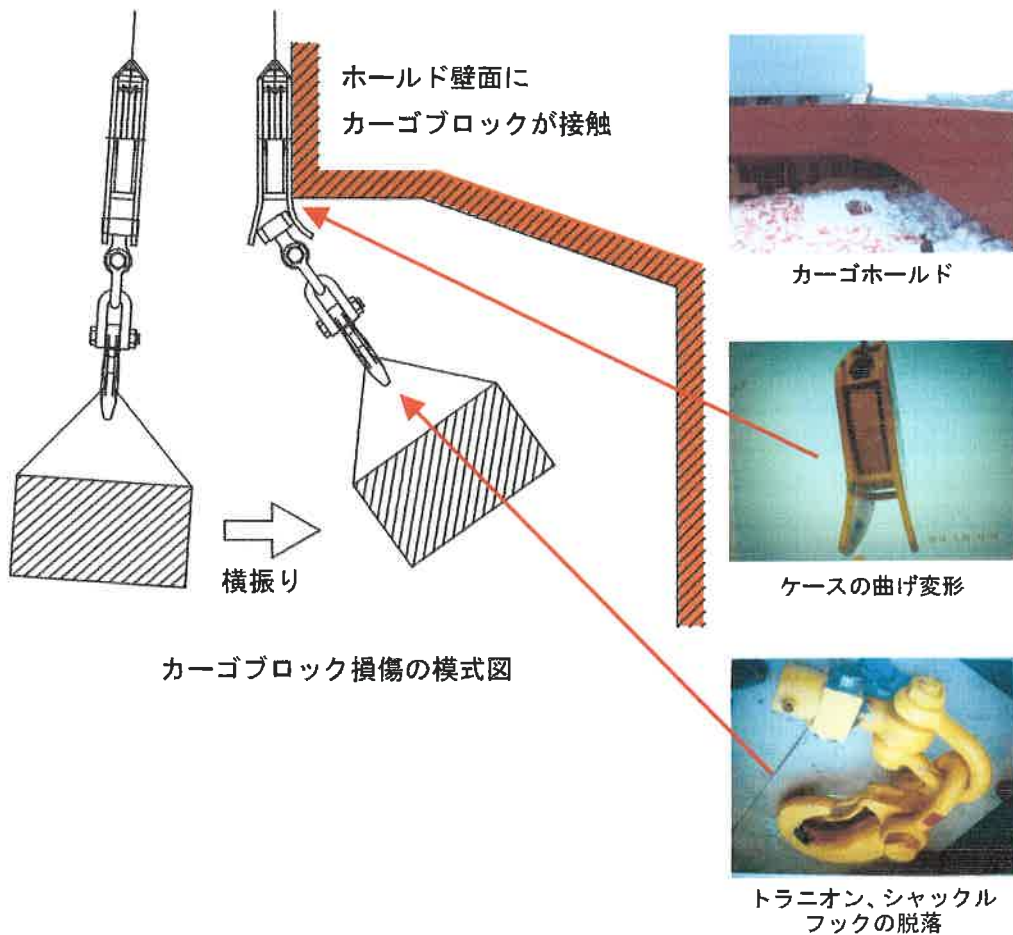
船体のカargoホールドへ貨物を積み込む際、貨物をスイング（横振り）させる荷役方法により、ホールド壁面にカargoブロックが接触した場合に、ケースに無理な力が掛り、曲げ変形します。

これは、クレーンで禁止されたオペレーションであり、損傷へとつながります。

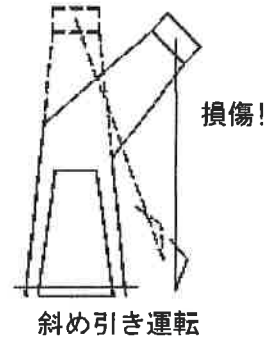
⚠ 危険……3) クレーン運転者は、荷役貨物ならびに吊り具をしっかりと目視し、斜め引きの状態でないことを確認してから運転してください。斜め引き運転をすれば、クレーンジブに無理が生じ、損傷事故につながる危険があります。
