# **San Rakaia**

Onehunga, on 10 January 2005

**REPORT NO: 96 345**

***SAN RAKAIA* – CARBON MONOXIDE POISONING**

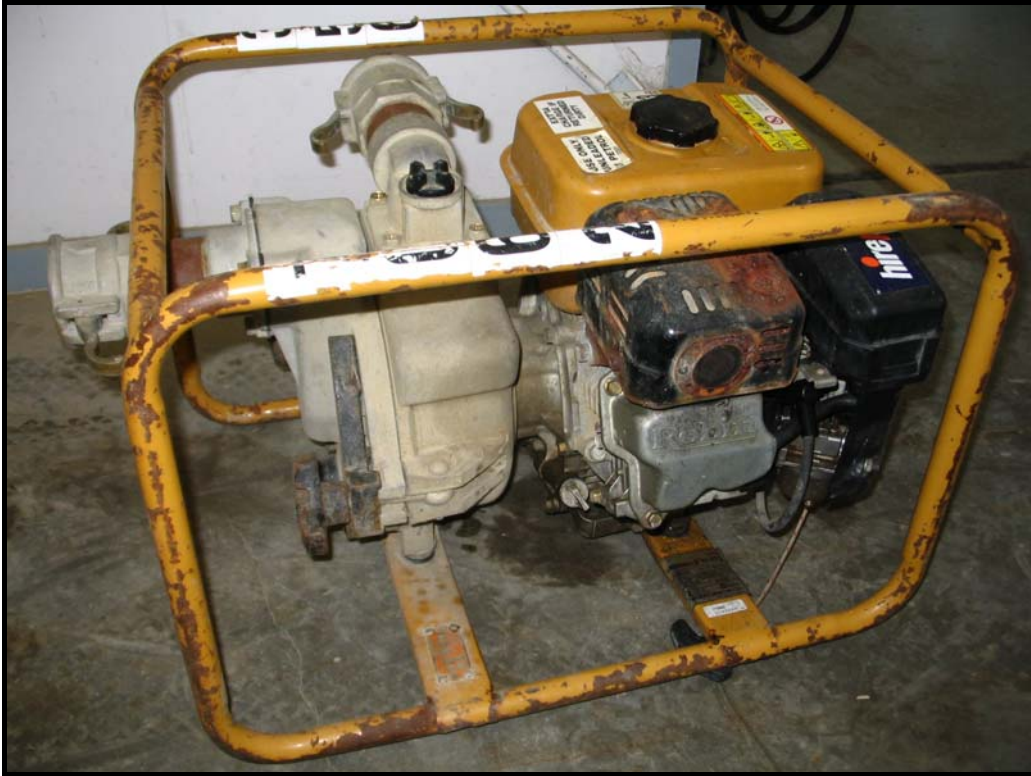
The pump was manufactured by Robin Pumps and was of a model type PTX-201. The contractors had hired the pump from the Henderson branch of Hirepool Ltd.

**FIGURE 1: PUMP USED IN INCIDENT.**

1. It is recommended that the use of a petrol drive pump in an enclosed space be included in the ship's hazard register and in the hazard register of all other vessels operated by Sanford.
2. It is recommended that a letter be written by the MSA to the Contractors, reminding them of their responsibilities under sections 6, 7 and 13 of the HSEA 1992 and of the need to have a documented hazard register and to erect signage on their portable pumps that they are not to be used in an enclosed space without proper and sufficient ventilation being present.
3. That copies of this report be passed to all Safe Ship Management Companies with a recommendation that when auditing vessels they ensure that a proper hazard register is being maintained and has been brought to the attention of all crew.
