Accident Report

Drowning

Unnamed Kayak

1 November 2006

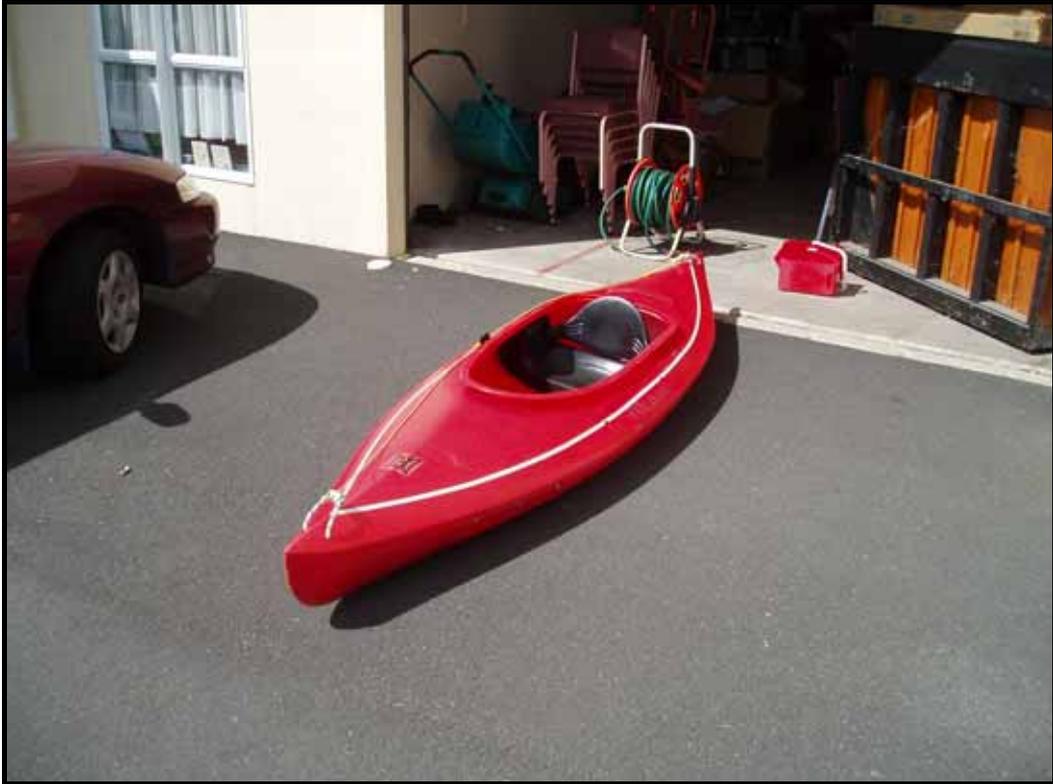
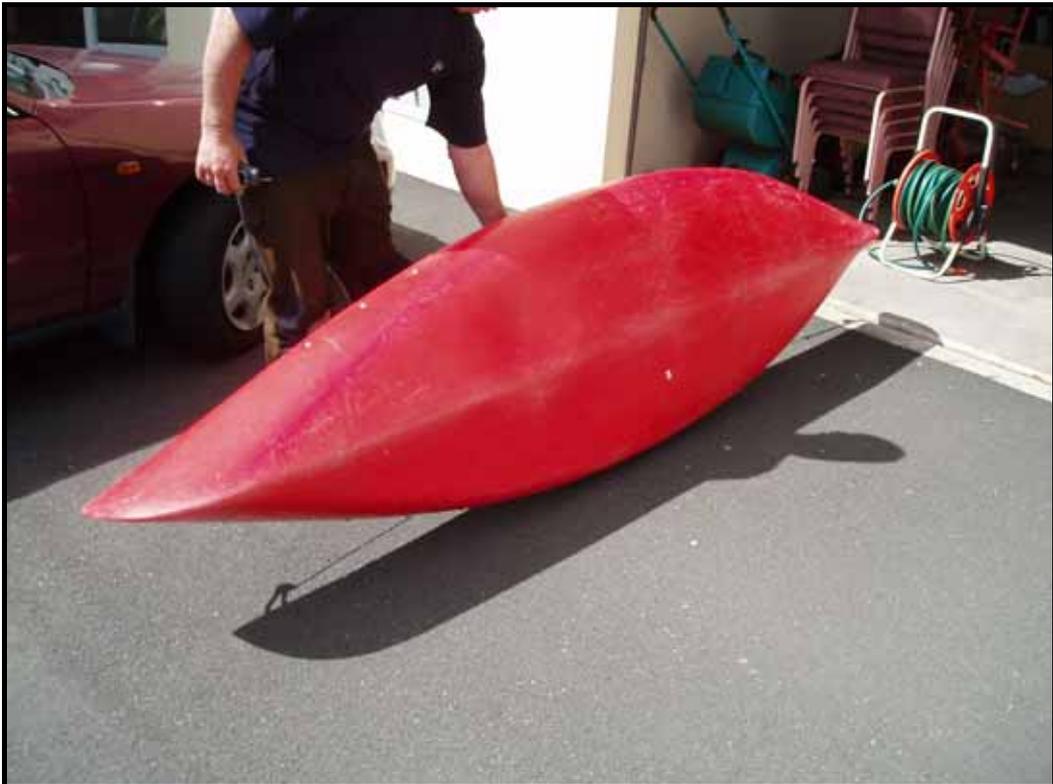
Photographs of the Perception Minnow kayak

The vessel was intact and in a satisfactory condition. Moulded internal buoyancy was fitted in its bow and stern.

The kayak was a small sit-in type of vessel.

The kayak was not suitable for use on the open sea.

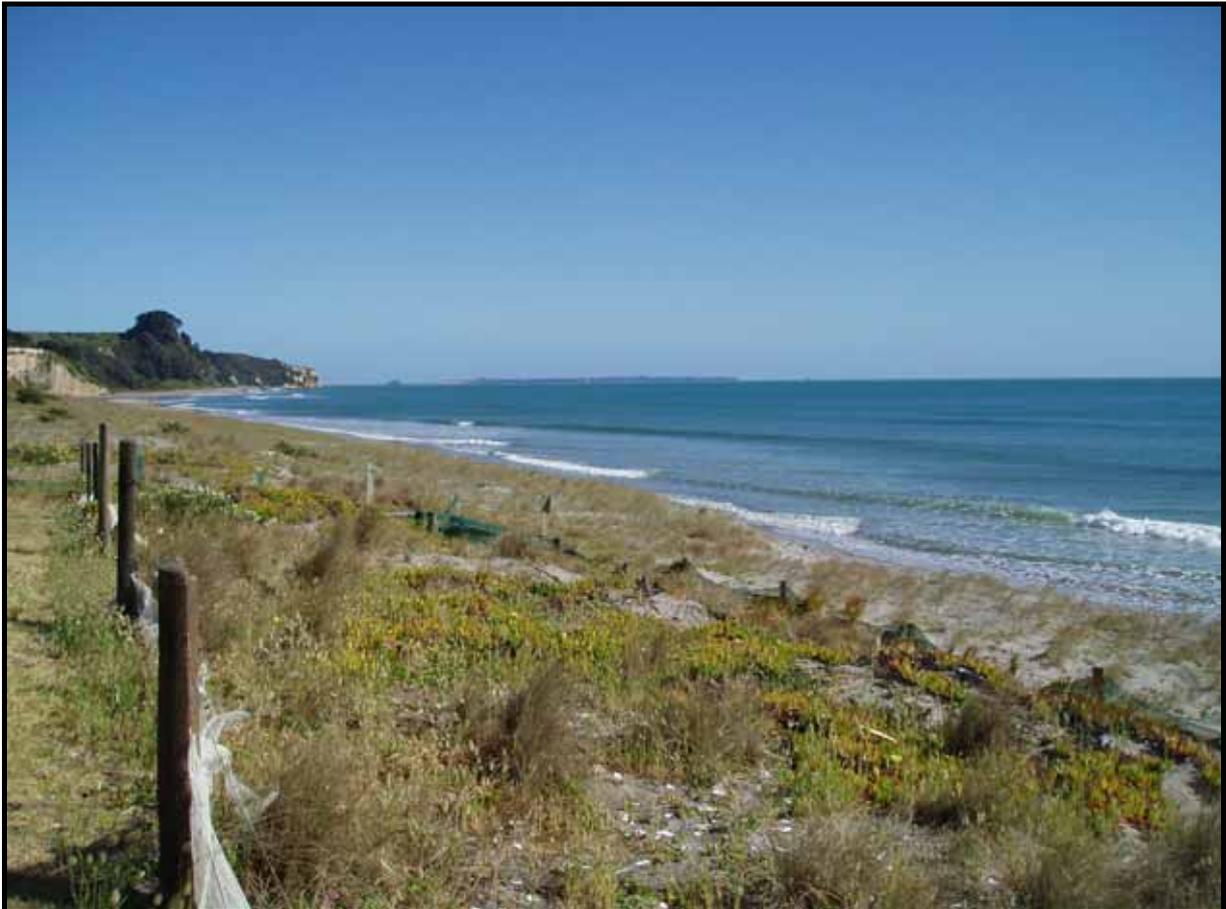
Photograph 1

Pukehina Beach near the Rogers Road car park.
