LESSONS LEARNT
BY ACCIDENT

LOOKOUT!

MARCH 2009 ISSUE TWELVE

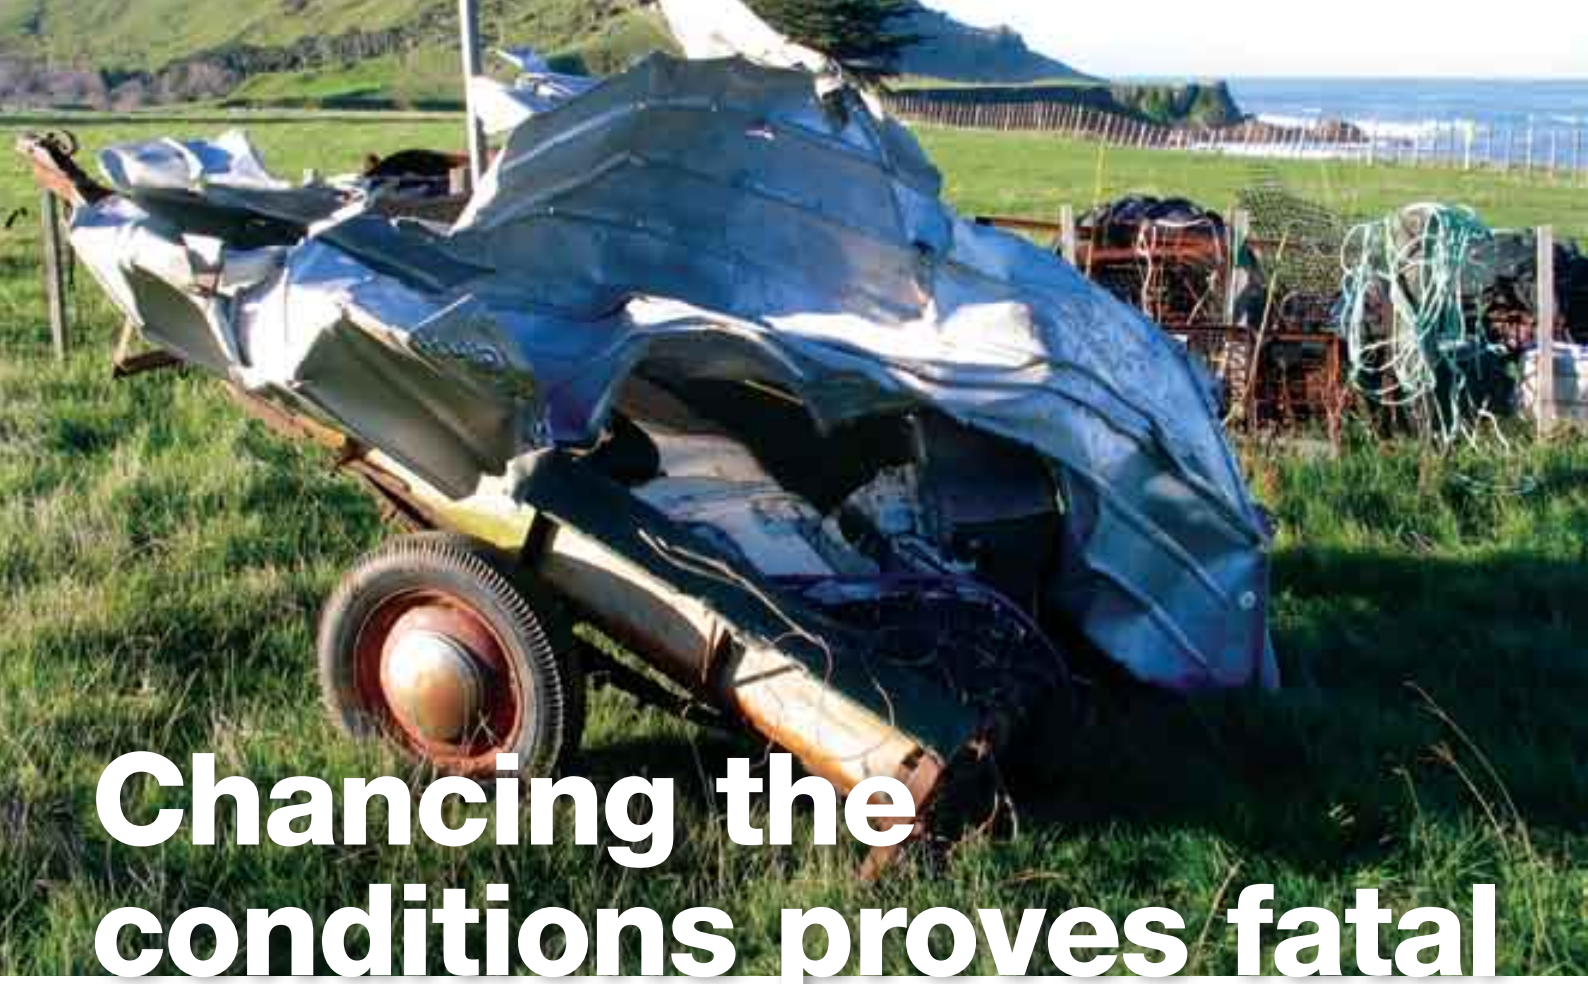
Chancing the conditions proves fatal

A man drowned after deciding to chance rough sea conditions in a friend's 15-foot aluminium runabout.

▲ THIS TRAGEDY INVOLVED TWO OF THE FOUR FACTORS COMMON IN PLEASURE BOAT ACCIDENTS – NO LIFEJACKETS AND FAILURE TO ADEQUATELY ASSESS WEATHER CONDITIONS.

1. The decision to make the trip in these conditions contained an element of chance. The men had spent most of the day deciding not to take that chance, but in the mid-afternoon, they decided to go. The lulls in the waves that they felt had provided a suitable safety margin were described by witnesses as lasting "about the time it takes 10 waves to come in".

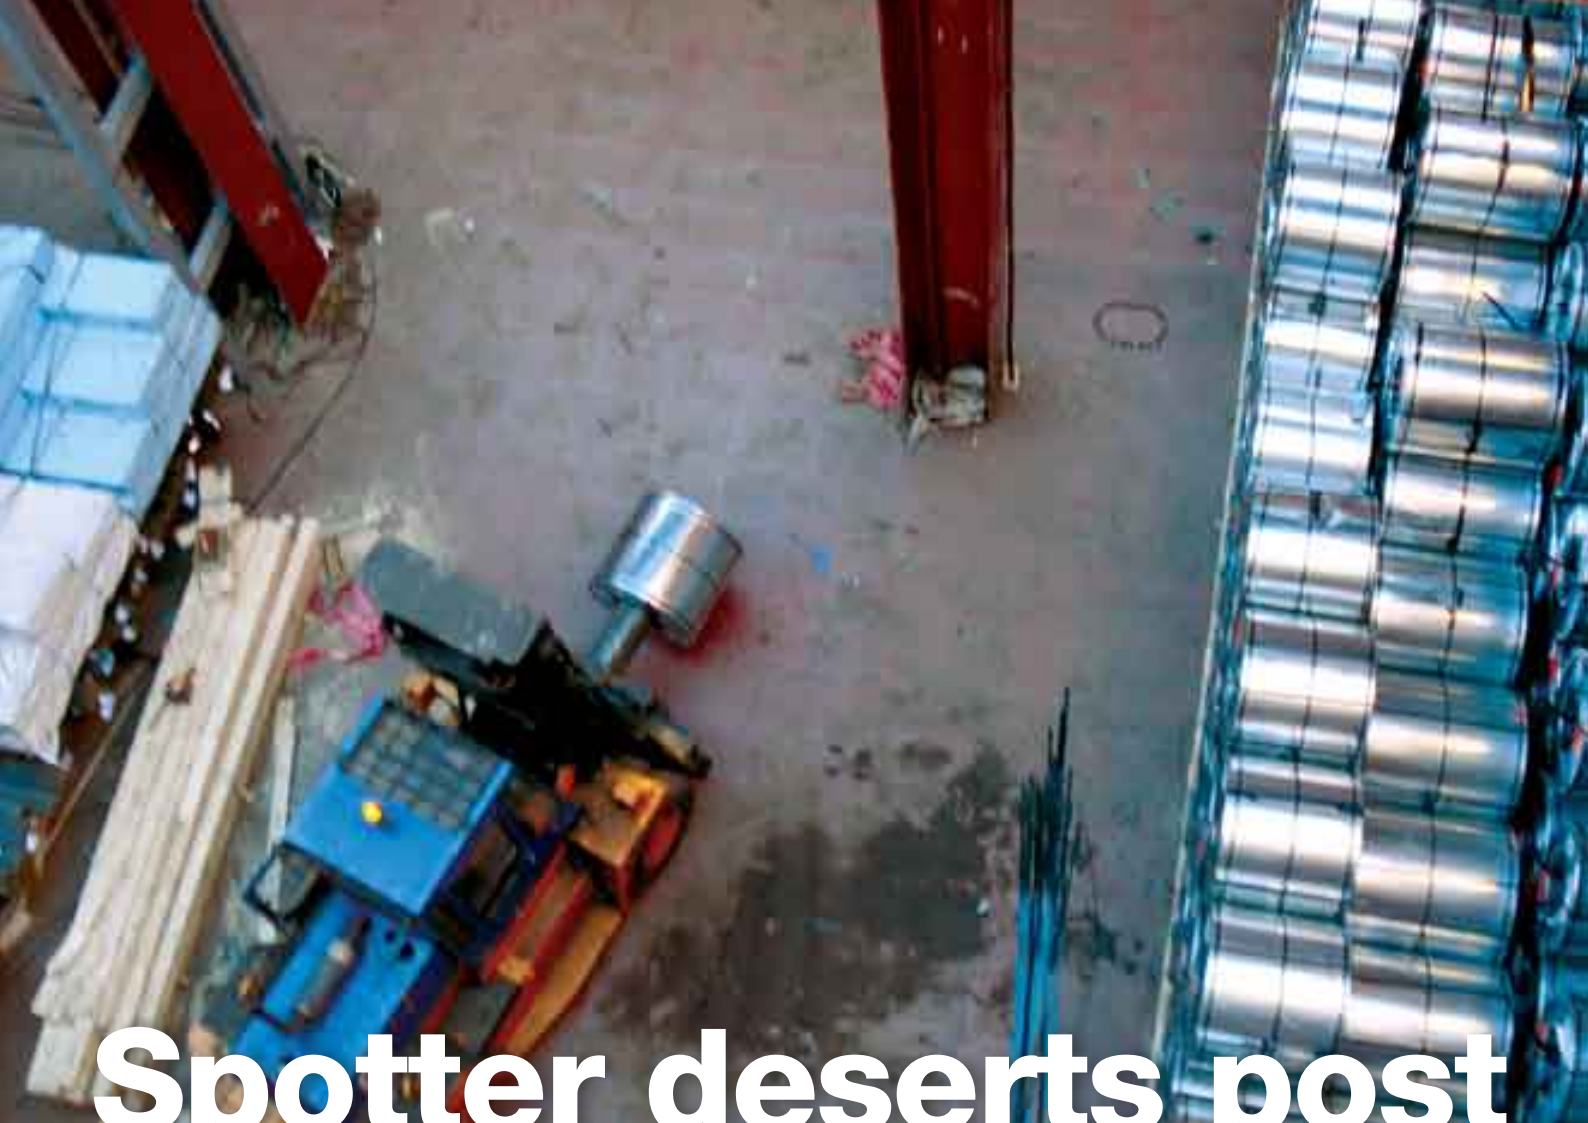
Spotter deserts post

An inexperienced stevedore was struck by a forklift when the gang's supervisor stopped monitoring safety.

The stevedore was initially thought to have broken his leg, but was later discharged from hospital with severe bruising.
