Accident Report  
Collision with Submerged Object  
*Black Diamond*  
28 July 2006  
Summary Report

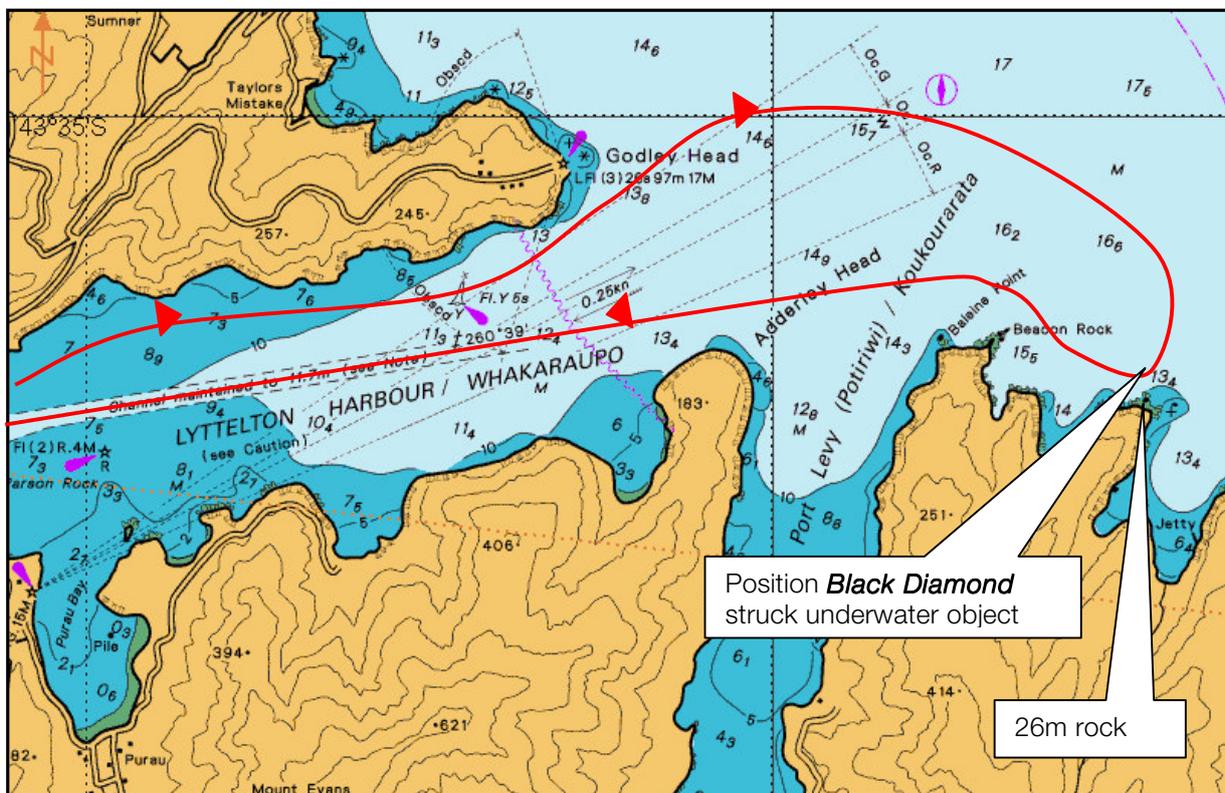
Figure 1

The Skipper followed his usual passage around the harbour and gave a commentary as he went (See *Figure 1 - Approximate track of Black Diamond*). As they reached the Heads, they crossed to the other side of the Heads, as it was a good area to sight dolphins.

The Skipper lined his bow up with the charted 26 metre rock located east of Beacon Rock (See Figure 1). As he approached he commenced a turn to starboard. The vessel's speed was about 13-14 knots. The vessel was about 80-100 metres off the reef situated at the end of the 26 metre rock and in 15 metres of water when the Skipper and passengers heard two consecutive thuds. The Skipper then felt a vibration coming from the port engine shaft and propeller. He immediately stopped the port engine.

Chart extract from Land Information New Zealand (LINZ) chart NZ 6321 showing the approximate course of **Black Diamond**
