Class A Accident Report

Louisa & Emma J

Collision

At Golden Bay on 7 November 2004

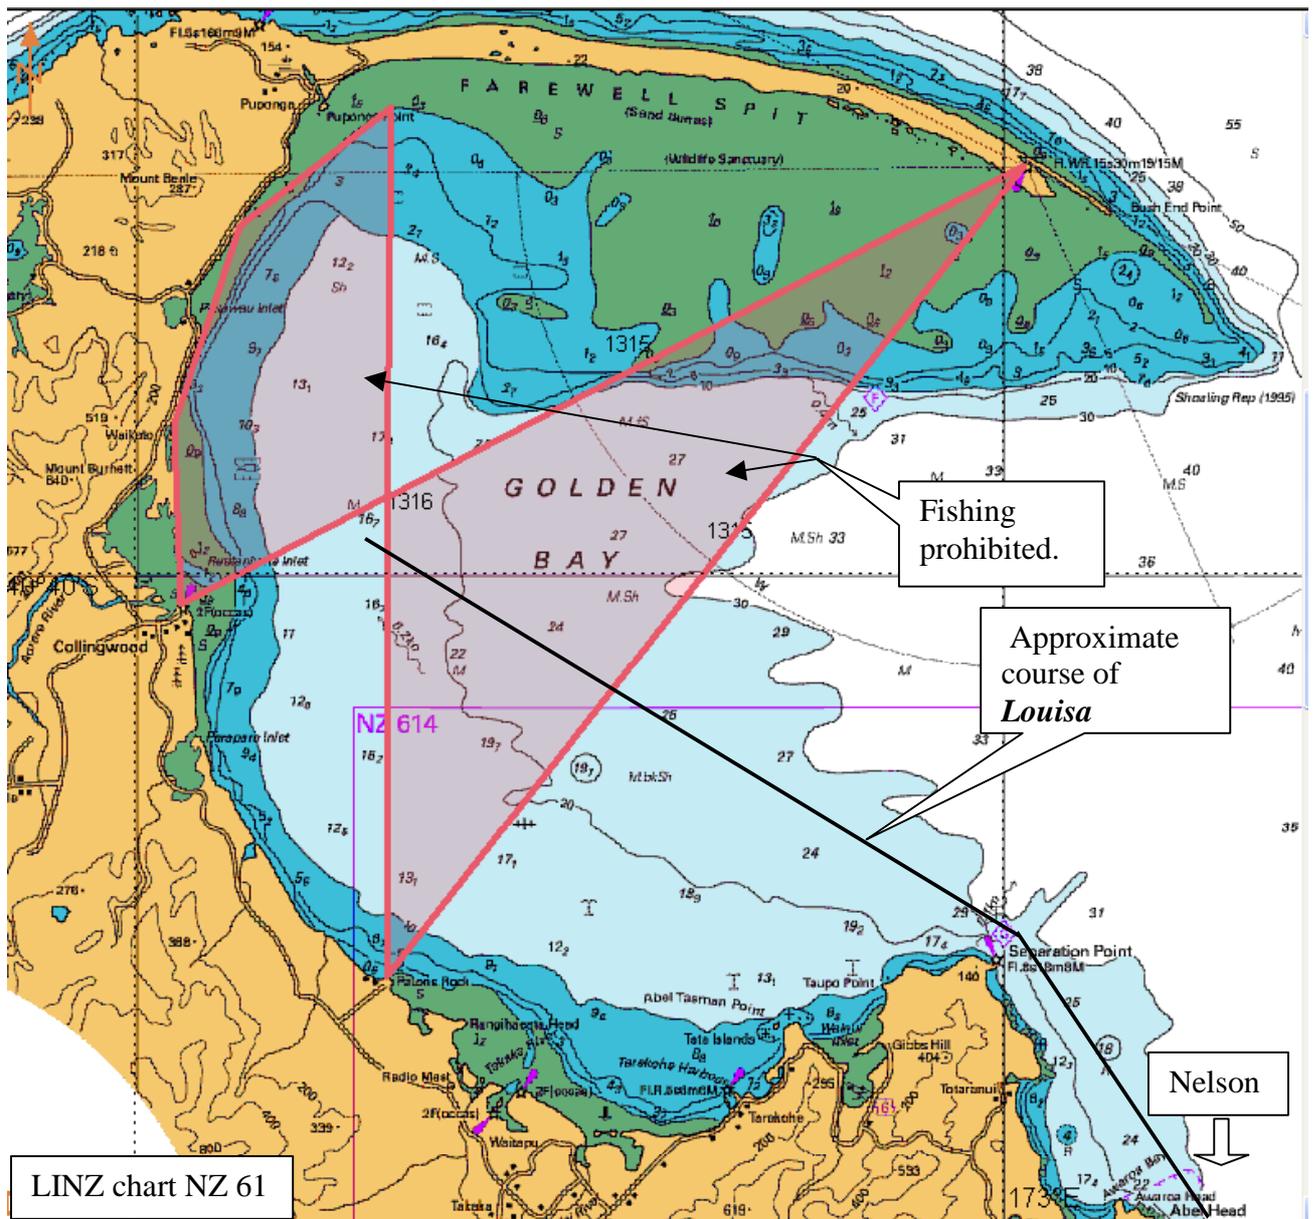
At about 0645 hours, *Louisa* had 0.2 nm to run to where the Skipper wanted to start fishing for the day. He looked down to adjust the GPS plotter scale, looked up again and saw *Emma J* about 10 m away ahead and to starboard. The Skipper engaged full astern but made no sternway and the vessels collided. The Skipper engaged neutral and he and the crewmember checked the vessel for water ingress. He ran to the bow where the vessels had started to drift apart. The Skipper saw that *Louisa* had sustained serious damage to the starboard shoulder. He rang the vessel *Unity* who was fishing in the general area and appraised them of the situation and asked them to bring a spare bilge pump to them as a back up. The Skipper then rang the owner and told him of the situation. It was decided that due to the vessel not taking on any water that they would steam to Tarakohe and effect temporary repairs before returning to Port Nelson for slipping and permanent repairs.

Louisa sustained extensive damage to the starboard side planking, ribs, beam shelf, deck beams, deck crash bulkhead, stringer, bull-works and capping rail.

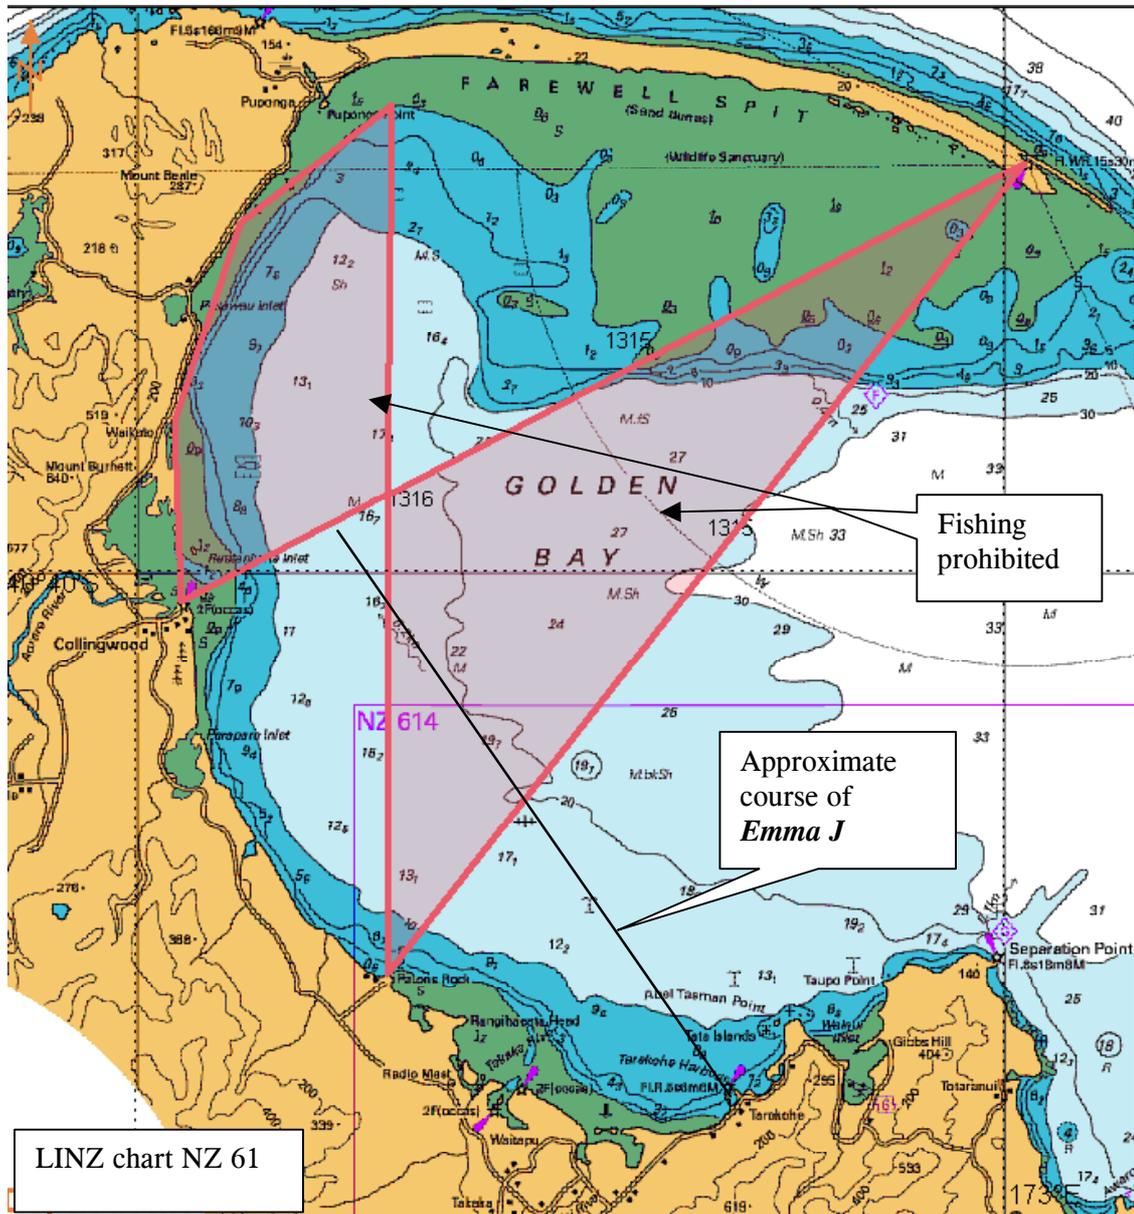
He reduced the radar range down from 3nm to 1½ nm and activated the ¼ nm range rings. He observed 7 to 8 other vessels within the 1½ nm range situated broadly south of his position.

Emma J sustained very minor damage to the paint work around the stem post.
