Accident Report

Crane Failure

Global Wind

16-November-2006

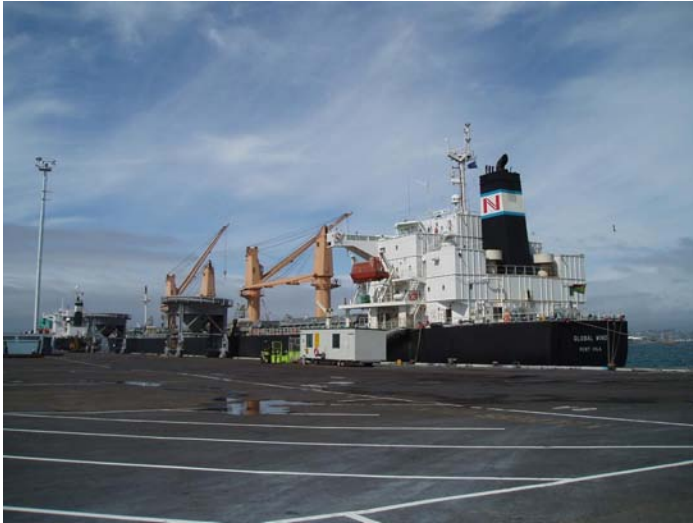
Photograph 1 **Global Wind**

An excavator weighing about 15 tonnes was lifted into No. 5 hold using No. 4 crane. Part of the excavator can be seen in Photograph 1.
