Accident Report

Sinking (1 fatality)

Hard Out

23 February 2008

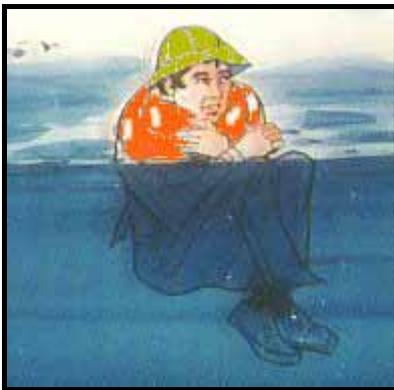
Figure 3
Showing HELP

- 3.84 It is not clear what sea survival techniques, if any, were employed by the persons in the water.
- 3.85 It does appear that all three of them made, understandably, a considerable effort to swim to shore.
- 3.86 During an in-water sea survival period conservation of body heat and energy is paramount to ensure that the person in the water has the maximum possible survival time.
- 3.87 For conservation of body heat several methods can be used depending on the number of persons in the water. For a single person the Heat Escape Lessening Posture (HELP) can be used. This is achieved by placing the arms across the chest to protect the axillae (armpits), and flexing the legs to protect the groin area. If present, wear headgear and remain still in the water. The HELP position will result in a 50% increase in survival time *(See Figure 3 – HELP position)*.

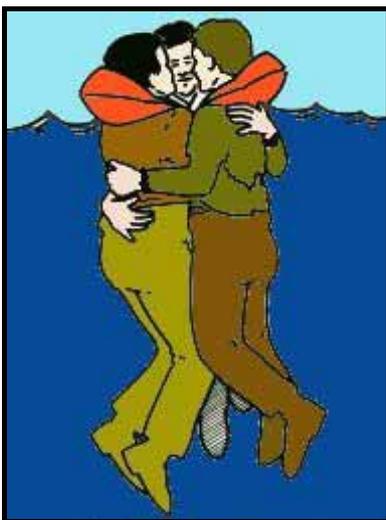
Figure 4
Showing HUDDLE position

- 3.88 If there are two or more the "HUDDLE" position is recommended to conserve heat loss. This again results in a 50% increase in survival time *(See Figure 4 - HUDDLE position)*.

3.89 It appears that once the occupants of *Hard Out* found themselves in the water they were not prepared for an extended in-water survival situation.
