Accident Report

Hirere

Injury – Pandora Banks area on
11 May 2005

REPORT NO.: 96 406

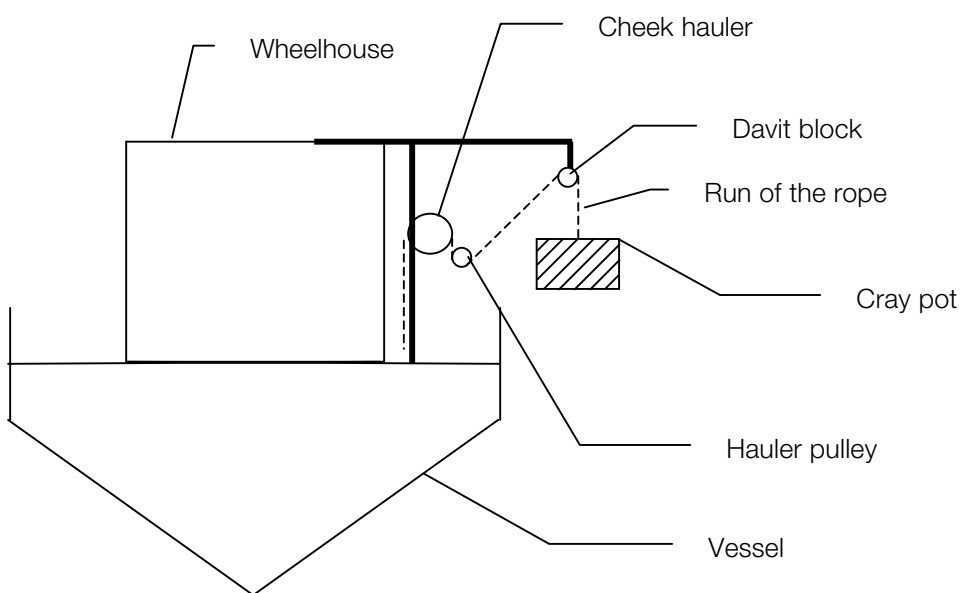
Photograph 2 – Winch and Approximate Hand Position

The winch was not fitted with a two-way rope peeler. This would allow the winch to be reversed without the need to tail off the rope manually.
