Accident Report

Kawau Kat III

16 September 2005

REPORT NO.: 96 458

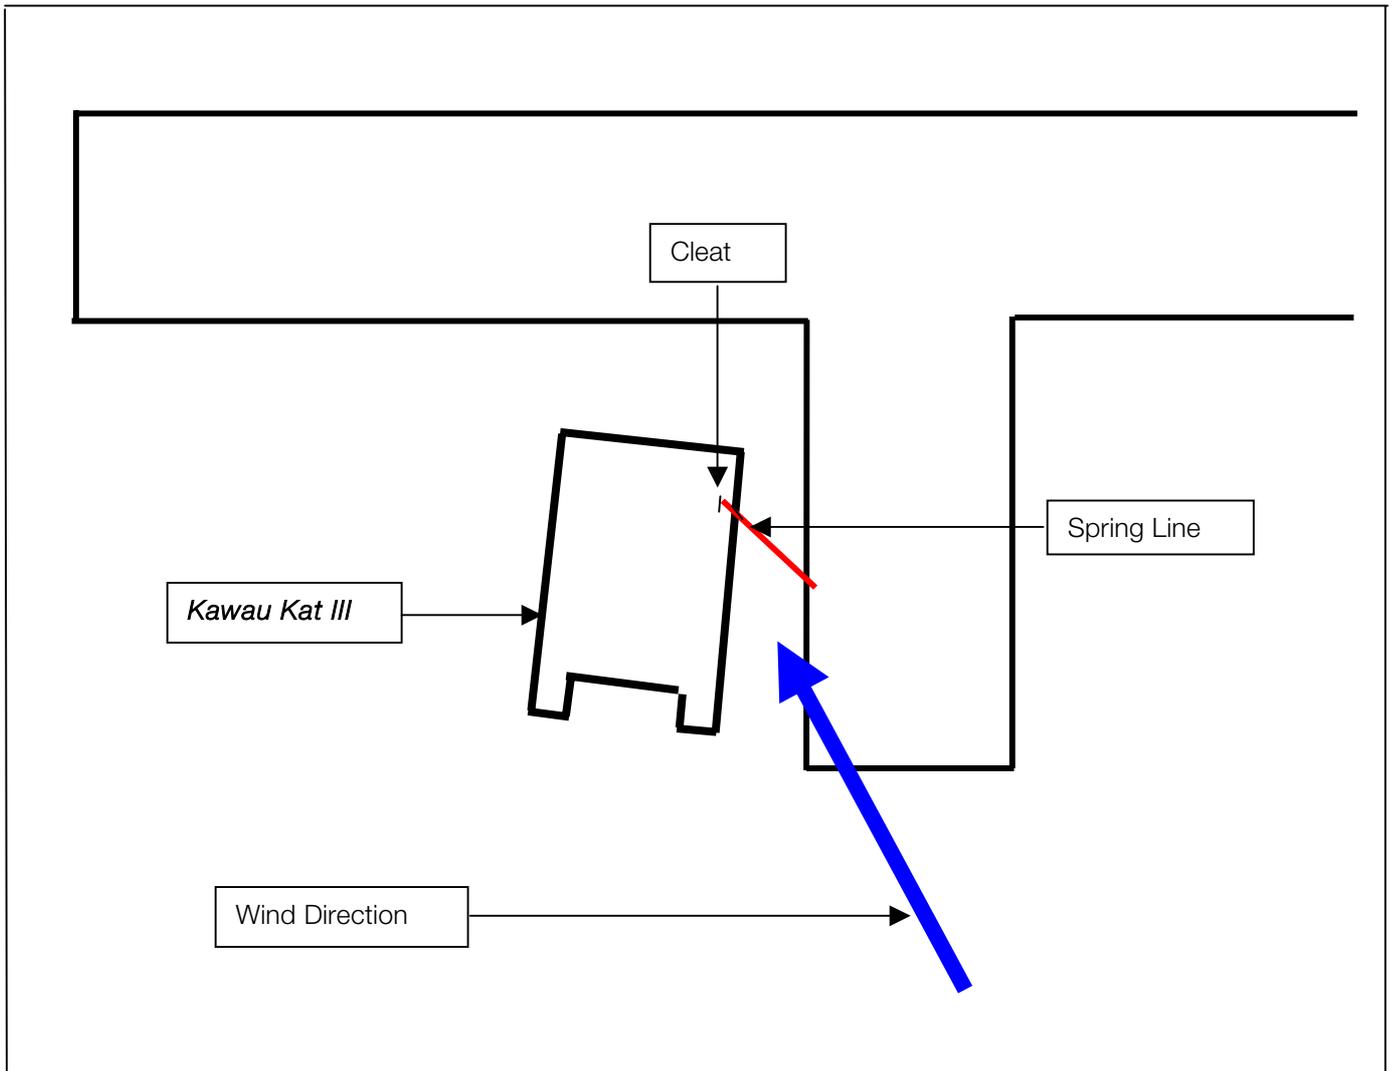
Figure 1
Diagram of Berth (not to scale)

On Friday 16 September 2005 at approximately 1055 hours NZST (New Zealand Standard Time), the commercial passenger vessel ***Kawau Kat III*** was approaching the commercial vessel berthing wharf known as Z Pier in Gulf Harbour Marina. The vessel had unloaded passengers at Tiri Tiri Matangi Island and was returning with the Master and Crewmember on board. A strong southerly was blowing. This caused the vessel to be blown off the face of the wharf during berthing (*See Figure 1 - Berth and approach (not to scale)*).
