Class B Non Serious Harm Accident Report

Lady Marie

At Havelock on 4 November 2004

REPORT NO: 96 323

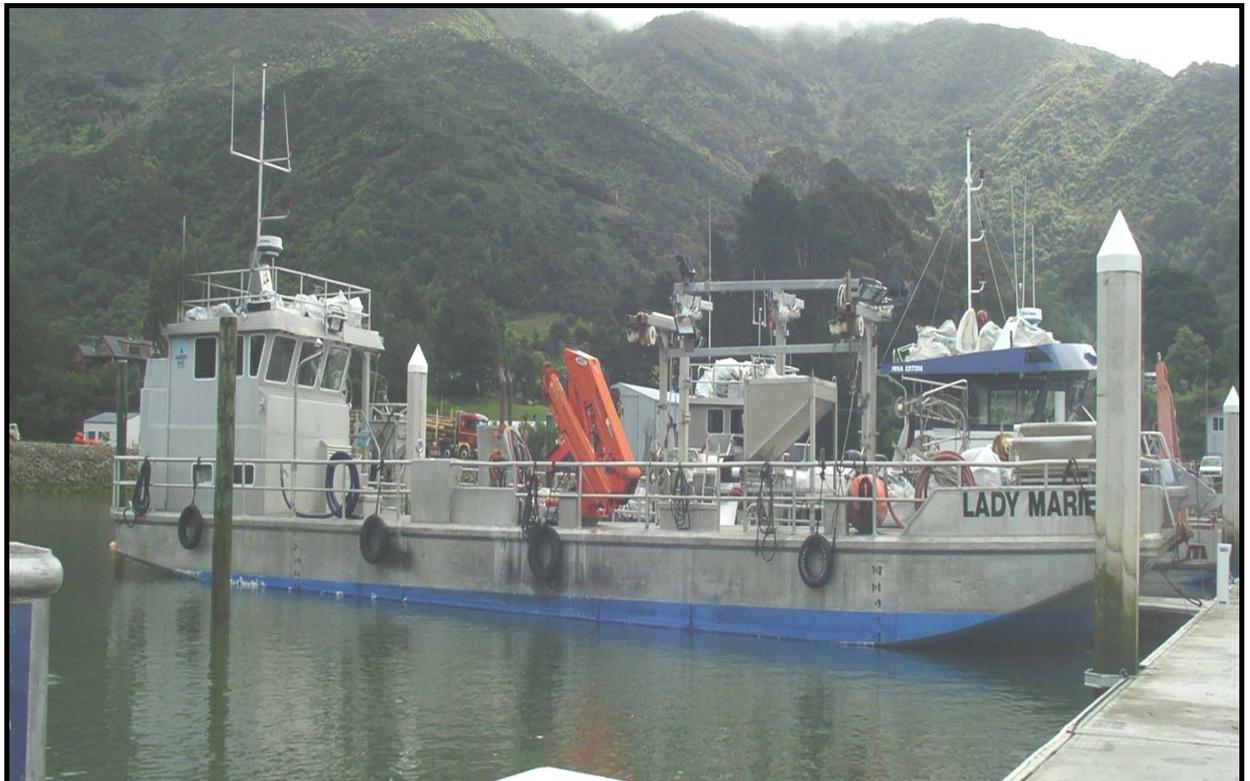
While berthing *Lady Marie* at Havelock, Marlborough, a crewman's fingers were caught in the stern gantry cleat when a gust of wind caught the vessel and swung the stern out. This caused the rope to tighten quickly and unexpectedly. Two of the crewman's fingers were severed and later re-attached in hospital.
