Class B Accident Report

Legacy Grounding

At Fiordland on 3 December 2004

REPORT No: 04 3614

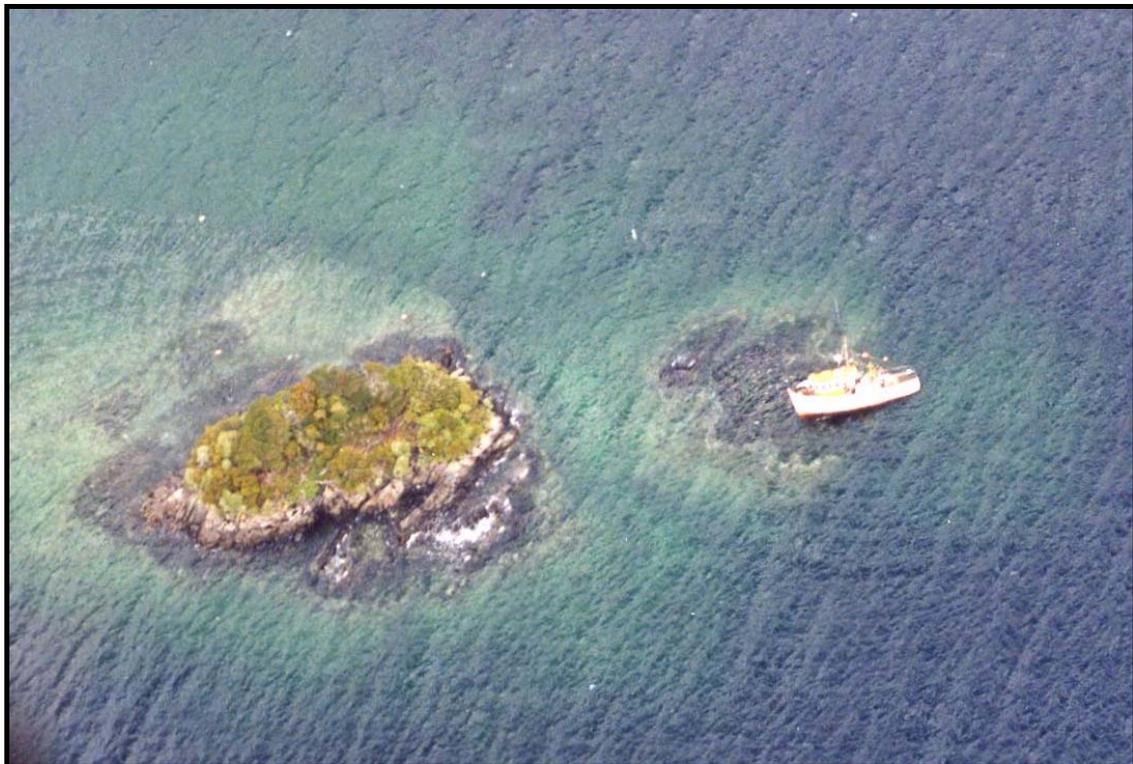
At about 1230 hours New Zealand Daylight Time (NZDT), on 3 December 2004, the fishing vessel *Legacy* grounded on a partially submerged rock off the south-eastern side of Small Craft Harbour Islands in Chalky Inlet, Fiordland. The vessel sustained damaged to the keel and took on water. The vessel was re-floated on the high tide with the assistance of the passenger vessel *Cindy Hardy*. There were no injuries and no fuel was spilled.
