Accident Report
Collision
Rescue Alpha v PWC 911
13 June 2009

Maritime New Zealand

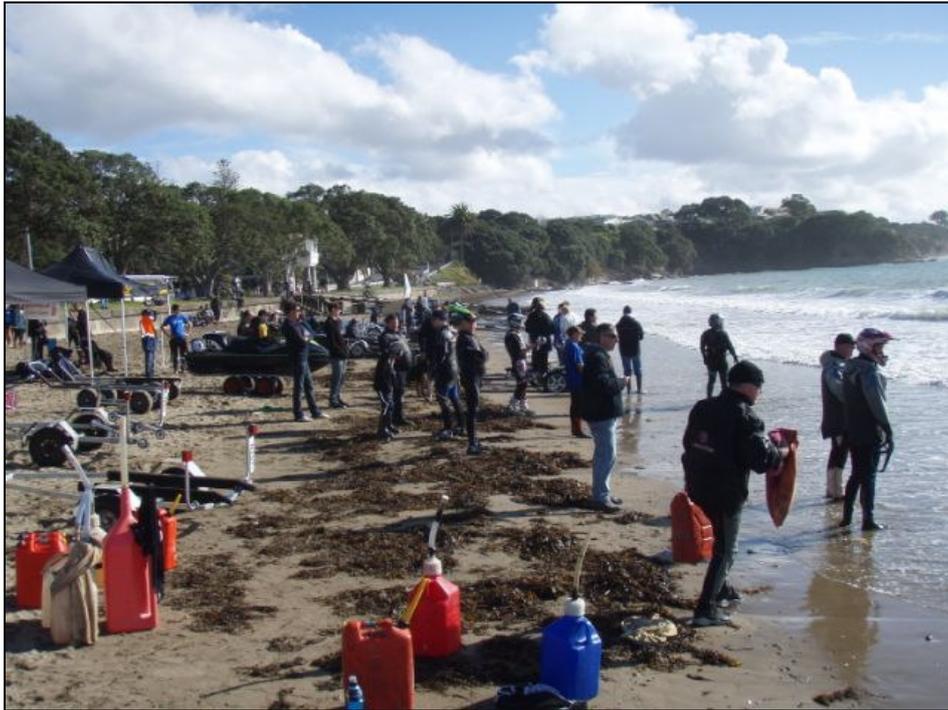
Figure 1 Photograph showing race participants and spectators on Narrow Neck Beach.

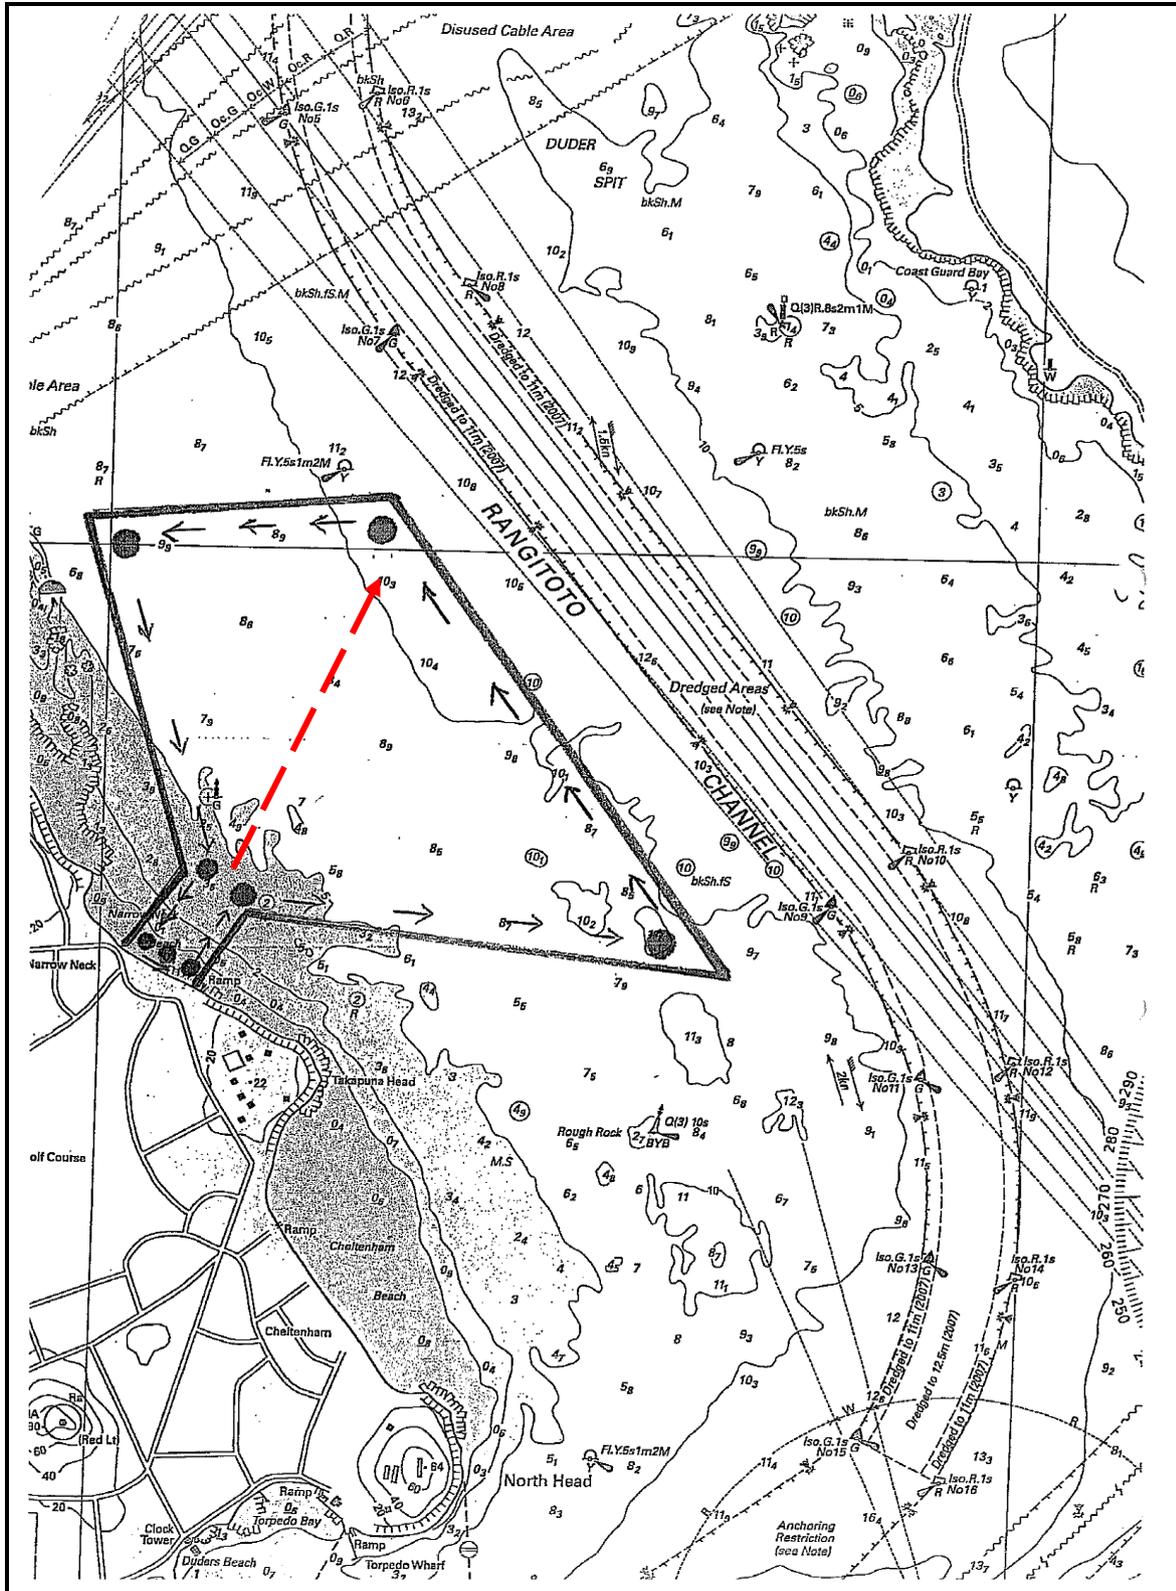
1. Layout of course as submitted to Auckland Harbour Master's office for approval.

The red dotted line indicates the shortened course for the Novice Women's event.
