Incident Report

Switchboard Fire

San Enterprise

18 September 2006

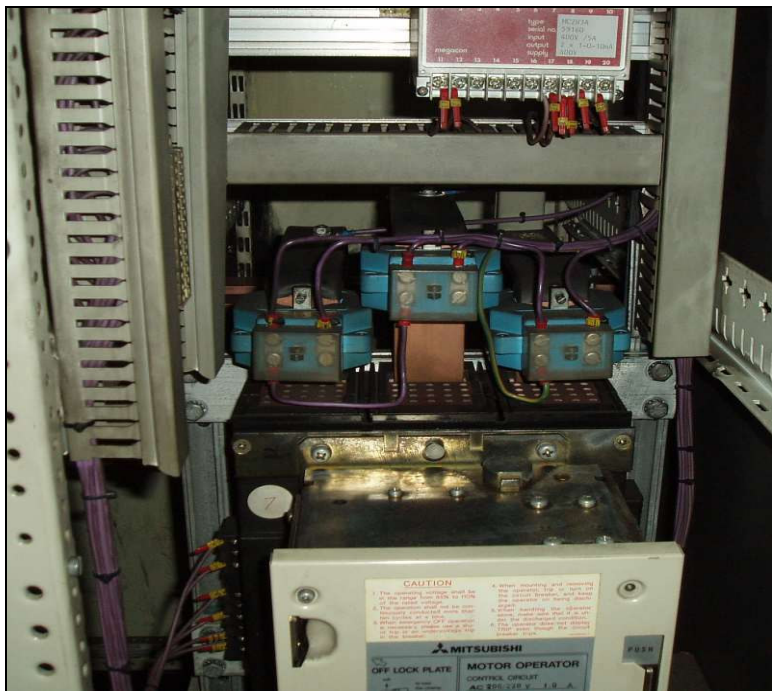
Figure 2

The breakers are housed in their own cabinets within the main switch board. (See Figure 2). The contactors in the breakers are closed by energising a coil drawing the three supply contactors simultaneously to close against the output contacts (See Figure 3).

Photograph of undamaged cabinet within the main switch board
