Accident Report

Grounding

Shangri-La

SHANGRI-LA GROUNDING

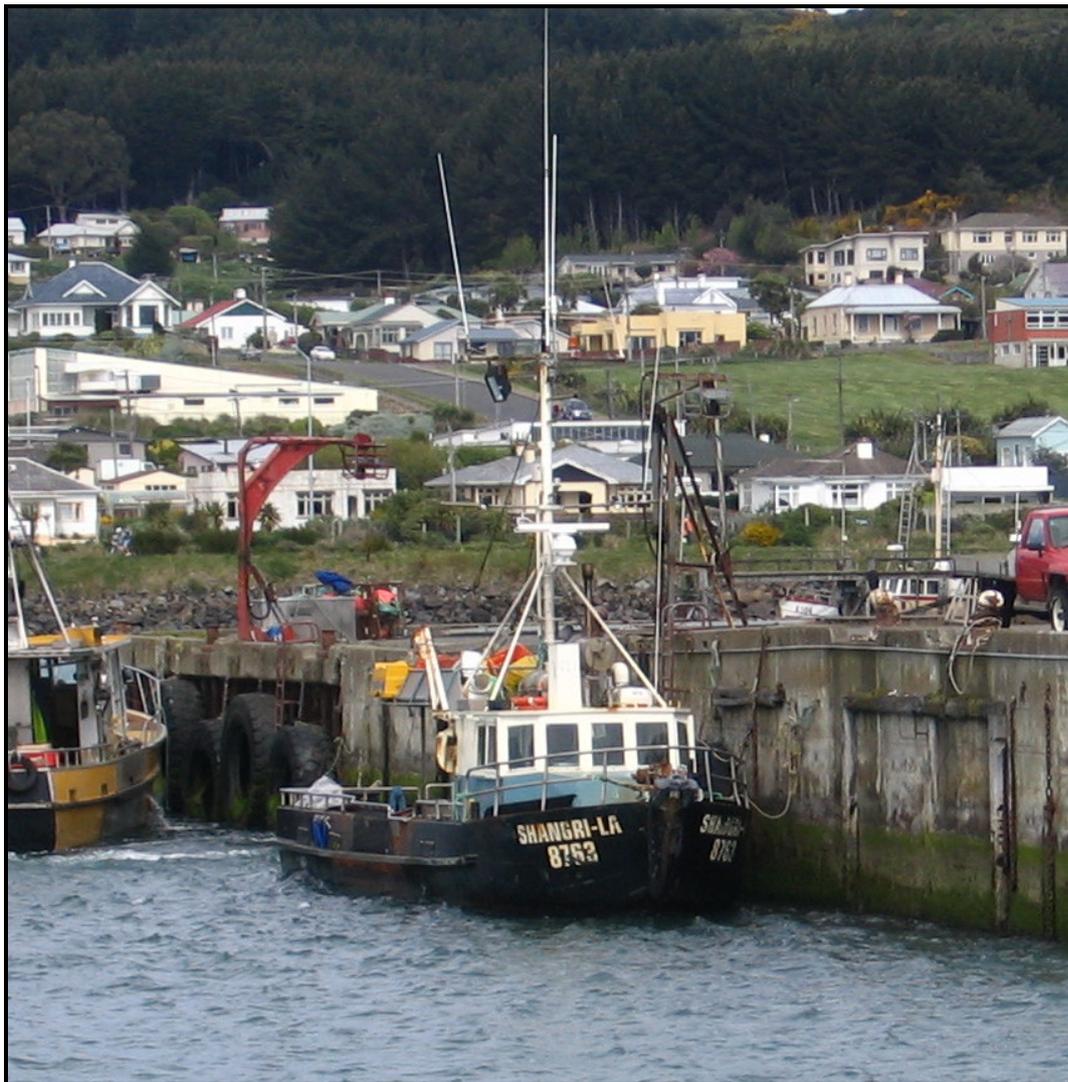
Shangri-La

Name of Vessel:	<i>Shangri-La</i>
MSA No.:	101361
Vessel Type:	Fishing vessel
Built:	1977
Construction Material:	Steel
Length Overall (m):	12.73
Maximum Breadth (m):	4.02
Propulsion:	Scania Diesel 280HP
Accident Investigator:	Andrew Hayton
