Investigation Report  
Grounding of *Te Ika*  
17 June 2010

**Maritime New Zealand**

## Executive summary

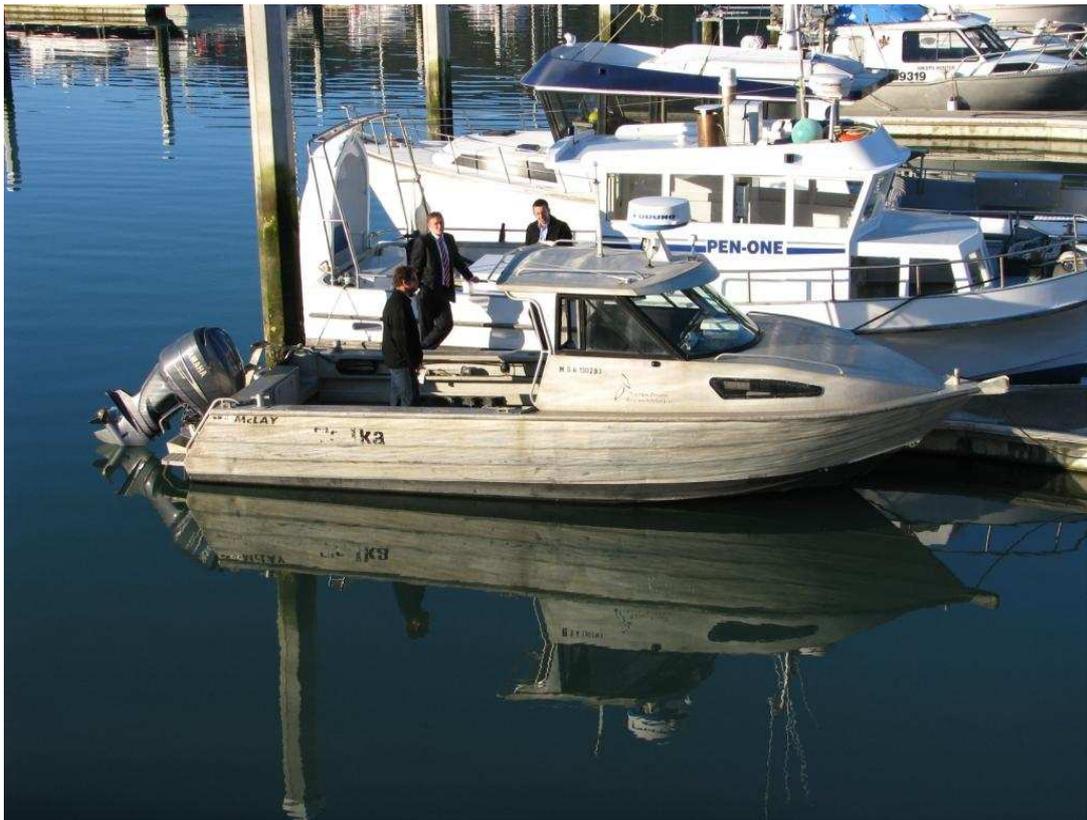
Figure 1 *Te Ika*

3. *Te Ika* is a 7.80 metre standard McLay designed aluminium mono hull, powered by a four stroke Yamaha outboard. The vessel is fitted with a Furuno Navnet which combines a Chart-plotter GPS and RADAR. The unit utilises Navtronics Gold © charting software. The vessel is not fitted with an echo sounder. The normal operating speed for the *Te Ika* is 28 knots. The vessel had a valid Safe Ship Management (SSM) certificate at the time of the grounding.
