# Accident Report

Capsize

*Time to Burn*

31 August 2008

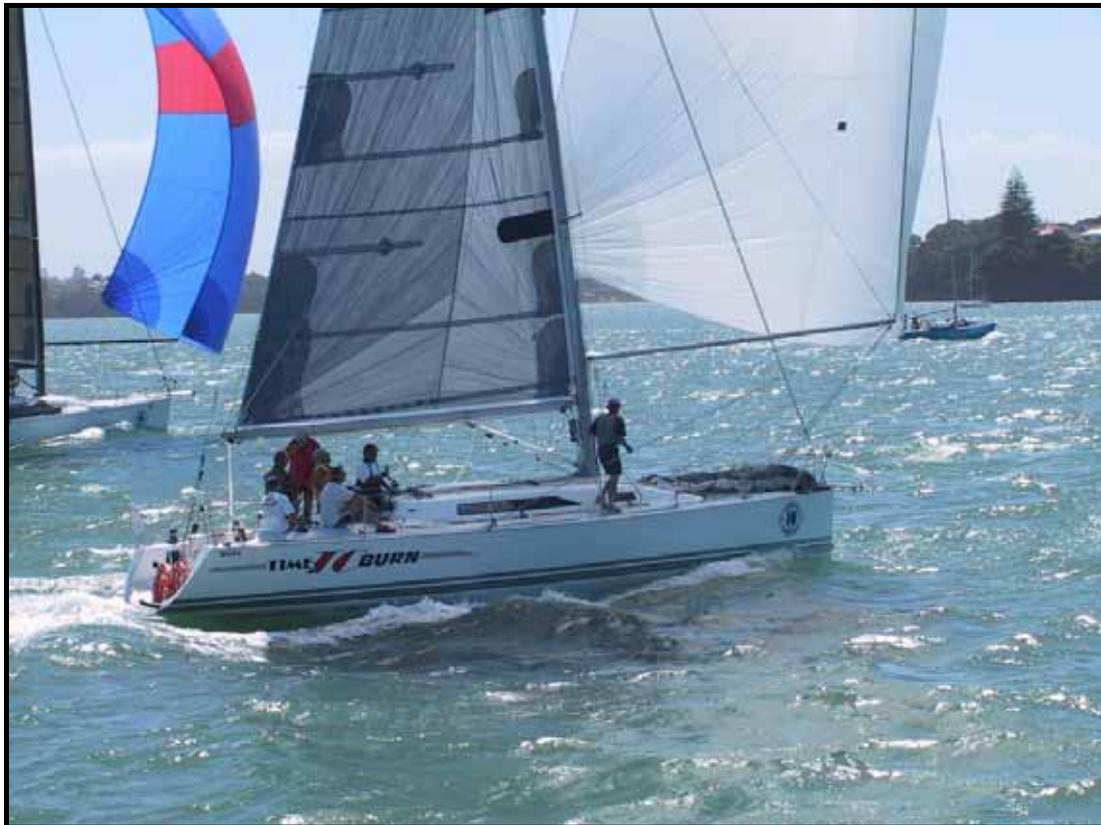
Photograph 1  
*Time to Burn*

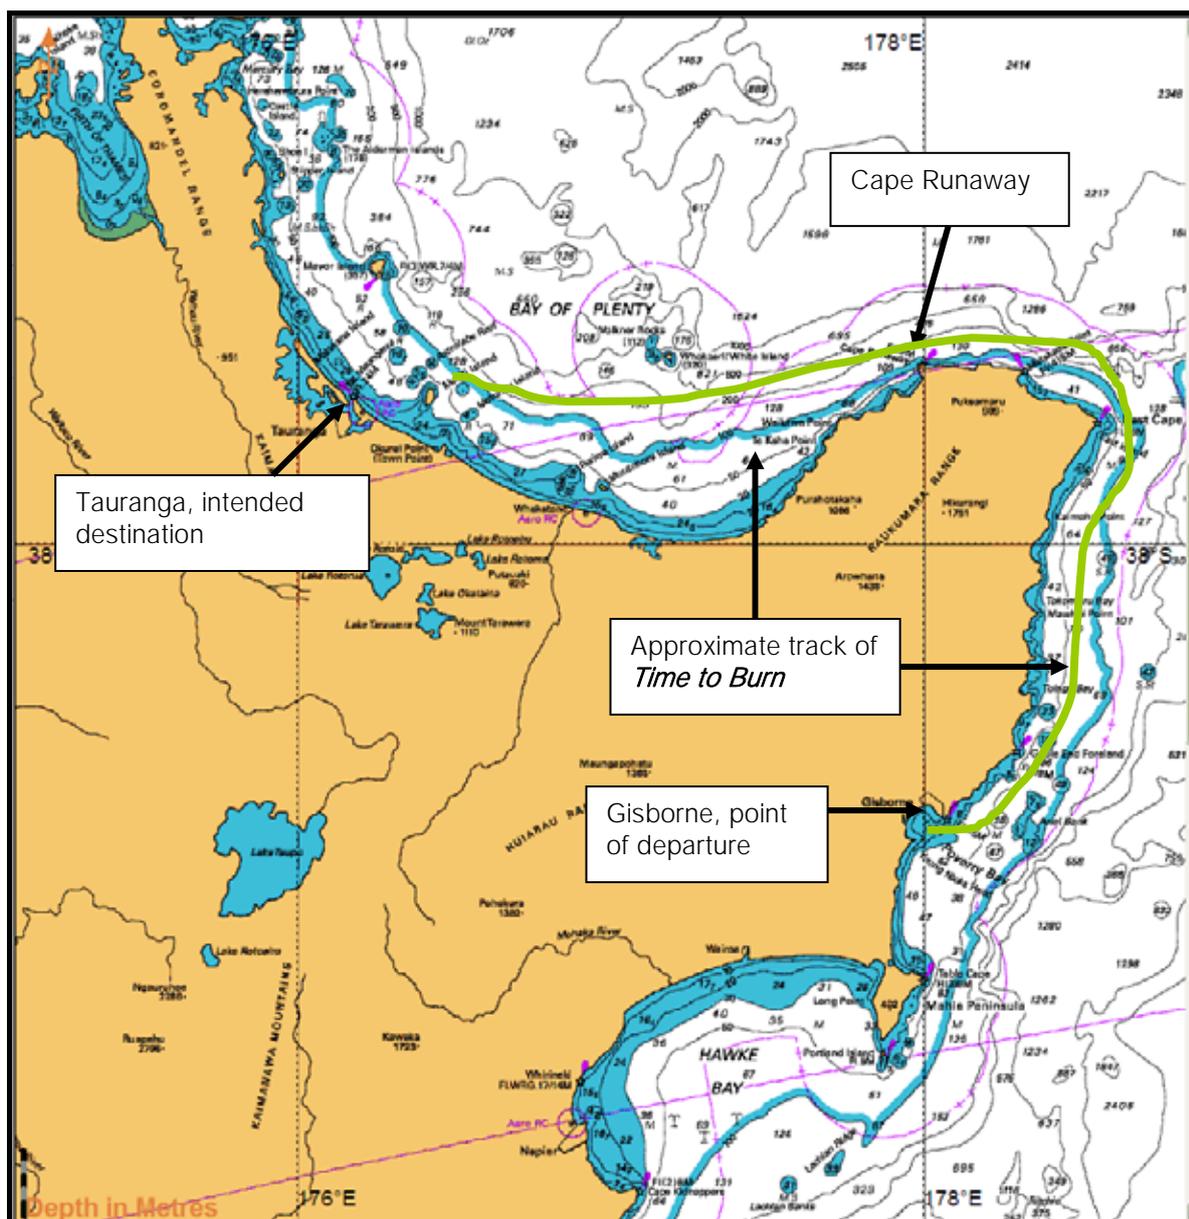
- 2.4 On 30 August at about 0630 hours *Time to Burn* departed Gisborne for Tauranga with two of the owners on board. (See figure 1 for the approximate track taken by *Time to Burn*.)

Figure 1  
 Extract of chart NZ23 New Zealand North Island, showing the approximate track of *Time to Burn* from Gisborne. (See figure 2 for detail on the vessel position off Tauranga.)

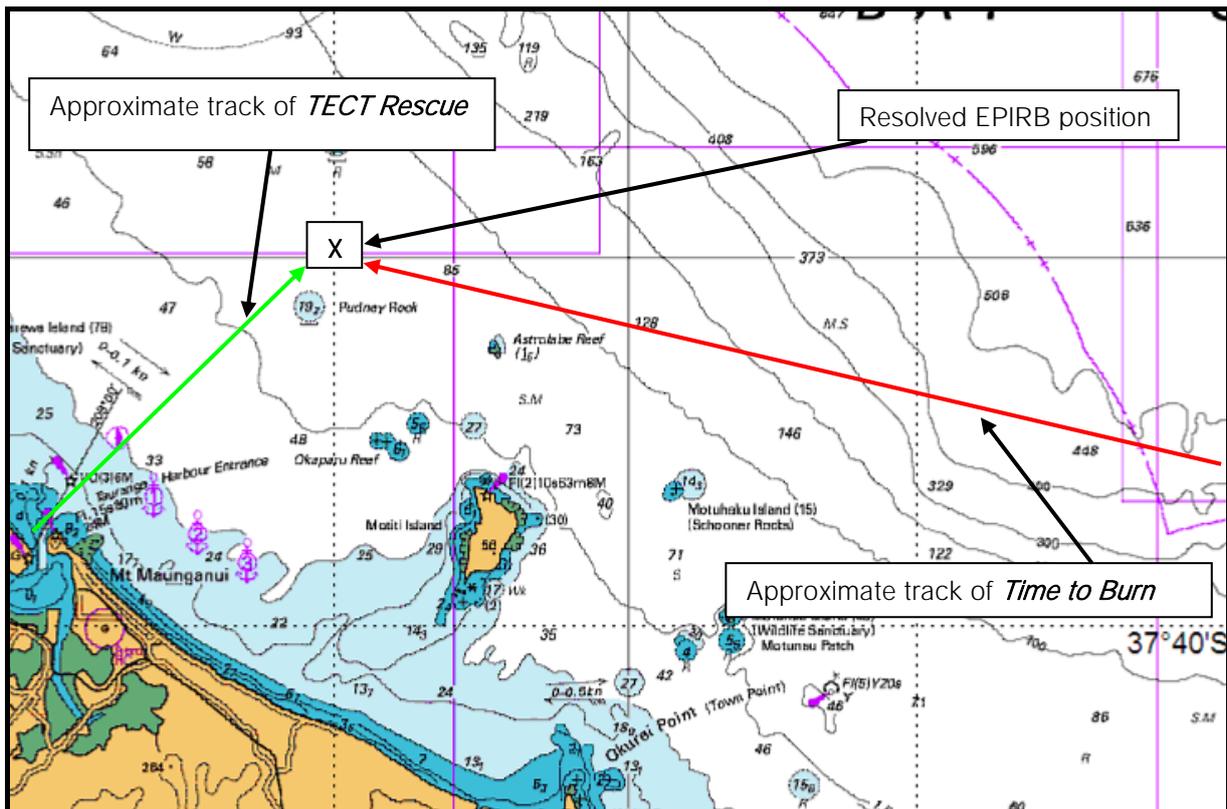
Figure 2  
Extract of chart NZ54, showing approximate track of *Time to Burn*, *TECT Rescue* and resolved EPIRB position.

0636 hours – The next satellite pass occurred and generated a second alert from the 406 MHz EPIRB transmissions. This alert gave a location for the distress at the position 37° 30'S 176° .20'E. RCCNZ gave this position to the aircraft, helicopter and Coastguard vessel. This was the first time that the agencies involved had a definite position to work with. (See figure 2 for resolved EPIRB position.)

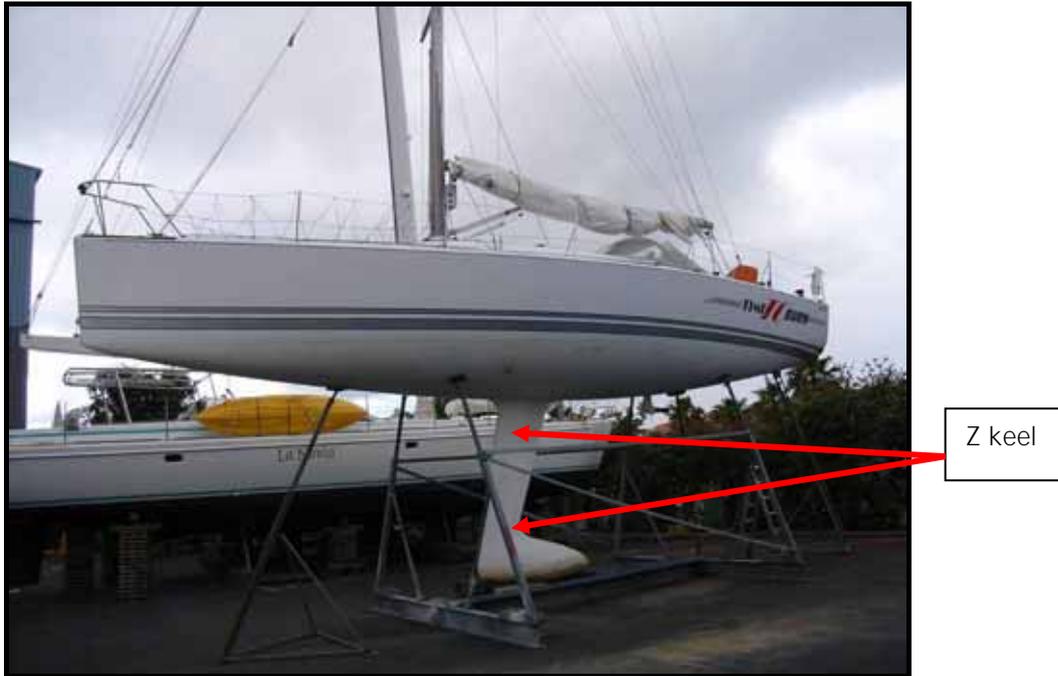
**Photograph 3**

(Courtesy of Hunter Marine Surveying Ltd) *Time to Burn* on a traditional cradle.

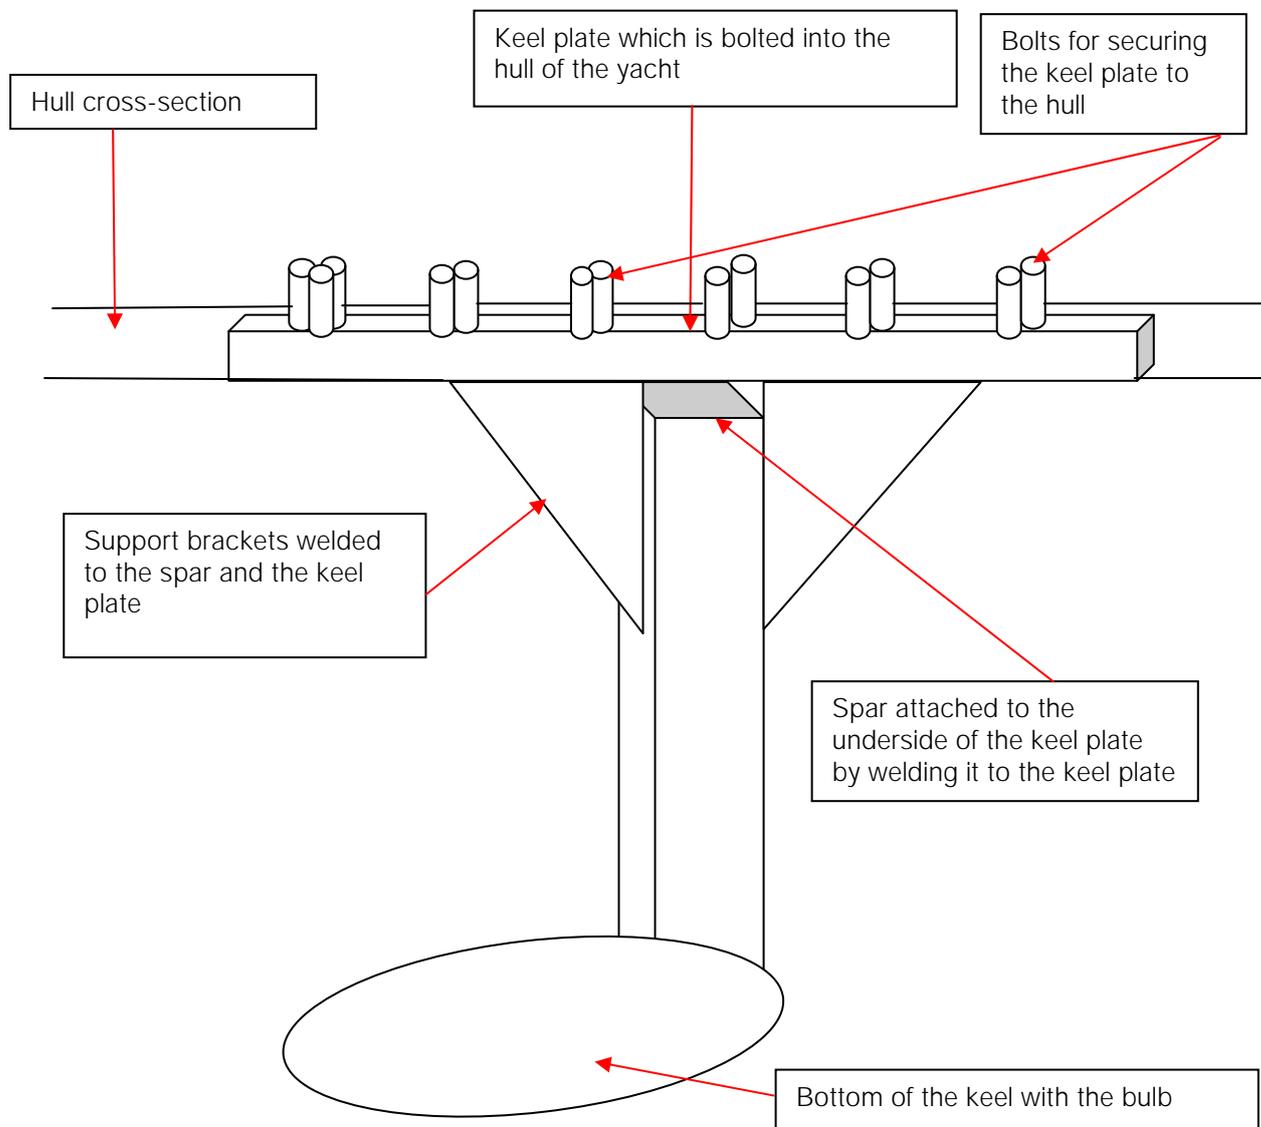
- 3.35 In simple terms, *Time to Burn's* keel plate, on which the keel structure was welded, was secured to the vessel's hull by bolting it to the hull. The keel plate was held in place by steel bolts. (See figures 3 and 4 and photograph 6 showing keel bolts.)
- 3.36 The keel comprised three basic parts: the keel plate (the part that bolts to the hull), the rectangular hollow section spar (the part that is fixed to the keel plate), and the bulb (the bulb is fixed to the hollow spar forming the bottom of the keel). The rectangular hollow section spar was connected to the keel plate by welding it to the plate.

**Figure 4**  
Visualisation of keel structure.

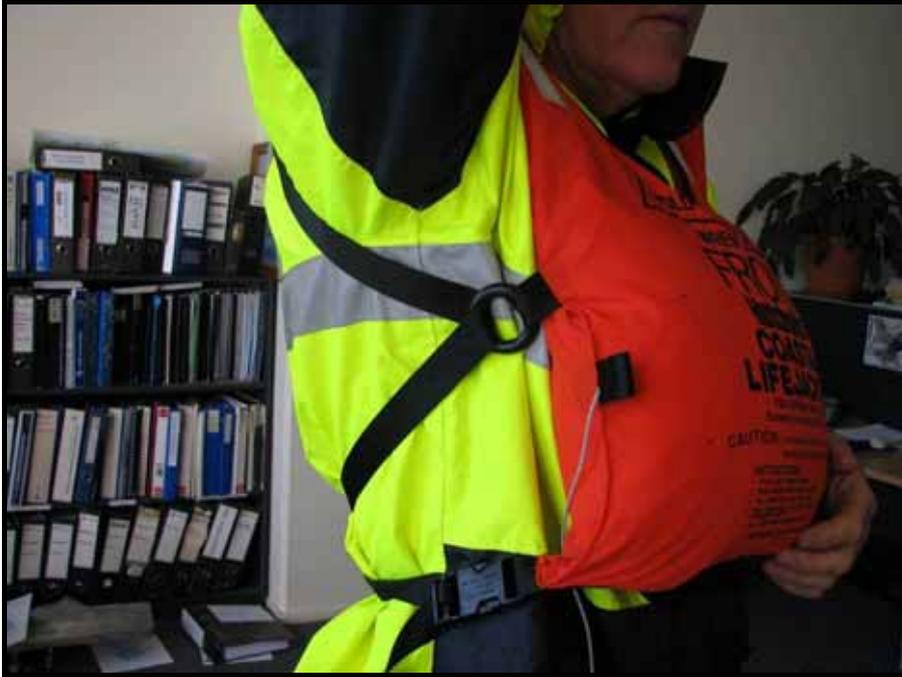
- 3.75 A properly fitted lifejacket is vital in situations where people in the water become tired, hypothermic or lose consciousness. (See photographs 10 and 11 of correctly and incorrectly fastened lifejackets.)

**Photograph 10**  
Correctly fitted lifejacket.

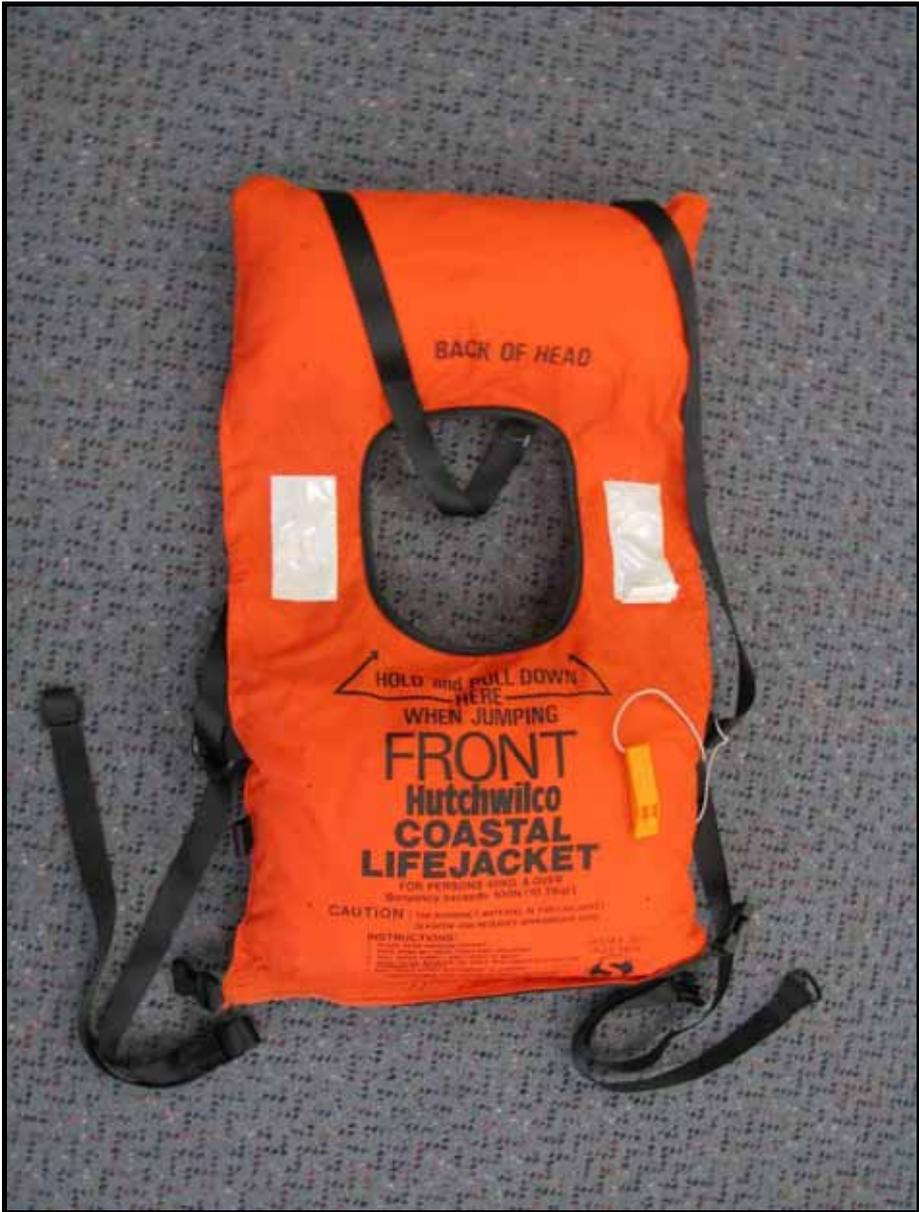
- 3.66 The crew opted to wear the 401 offshore lifejackets after previously experiencing failures with inflatable lifejackets. The offshore lifejackets are described as suitable for persons 40 kg and over with buoyancy exceeding 100 newtons<sup>13</sup>. The lifejackets were approved to NZS 5823. (See photographs 12 and 13 of the coastal lifejackets.)

Photograph 12  
One of the coastal lifejackets worn by the crew.

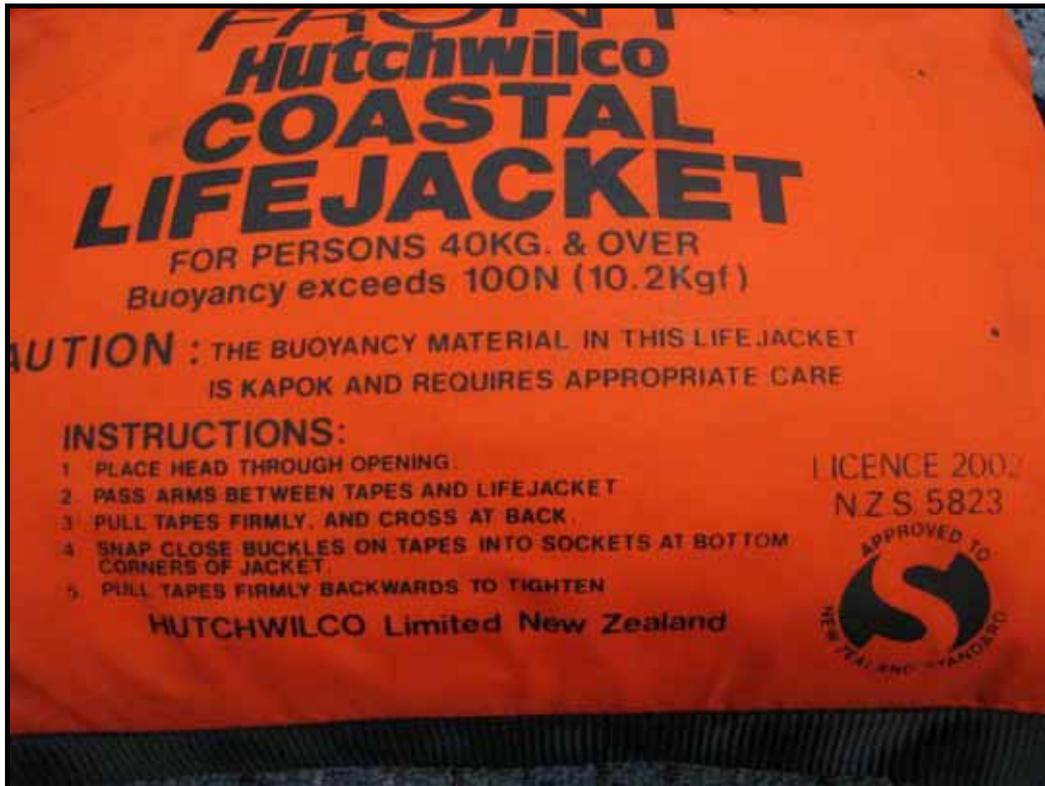
Photograph 13

Information on one of the coastal lifejackets worn by the crew.
