Accident Report
Foundering resulting in 2 fatalities
Viper 1
16 March 2009

Maritime New Zealand

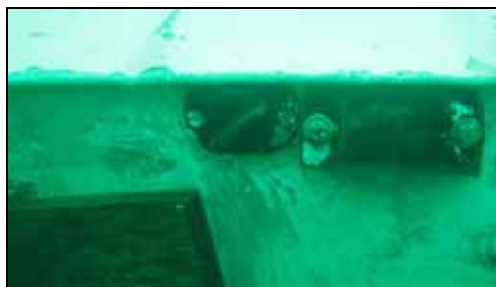
Photograph 16

- 3.28 *Viper 1* was fitted with a non-automatic bilge pump, and was known to leak to the extent that the fuel tank would sometimes begin floating. To rectify this, the skipper was known to usually turn the bilge pump on when returning to shore, however, the bilge pump was known to be unreliable.
- 3.29 Attempts to get the bilge pump working once the vessel was recovered were unsuccessful. The bilge pump was switched off when *Viper 1* was recovered, indicating that it was switched off at the time it sank.
