LESSONS LEARNT
BY ACCIDENT

LOOKOUT!

JUNE 2008 ISSUE NINE

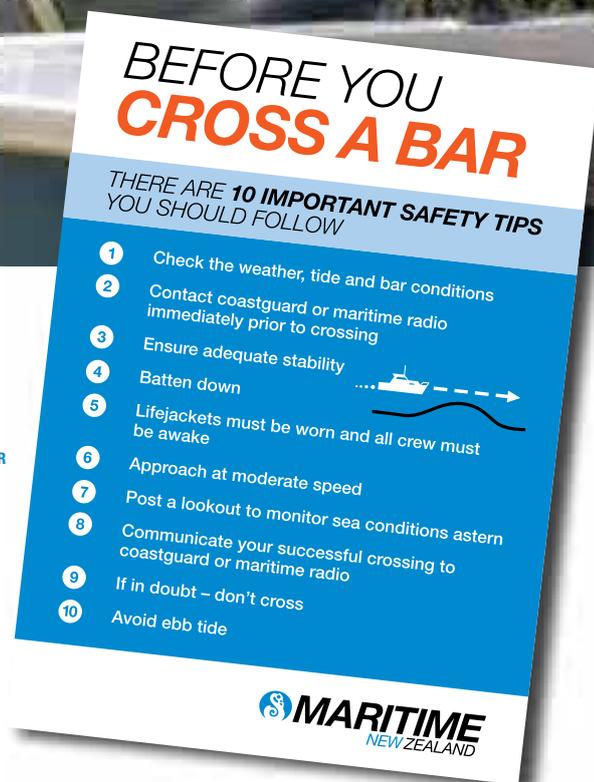
An injured skipper who could not swim spent 40 minutes being supported in 2 m swells by his crew after a botched bar crossing. None of the three people on board the runabout, which capsized during the bar crossing, was wearing a lifejacket.

As the two trapped men struggled clear of the upturned hull, the skipper became entangled in the anchor warp. It had broken free of its locker and had wrapped several turns around his torso and one leg before fully deploying. Because it was still tied off to the runabout, the skipper was being wrenched by the taught warp.

THE RUNABOUT CAPSIZED DURING THE BAR CROSSING.

1. Legal requirements in New Zealand for all persons on a boat crossing a bar are to wear a lifejacket, and at all other times of increased risk.

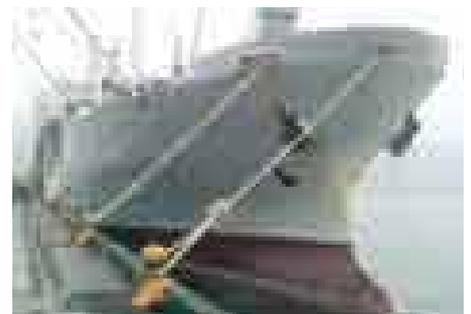
THE CONTAINER VESSEL.
