LESSONS LEARNT
BY ACCIDENT

LOOKOUT!

MARCH 2009 ISSUE TWELVE

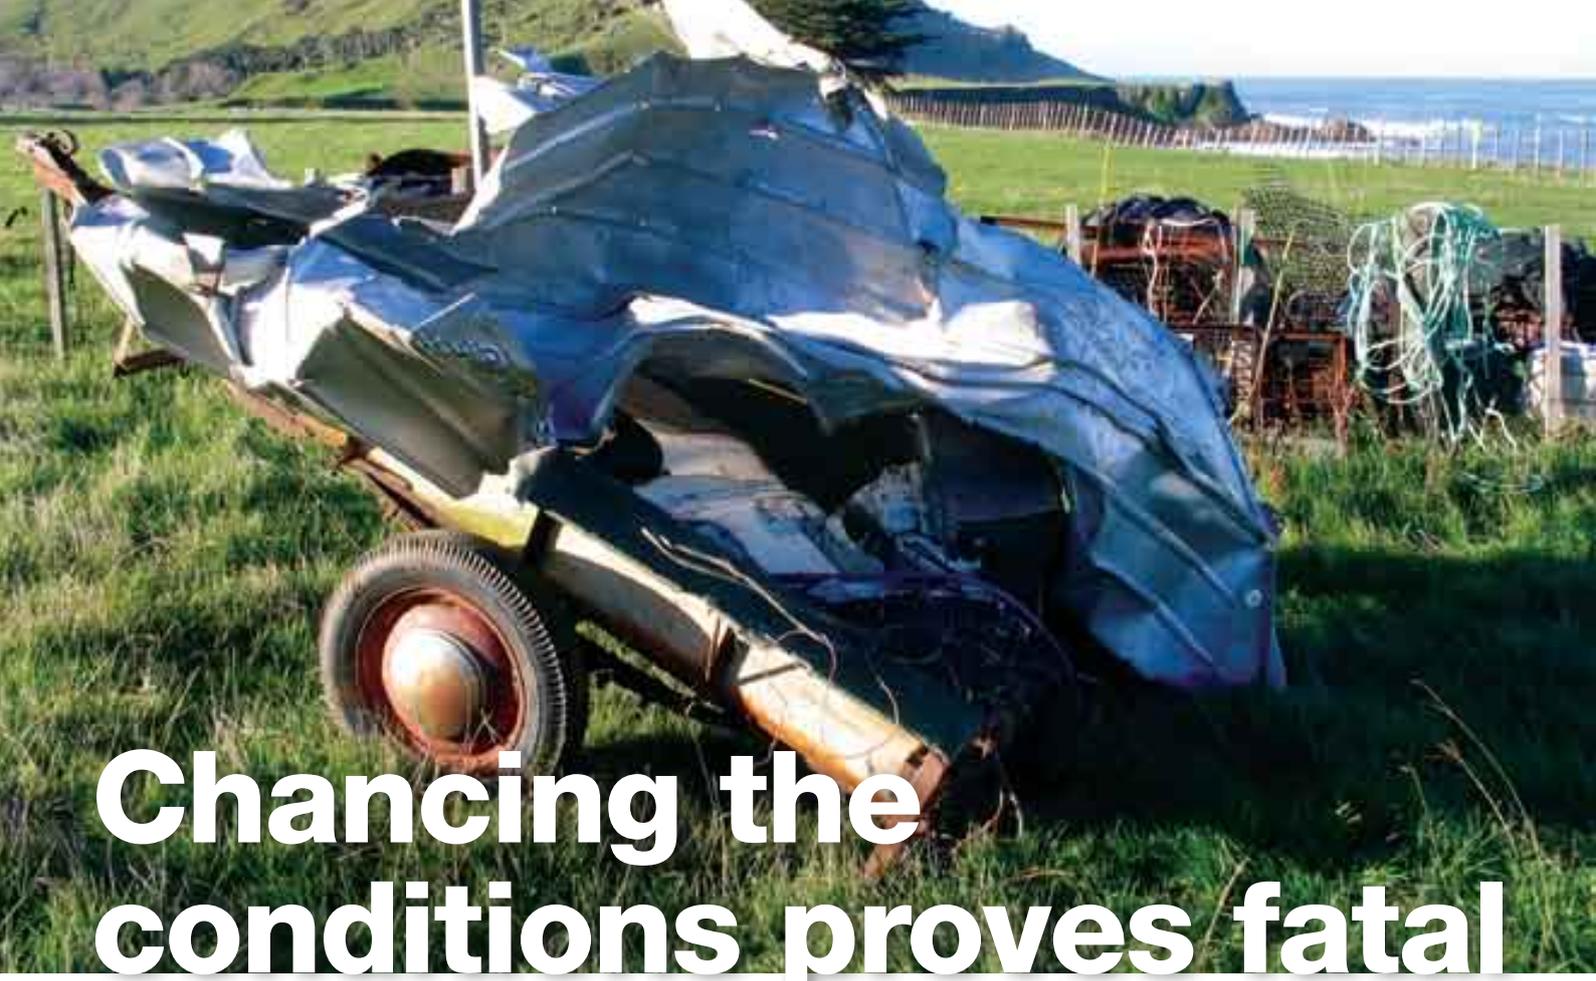
Chancing the conditions proves fatal

A man drowned after deciding to chance rough sea conditions in a friend's 15-foot aluminium runabout.

▲ THIS TRAGEDY INVOLVED TWO OF THE FOUR FACTORS COMMON IN PLEASURE BOAT ACCIDENTS – NO LIFEJACKETS AND FAILURE TO ADEQUATELY ASSESS WEATHER CONDITIONS.

1. The decision to make the trip in these conditions contained an element of chance. The men had spent most of the day deciding not to take that chance, but in the mid-afternoon, they decided to go. The lulls in the waves that they felt had provided a suitable safety margin were described by witnesses as lasting "about the time it takes 10 waves to come in".

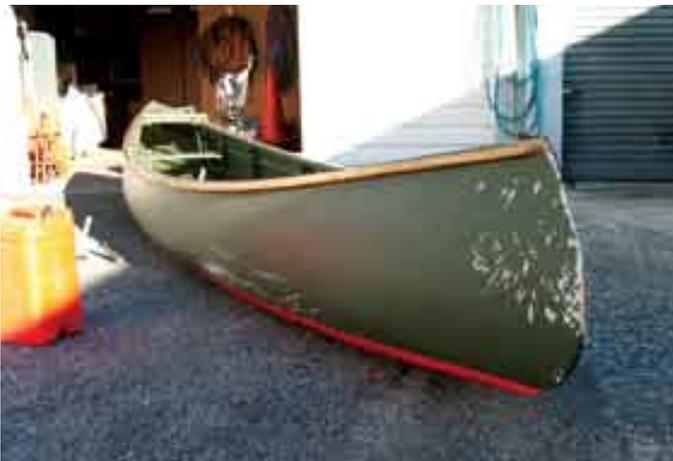
The first man managed to calm his companion, but by then the canoe was being blown toward the opposite shoreline, which was rugged and uninhabited. The pair decided to cut loose two 20 litre containers from under the canoe seats, which had been used as additional buoyancy, and abandon the canoe.

The first man struggled to keep his companion afloat, but his efforts were unsuccessful. The first man managed to reach shore dizzy, confused and suffering hypothermia. After resting to regain his vision, he was able to raise the alarm.

▲ CANADIAN OR OPEN-TOPPED CANOES ARE POPULAR FOR RECREATIONAL USE AND DUCK SHOOTING, AS THEY ARE CAPABLE OF CARRYING HEAVY OR BULKY LOADS AND EQUIPMENT. THEY ARE LESS RESILIENT TO THE EFFECTS OF SWAMPING THAN CLOSED-TOP KAYAKS.

1. Neither man wore a lifejacket, which was an exception for them both. They were both known to be fastidious in their use of lifejackets, but had failed to carry them on this occasion. Maritime law requires that lifejackets be carried and be easily accessible. They must be worn when there is any increased risk.

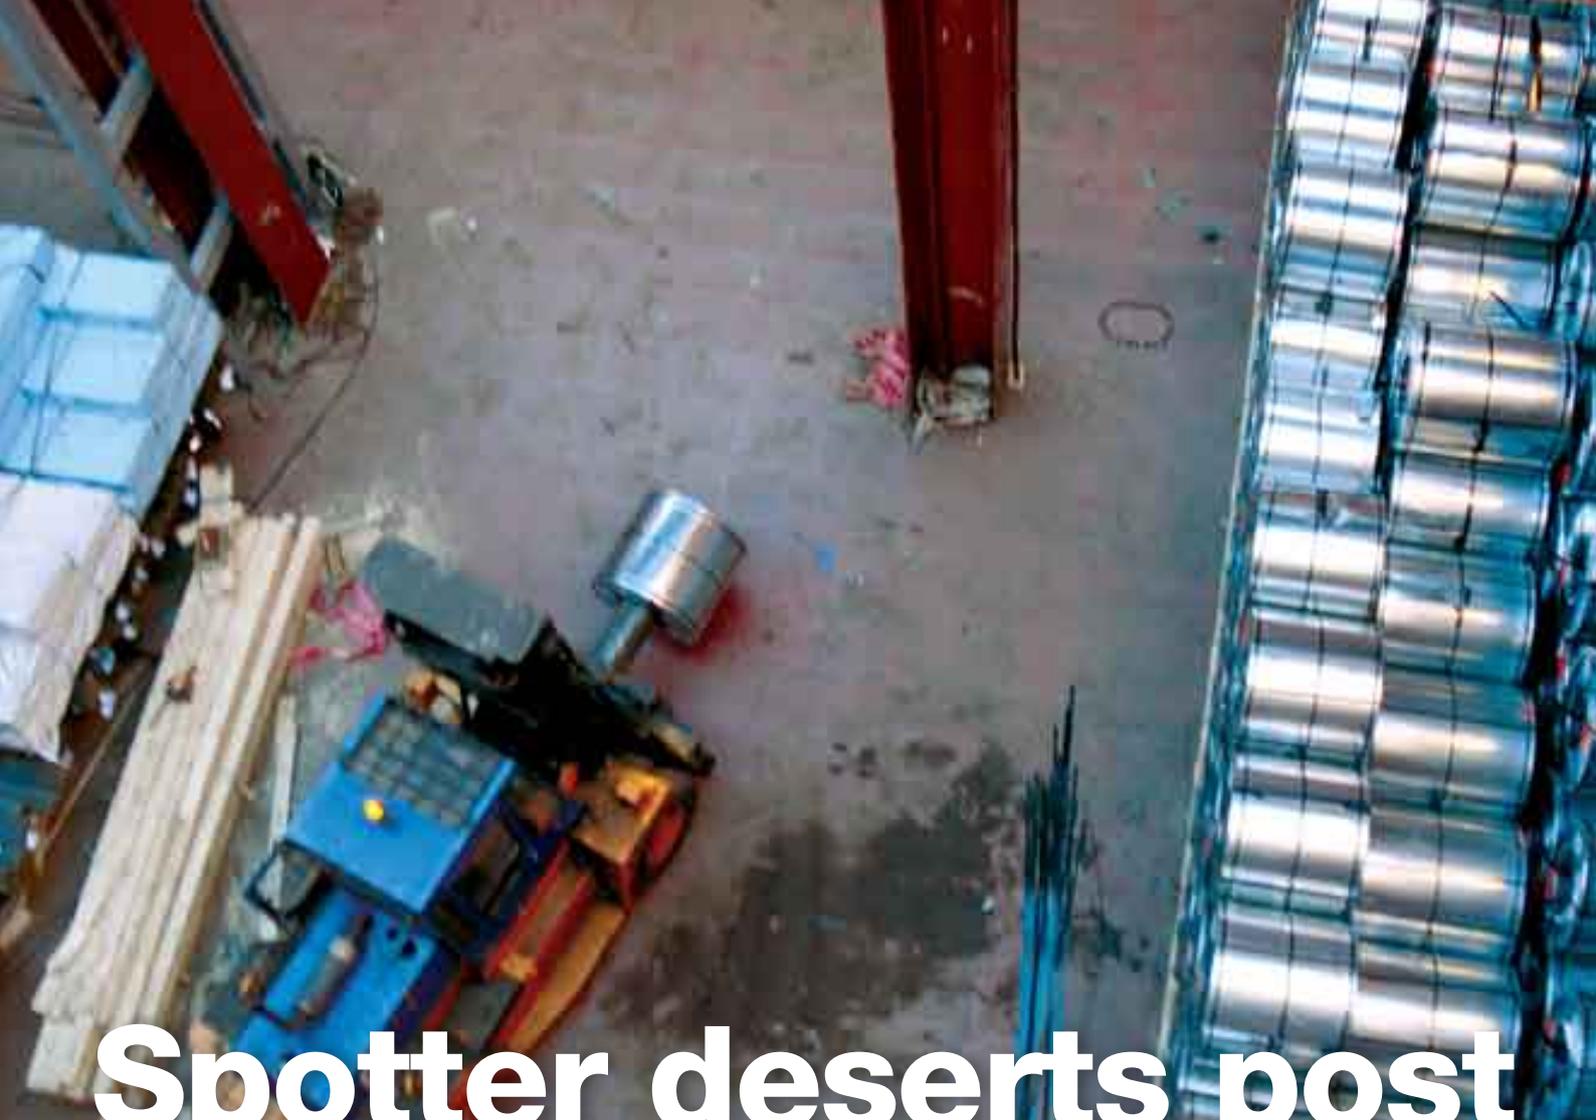
Spotter deserts post

An inexperienced stevedore was struck by a forklift when the gang's supervisor stopped monitoring safety.

The stevedore was initially thought to have broken his leg, but was later discharged from hospital with severe bruising.

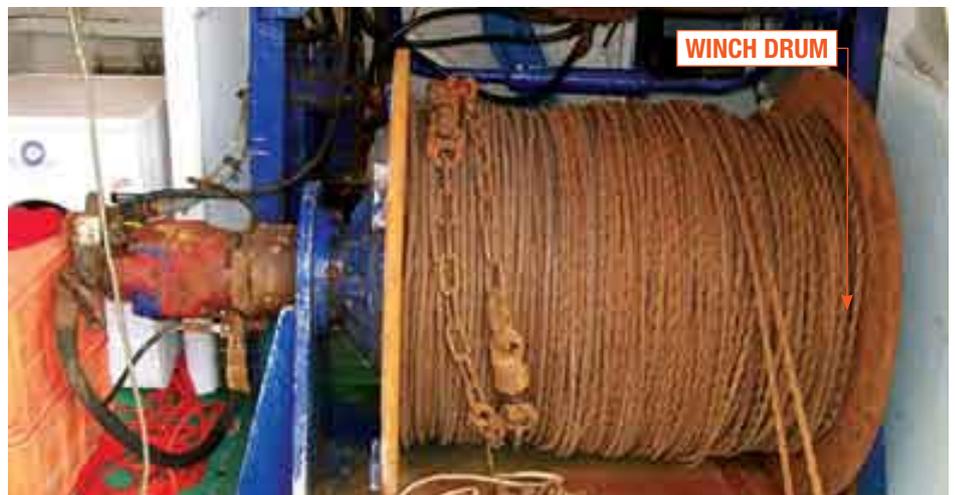
▲ THE OPERATOR MUST STAND BEHIND THE WINCH AND MONITOR THE WIRE LEVEL, AS WELL AS THE SPEED AND AMOUNT OF WIRE RETRIEVED SO FAR.
