# LOOKOUT!

DECEMBER 2008 *ISSUE ELEVEN*

***A yachtsman dies***  
***after falling overboard***

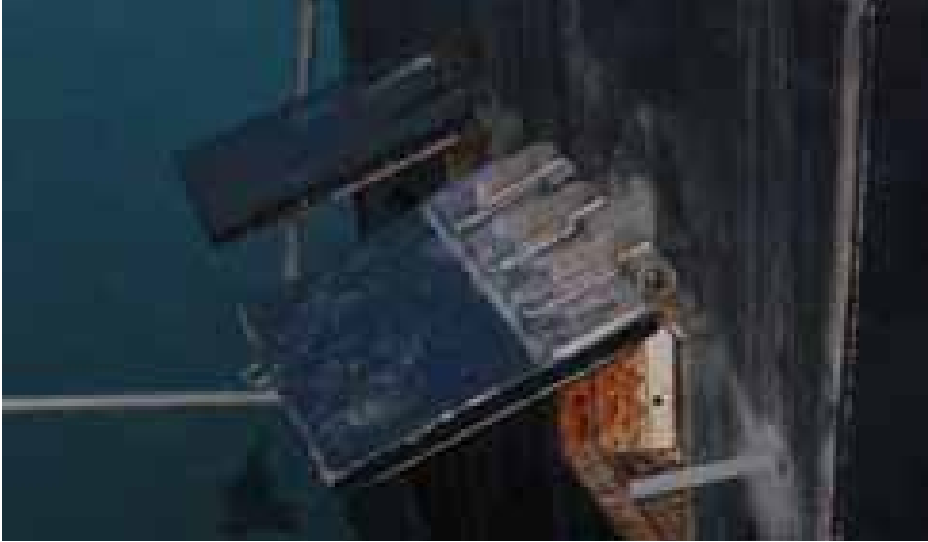
## The loss of one small hinge led to complete steering failure on a deep sea, long line fishing vessel at sea.

During operations, the long line was set into the water via one of two hatches set above the water line at the stern. Each hatch was fixed along the top with two hinges. With a heavy catch on board and 4 to 5 metres swells, one hinge on the starboard hatch failed. The remaining hinge was now under extra pressure, and after a further 2 hours, it too failed. With the hatch cover now held in place only by the hydraulic ram, the crew decided to remove it inboard and carry on fishing.

As the vessel continued with the haul, the position of the catch and the swell tended to cause it to roll to starboard. A significant amount of water started to enter through the open starboard hatch. The hook room

scuppers were quickly submerged and failed to operate effectively.

**1.** A breather pipe that led to the steering flat was found to terminate near the open hatch, and water had shorted out the steering pump. This design flaw had not been noticed before and the company plans to make changes on this and all of its vessels of similar design.

**2.** The hatch was last checked 8 days prior. It was an internal inspection as the ship was at sea. There was no external inspection, but the ship had been surveyed and found to be in good order 5 months earlier. The ship's engineer has been advised to ensure a regular external inspection is done, perhaps before the vessel leaves port.

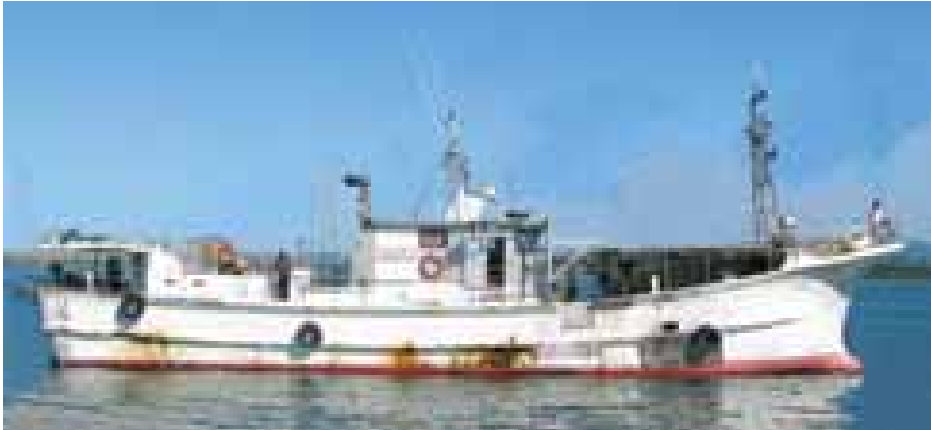
THE VESSEL.

# Unsecured, untidy and on fire

The vessel was returned to port under tow the following day. It had suffered extensive smoke damage to the engine room and minor damage to the electrics and the main engine's turbocharger and casing.

**1.** A fire safety officer reported that the most likely cause of the fire was plastic falling onto the engine's turbocharger casing and igniting. Inspection showed numerous plastic containers, aerosol cans and diesel-soaked rags scattered around the engine room. An open plastic container full of diesel sat by the main engine, and plastic trousers had been hung up to dry. There were several examples found of improper engineering practice. A flexible wire pull allowed the full flaps to be shut off remotely from the accommodation. This wire had broken at some time and had been repaired with a knot. The knot would not have

**2.** The fire burnt through all of the plastic material on the turbocharger and then extinguished. If there had been more combustible material scattered nearby, or if the open diesel container had ignited, the fire would have been far more serious.

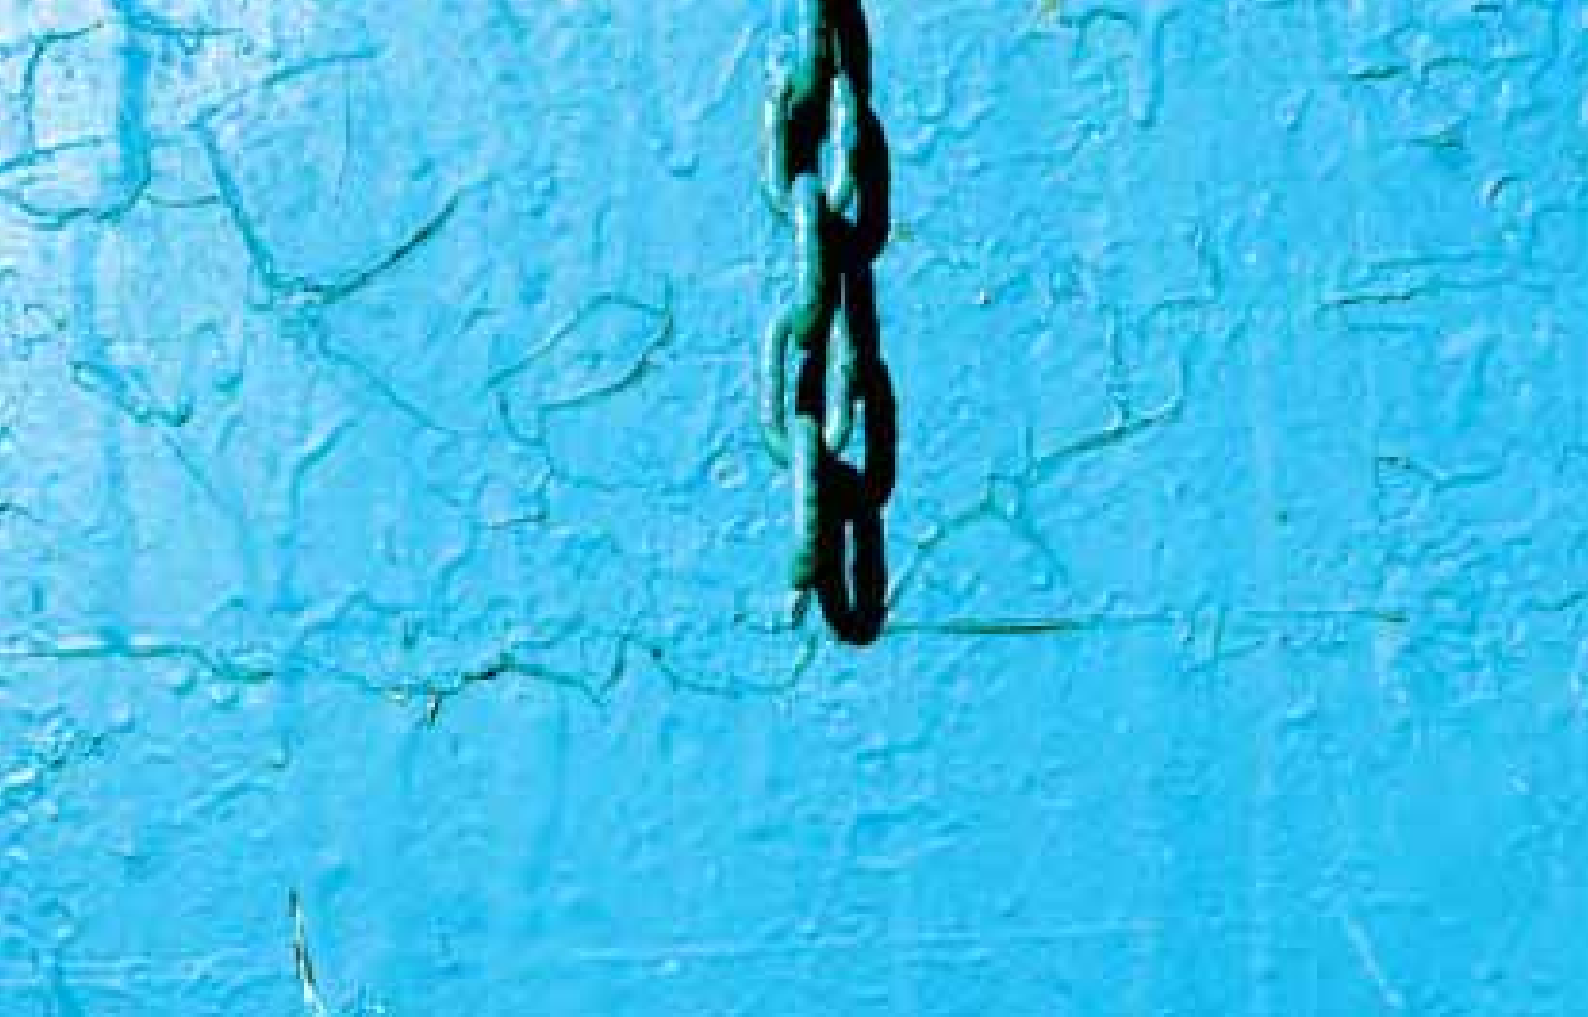
# Between a rescue boat and a hard place

“ THE CREWMEMBER REACHED OUT TO TRY TO FEND OFF THE APPROACHING SIDE OF THE VESSEL, TRAPPING HIS RIGHT THUMB BETWEEN THE RESCUE BOAT AND THE SHIP’S SIDE. ”

**1.** The rescue boat was not hanging correctly at its lift points. A larger, heavier outboard motor had been retrofitted and this had affected the vessel’s centre of gravity. The boat was also not stabilised by fore and aft lines as it should have been.

**2.** The crane operator was lifting the boat out board of the vessel. The international best practice method for retrieving a rescue boat is to lift it hard against the side of the ship. This information is covered in the crane operation unit standards available and administered by the Seafood Industry Training Organisation.

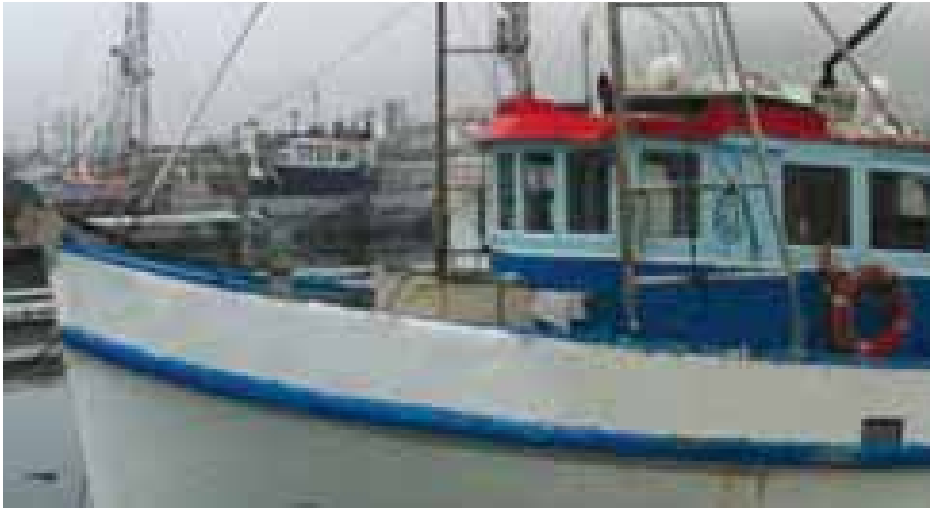
ONE OF THE VESSELS.

## Two wooden offshore fishing vessels collided while one skipper slept and the second skipper was preoccupied with a repair.
