IHI SERVICE INFORMATION	QAS—0021A
DECK CRANE DAMAGE PREVENTION OF CARGO BLOCK	15th Nov. 2013

The cargo block of IHI deck crane was damaged by operator's mistake during operation. We have confirmed with the following 2 cases about the cause of damage from the result of investigations. Please note that do not operation which is not allowed in our instruction manual, it may directly cause an accident.

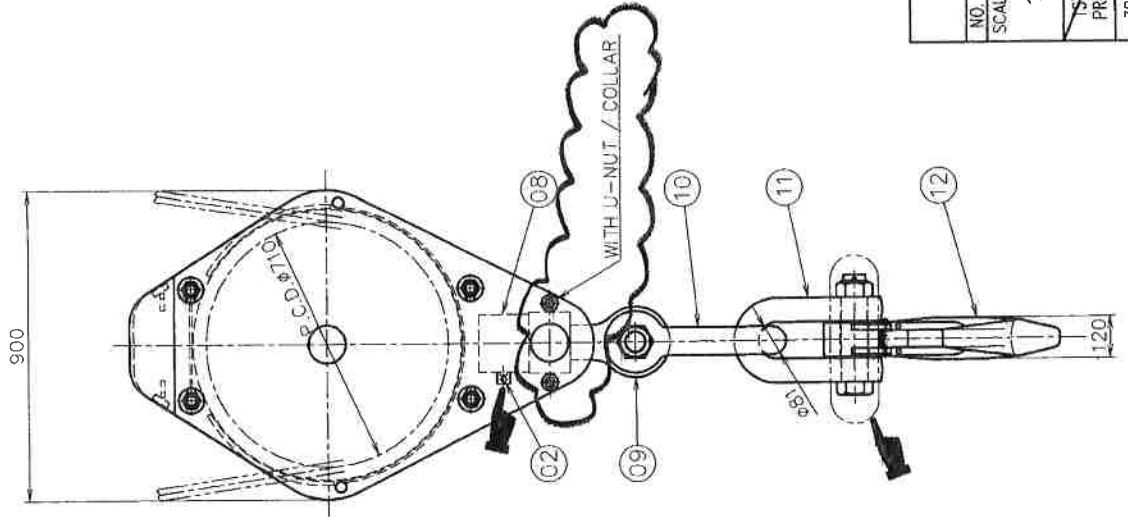
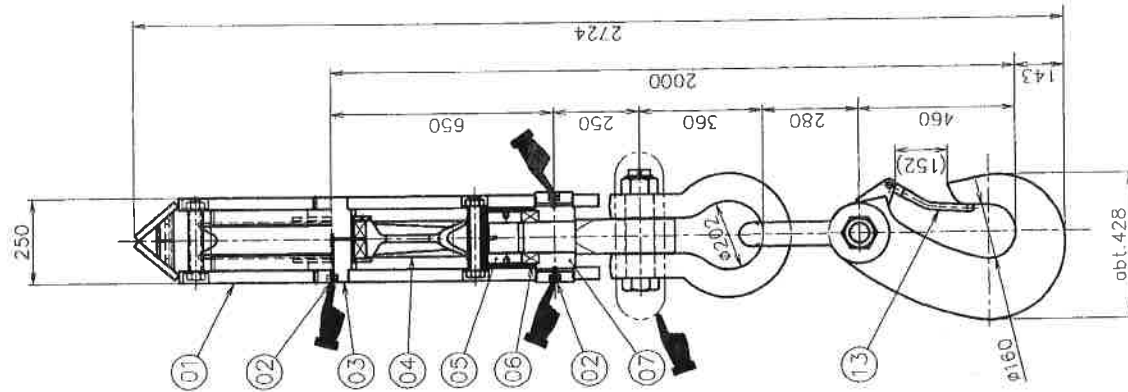
FOR REFERENCE

This reinforcement plan has strength of about 200% compared with standard cargo block. But, please check the daily inspection (deformation, defect, defective motion, etc.) to the cargo block before loading, during loading and after loading.

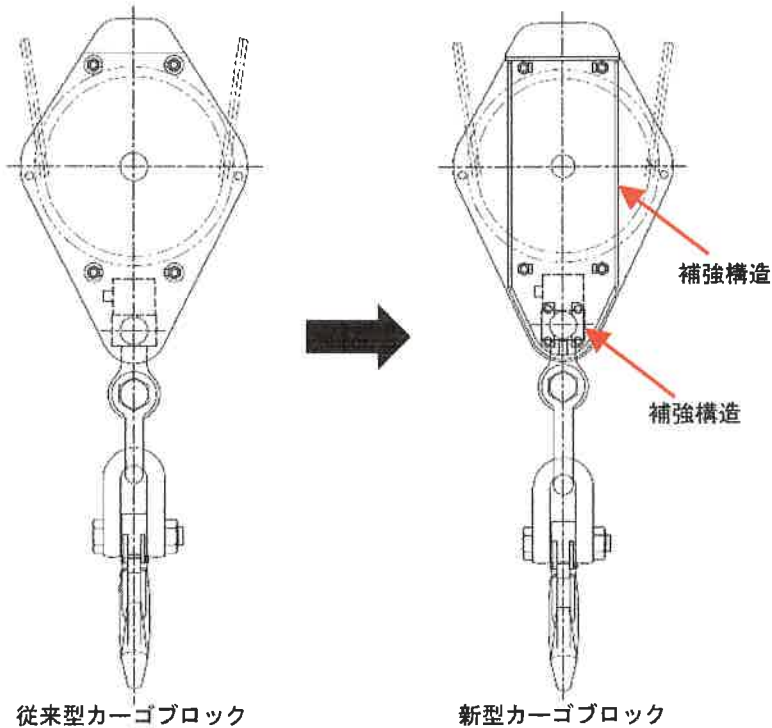
上述のとおり、カargoブロック損傷は、クレーンのミスオペレーションによって発生したことが確認されましたが、製品の安全性を高めるため、今後製造されるデッキクレーンでは、カargoブロックをより堅牢な構造に変更いたします。

5. 既存船の安全対策

一部の港湾では、類似のカargoブロック損傷が起こらないよう、港湾荷役員などがカargoブロックに補強の追加を求め、荷役拒否に至る事例があります。
